UAV data acquisition and analysis for a Cultural Landscape Heritage: the emergency area of the Vallone d'Elva.

E. PONTOGGIO¹, I. AICARDI¹, A. CALANTROPIO², E. COLUCCI¹, V. DI PIETRA¹,
N. GRASSO¹, A. LINGUA¹, P.F. MASCHIO¹

UAV DATA ACQUISITION AND ANALYSIS FOR A CULTURAL LANDSCAPE HERITAGE: THE EMERGENCY AREA OF THE VALLONE D'ELVA

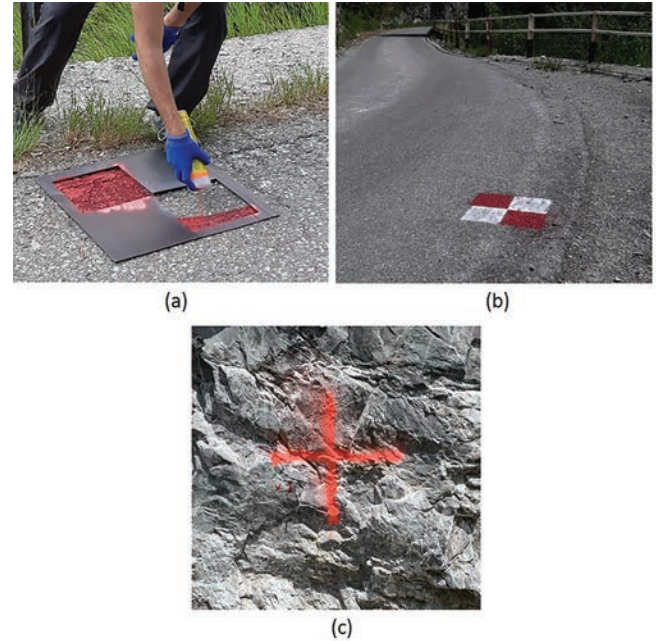
Figure 3. Control points materialization: (a) colouring of highly visible markers (30x30 cm) along the street, using a specially made template; (b) a horizontal marker; (c) a vertical marker.

Starting from the reference vertices with RTK GNSS survey, some photogrammetric control points has been acquired on markers, both on horizontal street surface and on vertical rock facades (Figure 3).

Finally, the positions of 54 vertical markers (Figure 3c) and 120 natural target points were measured by a total station (Leica Image Station) located on the reference vertices. All measurements were subsequently adjusted with the MicroSurvey StarNet v.9.0 software tool, in order to obtain the final coordinates: the RMSE (Root

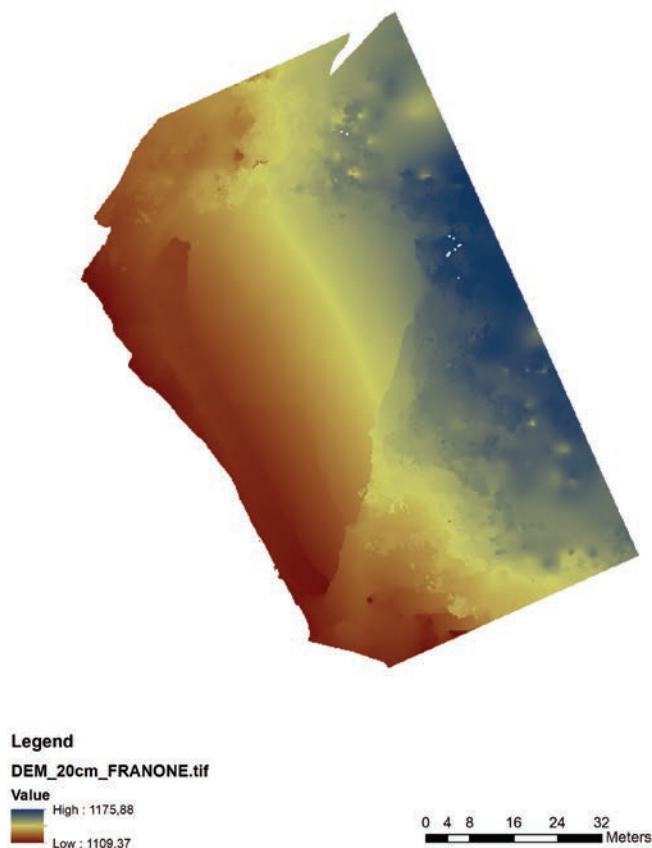
Figure 6. DSM generated on the LL site.

High density point clouds (about 1 point each 4 cm) and a moderate level of noise have been obtained: some noisy points, caused by vegetation and border effects have been removed manually. The triangulated 3D models have been obtained using the setting "high" of AMS (i.e. using 1/5 of the number of points of the source dense point clouds), generating high resolution meshes in terms of faces and vertices number, as summarized in Table 5. The final steps had regarded the generation of the DSM and the relative orthophotos in the coordinates system WGS84 – UTM 32N using the relative meshes (detailed in Table 6), as shown respectively in Figure 6 and Figure 7.
