## Tensile Stress Rupture Behavior of a Woven Ceramic Matrix Composite in Humid Environments at Intermediate Temperature

DISSERTATION

Kevin J. LaRochelle, Major, USAF

AFIT/DS/ENY/05-01

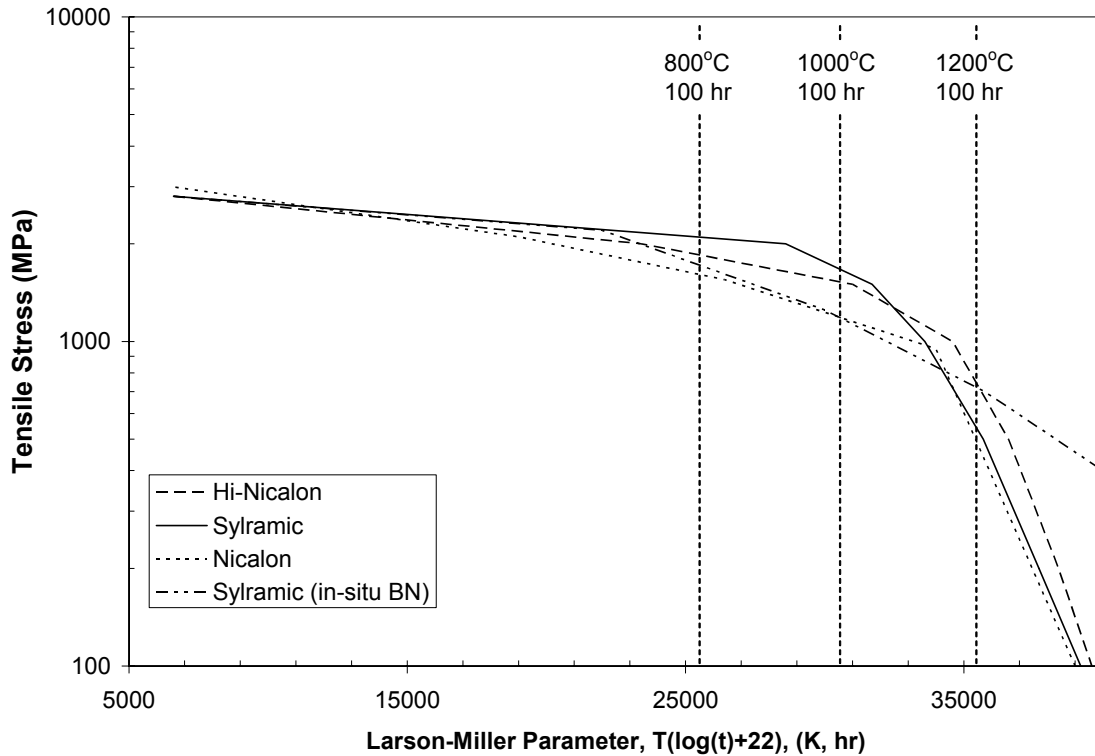
**Figure 7: Larson-Miller plot for Nic, HN, Syl, and Syl-iBN fibers [10,27,28]**

Figure 7 [10,27,28] is a Larson-Miller plot for four SiC fibers: Nicalon™ (Nic), Hi-Nicalon™ (HN), Sylramic™ (Syl), and Syl fiber with an in-situ BN layer (Syl-iBN). The relationship between fiber stress rupture strength and both time and temperature can be seen in these plots (i.e. one fiber may be more stable at a particular temperature while another is more resistant to oxidation at another temperature). When comparing the fibers, the higher the curve on a Larson-Miller plot, the more resistant the fiber is to failure. The slopes of the curves indicate the rate at which the fiber strength degrades.

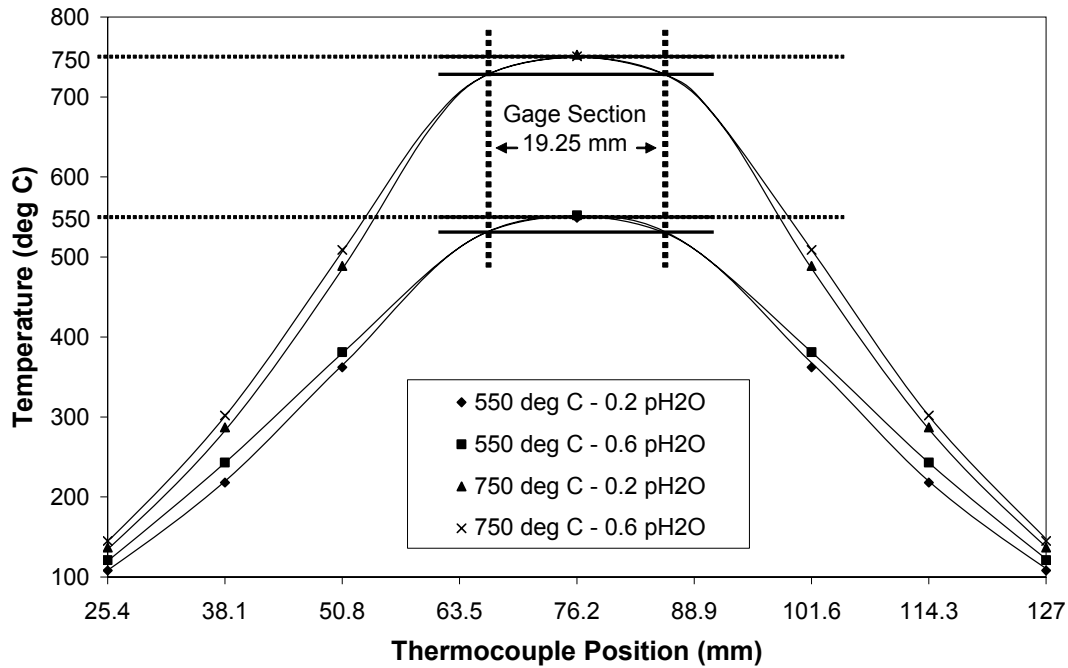
**Figure 25: Temperature Profile Plots**

occurred within this gauge length. Third, the specimen temperature in the center of the gauge length was the same as the heating chamber temperature. Hence, it was determined the Syl-IBN/BN/SiC specimen was not being inductively heated to a higher temperature than the heating chamber temperature.

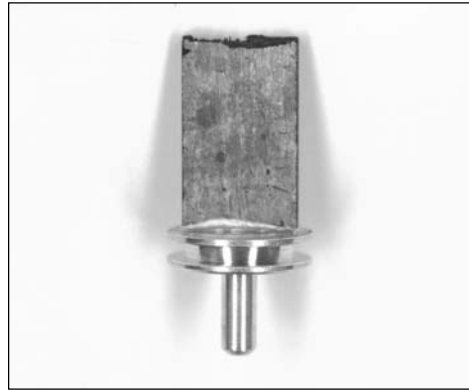
**Figure 28: Fracture Surface Specimen**

Figure 27 is an image of a failed specimen. The bottom portion of the failed Syl-iBN/BN/SiC specimen was used to get fracture surface data since it was removed from the heating chamber immediately following failure. This ensured the surface was not exposed to the hot humid environment after the failure. The fracture surfaces specimens, shown in Figure 28, were cut using either a Buehler Isomet 1000 or Buehler Isomet 2000 saw with Buehler Isocut Cutting Fluid approximately 12.5 mm away from the fracture surface and then mounted on silver SEM posts using various types of silver paste and paint.

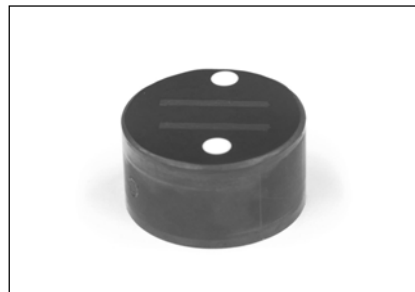
**Figure 29: Crack Density/Spacing Specimen**

The upper pieces of the failed Syl-IBN BN/SiC specimens were also cut using either a Buehler Isomet 1000 or Buehler Isomet 2000 saw with Buehler Isocut Cutting Fluid approximately 12.5 mm from the fracture surface. These pieces were mounted in Buehler Konductomet Conductive Filled Phenolic Mounting Compound using the Buehler Simplimet 2000 and then polished using Buehler Metadi Diamond Suspension water based solution (9, 6, 3, 1, 0.25 micron) and various Buehler polishing pads on either the Buehler Phoenix 4000 or the Buehler Vibromet 2, as shown in Figure 29.

Crack density measurements were attempted in this research to see if the crack density was dependent on temperature and moisture content level. The measurements were made using both bright field and dark field lenses to accentuate the cracks. Interior and exterior plies were scanned, and cracks, which extended through the entire ply, were counted. The cracks per ply were averaged and divided by the specimen length to determine an overall specimen crack density measurement. Figure 30 has two examples of through-the-ply cracks seen in this research.
