HURRICANE RISK OF MULTI-FAMILY DWELLINGS IN PUERTO RICO

Peter L. Datin

*Risk Management Solutions, Inc., 7575 Gateway Blvd., Newark, CA, USA, peter.datin@rms.com,
<http://www.rms.com>*

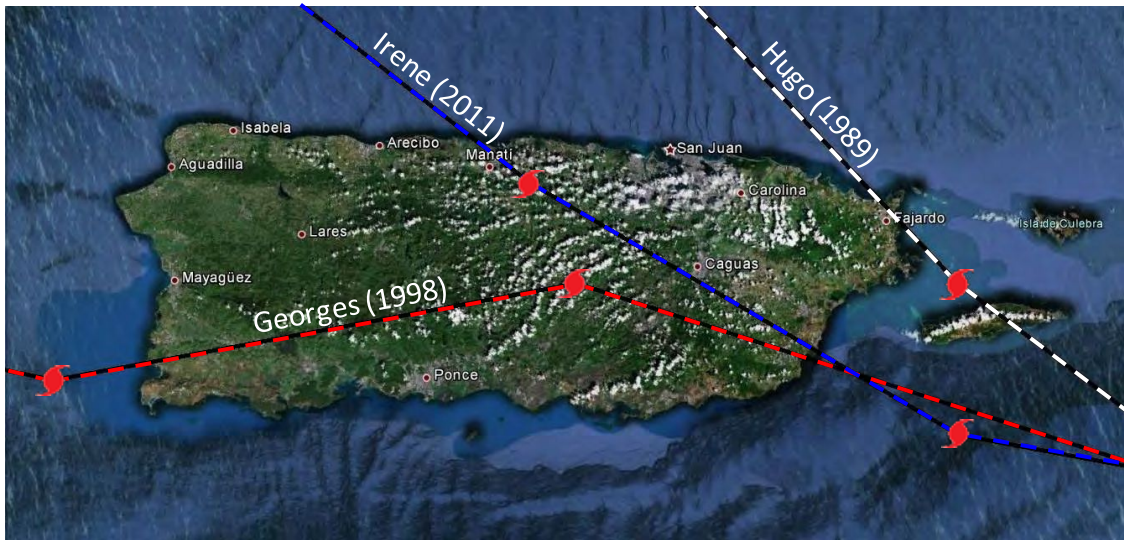
Figure 1: Major hurricanes to impact Puerto Rico

Hurricanes in the North Atlantic Basin cause widespread damage to the Caribbean islands on a regular basis. Puerto Rico is highly susceptible to landfalling hurricanes that usually move in an east to west direction across the island. The last two major hurricanes to impact the island are Hurricanes Hugo (1989) and Georges (1998), each causing significant damage (Figure 1). More recently, Hurricane Irene (2011) made landfall as a category 1 hurricane but did not cause significant damage.

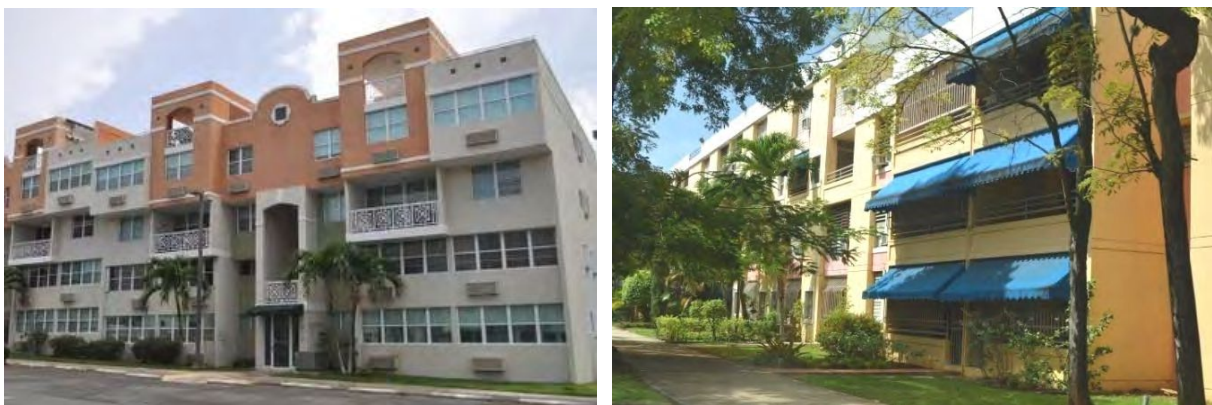
In Puerto Rico, multi-family dwellings with 2-4 stories are referred to as "walk-ups" because there are no elevators and occupants use stairs to access the upper floors. [Figure 2](#) shows a typical "walk-up" in San Juan, Puerto Rico.

Figure 2: Typical "walk-up" multi-family dwellings in Puerto Rico

Walk-up buildings primarily use reinforced concrete shear walls to resist lateral loads. Moment-resisting frames are almost never used and were not observed in the field. Interior walls are constructed using reinforced concrete masonry blocks (CMU). Gypsum partitions are not used in walk-ups because they are more expensive than masonry and because there is

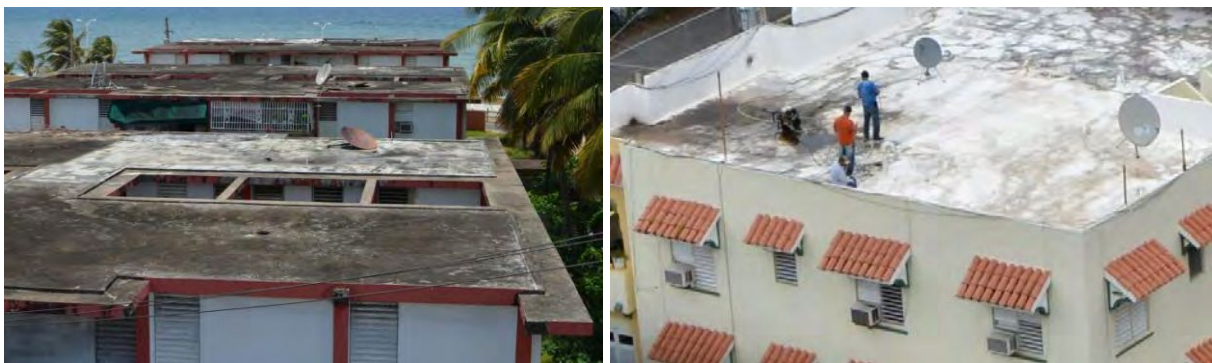
The roofs are reinforced concrete decks that are generally five to six inches thick. They are essentially flat with a minimal slope for water drainage (Figure 3). Most roofs are covered with either paint or a chemical that combines with the concrete to prevent leakage. When a built-up roof cover is used, the cover is a thermoplastic polyolefin (TPO) membrane or something similar. Gravel is almost never used on the roofs of MFD buildings, even when the roof cover is built-up. Parapets are also common and generally range from a few inches to four feet in height.

Figure 3: Typical reinforced concrete roof deck

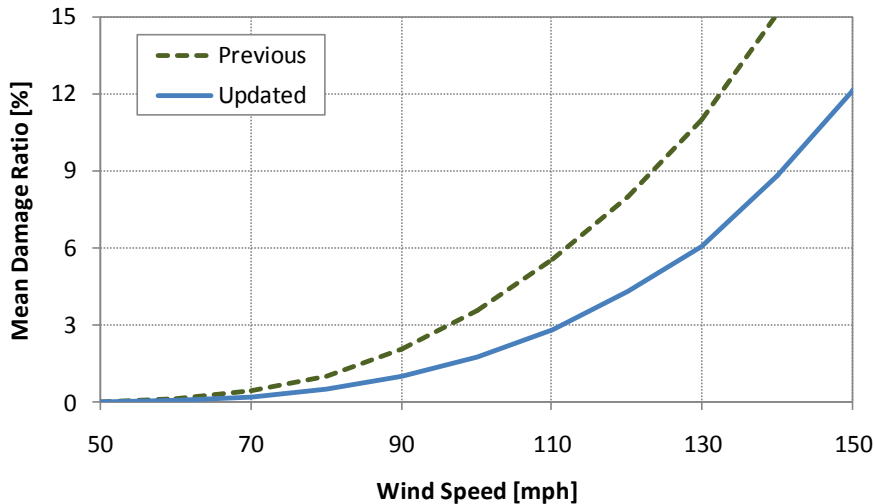
By combining the fragility curves for various components with the wind pressure distributions and cost factors that relate the replacement cost of individual components to the total building replacement cost, vulnerability functions can be derived. The original and updated vulnerability functions for a typical Puerto Rico walk-up building are shown in Figure 5. It should be noted that this vulnerability is only for the building itself and anything permanently attached to the building. Individual unit owner's property (or the building

contents) is not included in these curves. As can be seen, the updated vulnerability for this specific curve is approximately 40% lower than the original. Due to the "bunker-style" construction of the walk-ups, this new curve seems to be a better representation of the vulnerability of Puerto Rico's walk-ups when taking into account the building characteristics as outlined previously.

Figure 5: Representative vulnerability curve for Puerto Rico walk-ups

Rodriguez et al. (1992) performed a post-event damage survey of multiple buildings in Puerto Rico following the impact of Hurricane Hugo in 1989. Although they did not survey a walk-up building, they did survey two high-rise MFDs constructed of reinforced concrete. The major damage was to the building facade with the damage focused on the windows and doors; no major structural damage was observed. After Hurricane Georges impacted the entire island in 1998, damage surveys indicated that MFD buildings constructed of concrete performed well structurally (FEMA, 1999). With reported peak gust wind speeds up to 133 mph, the windows and mechanical equipment mounted on the roofs sustained major damage. However, the majority of damage in high-rise MFD buildings was to upper floors, generally above the 7th story. Using these reports, the updated vulnerability curve in Figure 5 seems reasonable for walk-up buildings in Puerto Rico.
