# Evaluation of extreme load performance of pre-Northridge connections

Scientific paper - Preliminary note

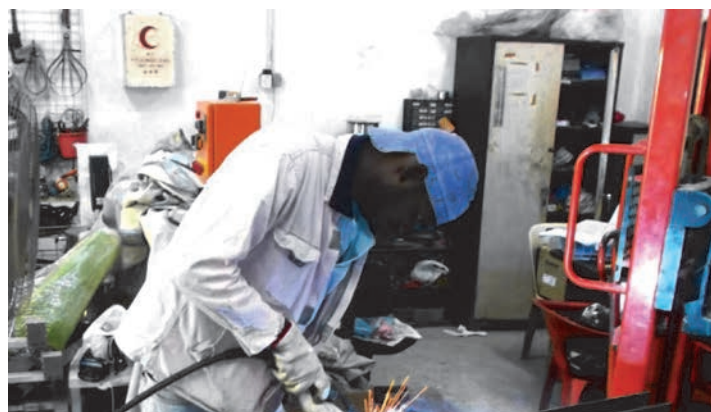
Figure 4. View of welding transfer and accessories

The fabrication of test specimens was conducted through collaboration of the university laboratory personnel and commercial fabricators. The Gas Metal Arc Welding (GMAW) process was used in this study. The GMAW, commonly known as the Metal Inert Gas (MIG), is a group of arc welding processes in which powered feed rolls (wire feeder) feed a continuous electrode (the wire) inside the weld pool (Figure 4). By the time the welding process commences, an electric arc is made between the weld pool and the tip of the wire. The melting of the wire is operated in a progressive manner at the same rate at which it is being fed and consequently, the weld pool is implemented. For simultaneous protection of the weld pool and arc against atmospheric contamination, a nozzle concentric with the welding wire guide tube is incorporated to convey a shield of inert (non-reactive) gas. The speed, comparative freedom from distribution, continuity and reliability of automatic welding, as well as the control and versatility of manual welding, are listed as the advantages of this type of welding application. The incorporation of this technique in mechanized set-ups has been rapidly accepted. A handheld gun was used to successfully perform the MIG welding as a semiautomatic process. Since the voltage, speed, arc (stick-out) length, and wire feed rate set to plate thickness, are listed as

common welding parameters, the filler metal transfer method was determined by the arc voltage and wire feed rate. Once the welding process was completed, lime was used to observe the yielding within the connection region.

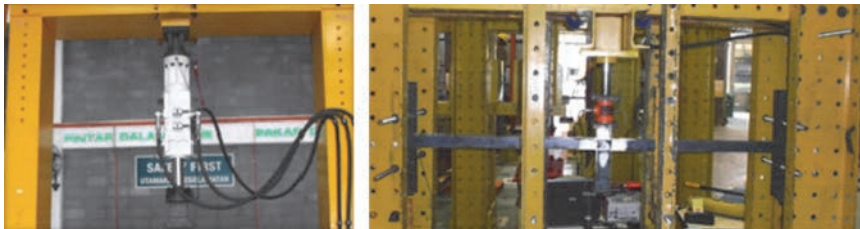
Figure 6. Dynamic actuator and hydraulic jack used for seismic and progressive collapse evaluations

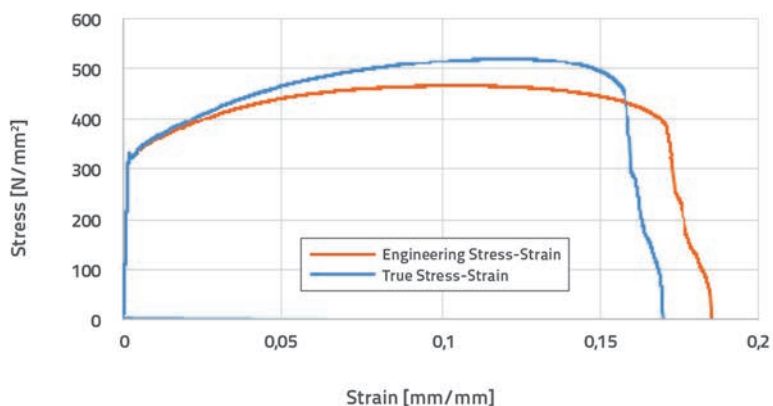
Figure 7. Material properties for true stress-strain and engineering stress-strain curves (left), universal testing machine (right)

where  $\sigma$  and  $\varepsilon$  are the true stress and strain values determined from equations 6 and 7, while  $e$  and  $S$  are the engineering strain and stress values, respectively, as obtained from the uniaxial tensile test (equations 4 and 5). True and engineering stress-strain curves, and the universal testing machine used in the testing, are shown in Figure 7.

The yield stress, ultimate tensile strength, and elongation values obtained during the tensile strength testing amounted to 320 MPa, 510 MPa, and 18 %, respectively. Material properties of the sheet steel plate used in this research are similar to Grade 50 according to American standard ASTM A572-07. Notice that this grade is equivalent to European standard S420M/EN 10025-4. In all the FEA cases, and at all degrees of freedom, the column base was fixed and the load was applied by controlling displacement in vertical directions. The quasi static loading at the rate of 2mm/s was chosen for the testing. The hex element

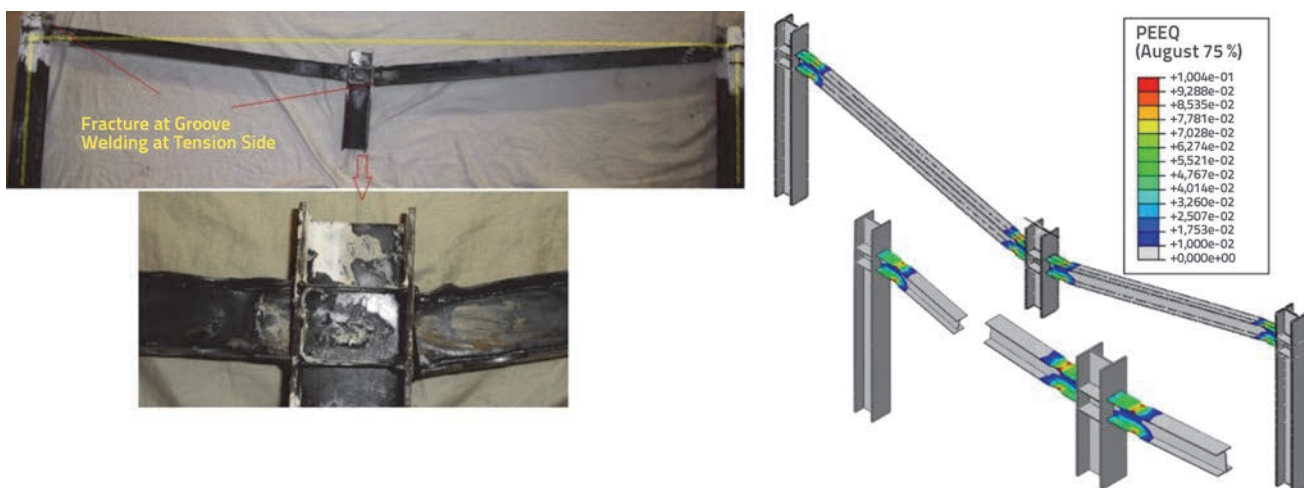
Figure 10. Specimen damage at the end of progressive collapse test and plastic equivalent strain distribution

The fracture of the groove welding between the beam flange and column face at the tension side of the beam, along with further propagation of the beam web cracking, was the governing failure mode according to experimental assessment. The specimen was capable of resisting the vertical load of 6 kN prior to initiation of the groove weld fracture. Strain gauges placed at the beam flange did not record strains higher than 1800  $\mu\epsilon$  (micro-strain), which pointed to the limited performance of the connection to develop catenary action. The connection resisted the plastic rotation angle of 0.015 rad prior to severe degradation and, therefore, the specimen did not meet the DoD guideline requirements [23]. The damaged state of the specimen, and the plastic equivalent strain distribution after the final stage of the progressive collapse test, is shown in Figure 10.

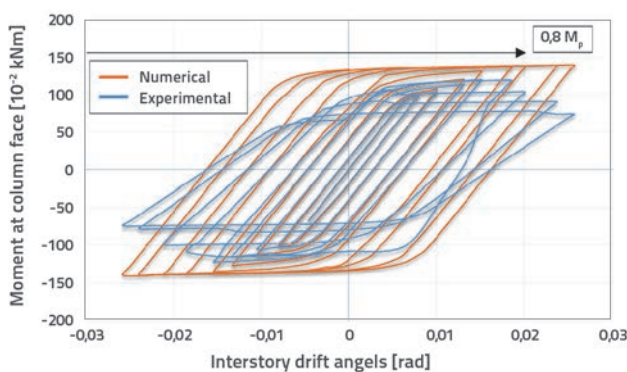
Figure 13. Moments at column face versus interstorey drift angles

Moments computed at the column face versus the interstorey drift angles, are recognized as the global cyclic response of the specimen shown in Figure 13. Numerical modelling and experimental testing results were in good agreement as to the overall cyclic behaviour.

continued until degradation by damage. Accordingly, stiffness degradation cannot be seen numerically in contrast with experimental testing, where stiffness degradation was related to the localisation of damage in the welding zone. Besides, numerical results also confirmed the formation of plastic hinges in the vicinity of groove welding. Therefore, the vulnerability of groove welds to probable fractures was increased.
