# STUDY OF THE SURFACE INTEGRITY MICROHARDNESS OF AUSTENITIC STAINLESS STEEL AFTER TURNING

*Grzegorz Krolczyk, Stanislaw Legutko, Piotr Nieslony, Maksymilian Gajek*

Original scientific paper

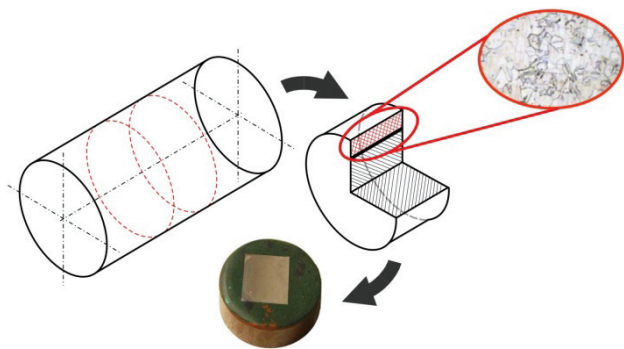
**Figure 1** Method of sample preparation for microhardness testing

The Fig. 1 shows how the pieces were separated from the initial specimen for the microhardness measurements analysis (from bar material to microhardness sample). The measurements of microhardness have been performed into the depth of material along a straight line perpendicular to the machined surface (radially). In the testing schedule, it was assumed that microhardness would be measured down to the depth for which hardness comparable to that of the core was obtained. The first point of microhardness measurement was located at the distance of up to 20 µm from the machined surface, depending on the profile hump or caving. The second measurement was performed at the depth of 40 µm, the successive ones were performed at 20 µm intervals till the hardness of the core was obtained. The microhardness measurements were effected by MHV-2000. The load of an intender was

adopted in accordance with the standard PN-EN ISO 6507-1. The standard limits the time of the load increase until the required force  $F$  is obtained to 15 s. Therefore, the safe time of 10 s and the intender’s load 0,49 N were assumed. After the cutting made in a cut-off machine with abundant abrasive disc and water fluid, the samples were prepared using standard metallographic techniques (grinding, polishing and etching).

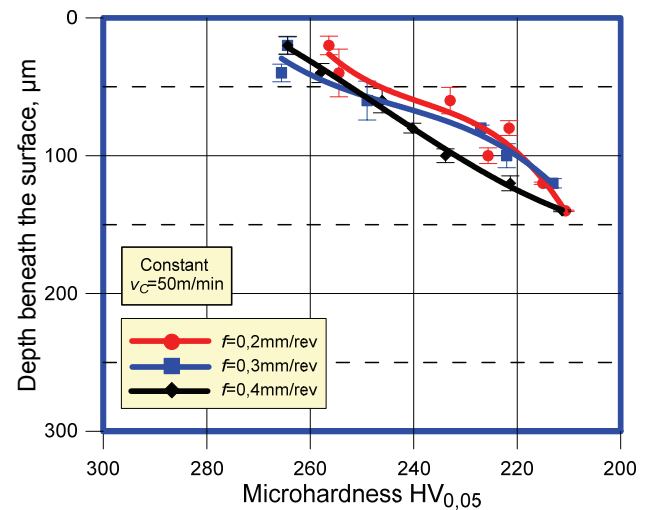
**Figure 2** Influence of the feed on the microhardness of surface layer after turning austenitic stainless steel ( $v_c = 50$  m/min,  $a_p = 1$  mm, dry cutting)

Fig. 2 presents the influence of feed on SI microhardness for constant speeds and depths of cut ( $v_c = 50$  m/min,  $a_p = 1$  mm). The biggest values of microhardness were obtained for the feed  $f = 0,3$  and  $0,4$  mm/rev, the smallest ones for  $f = 0,2$  mm/rev. The microhardness values fluctuate within the range from 250 to 270  $HV_{0,05}$ . The value of the hardening depth for constants  $v_c = 50$  m/min and  $a_p = 1$  mm for the analysed feeds is 140 µm.

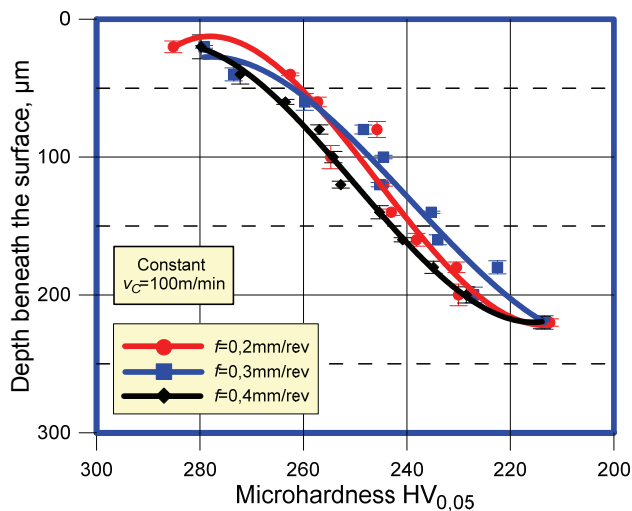
Another analysed case presented in Fig. 3 concerns the measurements of SI microhardness for variable feed and constants  $v_c = 100$  m/min and  $a_p = 1$  mm, analogously to the previously analysed cases for machining without the use of a cooling and lubricating substance. For the discussed feeds within the range from 0,2 to 0,4 mm/rev no significant changes in SI microhardness were observed, that is the depth of hardening for all the studied feed values was 220 µm. The initial measured value of

microhardness situated under the machined surface of the studied austenitic steel is within the range from 270 to 290 HV<sub>0,05</sub>. For the analyzed value of feed we can observe a monotonic and moderate drop of the value of SI microhardness. Moreover, the results of the presented experiments characterize small fluctuations of changes, which is proven by the standard deviation values. In the analyzed case, we can observe the lack of an influence of feed on SI microhardness. There is no influence on the depth of hardening of the biggest value of microhardness HV<sub>0,05</sub>.

**Figure 3** Influence of the feed on the microhardness of surface layer after turning austenitic stainless steel ( $v_C = 100$  m/min,  $a_p = 1$  mm, dry cutting)

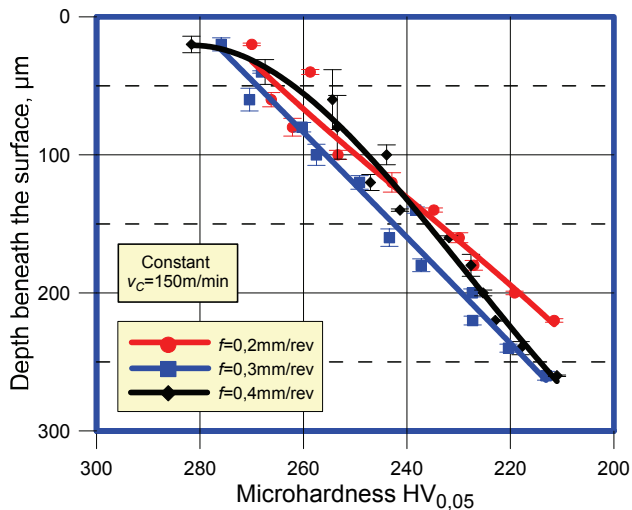
**Figure 4** Influence of the feed on the microhardness of surface layer after turning austenitic stainless steel ( $v_C = 150$  m/min,  $a_p = 1$  mm, dry cutting)

The other analyzed case illustrated in Fig. 4 concerns the measurements of SI microhardness for variable feed and constants  $v_C = 150$  m/min and  $a_p = 1$  mm. For the biggest studied speed of machining, the microhardness values do not basically differ in the angle of the drop of values of microhardness HV<sub>0,05</sub> and the depth of hardening shapes on the similar level as for the value  $v_C = 100$  m/min, namely at the level of 220 ÷ 260 μm. The average value of the biggest microhardness fluctuates as for  $v_C = 100$  m/min within the range from 270 to 290 HV<sub>0,05</sub>.

The findings of the research into the influence of the machining speed on the microhardness of the studied austenitic steel surface layer are presented in Fig. 5. Turning took place with the use of an edge of cemented carbide covered with a coating with an intermediate ceramic layer, for the feed  $f = 0,2$  mm/rev and the constant depth of cut  $a_p = 1$  mm; dry machining. The results are presented in the form of graphs, as the arithmetic mean of three measurements of microhardness with standard deviation. The biggest values of microhardness were obtained for the speed  $v_C = 100$  m/min. They were obtained for the layer closest to the machined surface, namely at the depth of up to 20 μm. In this case, microhardness was over 280 HV<sub>0,05</sub>. For the speed of machining 150 m/min, the microhardness obtained in this area was by 15 % smaller on average, whereas for  $v_C = 50$  m/min, the observed microhardness was smaller by 30 %. Alongside departing from the surface, the SI microhardness decreases, in the analyzed case reaching the hardness of the core at the depth of about 140 μm for  $v_C = 50$  m/min and 220 μm for  $v_C = 100$  and 150 m/min. In Fig. 4, we can observe a monotonic and smooth decrease in the SI microhardness values for

$v_C = 150$  m/min, whereas the microhardness for the remaining analysed speeds of machining ( $v_C = 50$  and  $100$  m/min) is characterized by a sharp angle of the drop of values to the depth of  $60 \mu\text{m}$ . The reason for that may be a non-uniform deformation of the material, and thus the strengthening of austenite in the subsurface layer.

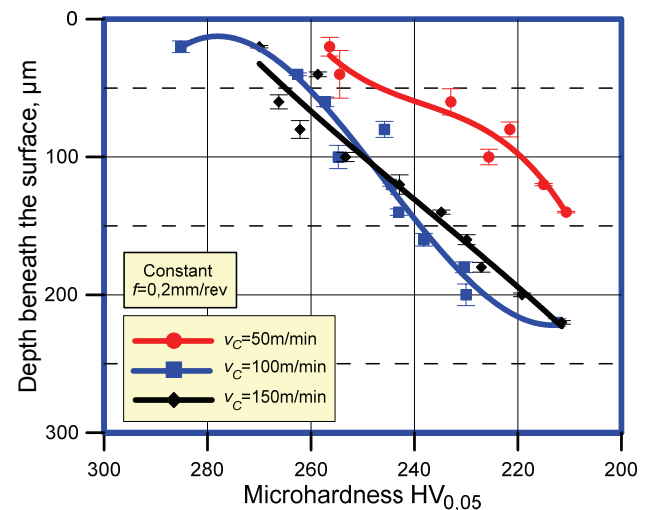
**Figure 5** Influence of the cutting speed on the microhardness of surface layer after turning austenitic stainless steel ( $f = 0,2$  mm/rev,  $a_p = 1$  mm, dry cutting)

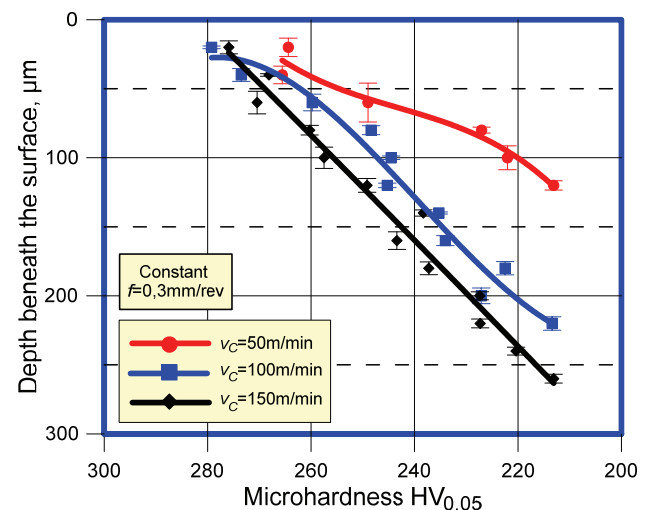
**Figure 6** Influence of the cutting speed on the microhardness of surface layer after turning austenitic stainless steel ( $f = 0,3$  mm/rev,  $a_p = 1$  mm, dry cutting)

Fig. 6 presents the results of the measurements of SI microhardness as a function of machining speed after turning with the edge MM 2025, for the feed  $f = 0,3$  mm/rev and the constant depth of cut  $a_p = 1$  mm, also for the machining without the use of a cooling and lubricating substance. The biggest values of microhardness were obtained for the speed  $v_C = 100$  and  $150$  m/min – at the level of  $275 \text{HV}_{0,05}$ , whereas SI microhardness for a smaller speed of machining shapes at the level of about  $265 \text{HV}_{0,05}$ . Alongside an increase in the speed of machining, microhardness after turning steel 1.4541 for the feed  $f = 0,3$  mm/rev goes up, reaching hardness of the core at the depth of  $120 \mu\text{m}$  for  $v_C = 50$  m/min,  $220 \mu\text{m}$  for  $v_C = 100$  m/min and  $260 \mu\text{m}$  for  $v_C = 150$  m/min. For the speed of machining  $v_C = 100$  and  $150$  m/min, we can observe a monotonic decrease in the value of SI microhardness, whereas in case of the speed of machining  $v_C = 50$  m/min, there are considerable fluctuations of changes in the values and their sharp drop. Bigger depth of hardening for an increase in the speed of machining is probably caused by a higher temperature in the machining process. Alongside an increase in the machining speed a bigger amount of heat is generated, and the heat penetrates the machined material deeper.

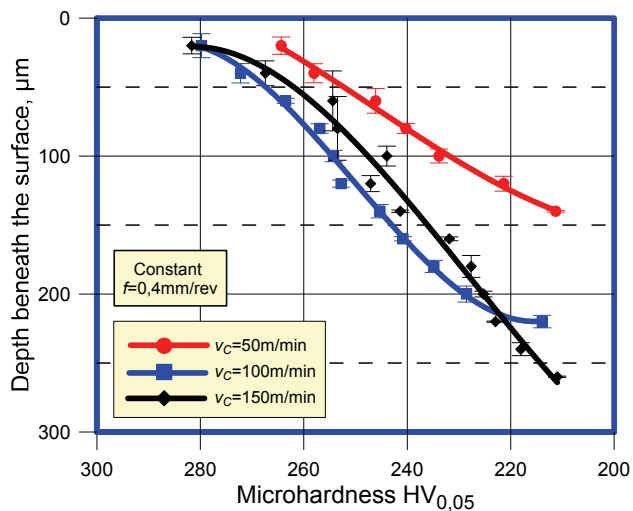
**Figure 7** Influence of the cutting speed on the microhardness of surface layer after turning austenitic stainless steel ( $f = 0,4$  mm/rev,  $a_p = 1$  mm, dry cutting)

Last analyzed case illustrated in Fig. 7 concerns the results of the SI microhardness measurements for the variable speed of machining and constants  $f = 0,4$  mm/rev and  $a_p = 1$  mm. For the biggest studied feed, the depth of hardening shapes at the level of  $140 \div 260 \mu\text{m}$ , namely the range of the depth of hardening shapes in a similar way like for the average values of the analysed feeds. The biggest average values of microhardness were obtained for the speed  $v_C = 100$  and  $150$  m/min and they were equal to  $280 \text{HV}_{0,05}$ . On the other hand, the smallest values of microhardness  $265 \text{HV}_{0,05}$  were obtained for the speed of machining  $v_C = 50$  m/min. For the studied speeds

of machining we can observe a monotonic decrease in the value of SI microhardness. For the analysed values of machining speed and the biggest feed, we can observe big fluctuation of changes in the biggest values of SI microhardness within the range from the surface of the machined material to  $80 \mu\text{m}$ .
