STREAMBANK REVEGETMENT

MF-2294

September 1997

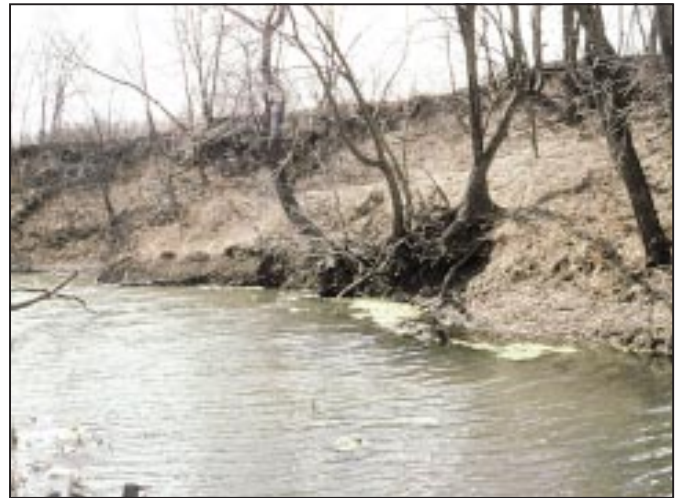
Tree revetments are constructed by anchoring finely branched trees, like eastern red cedar at the bottom of an unstable streambank. Installation starts at the downstream end of the eroded bank—at a point where the bank is stable. Each tree is placed into the stream with the cut end pointing upstream. Trees are overlapped approximately one-third and are anchored twice using a Duck-bill Anchor. Construction continues until the entire eroded surface is covered and the tree revetment is secured at a stable point upstream.

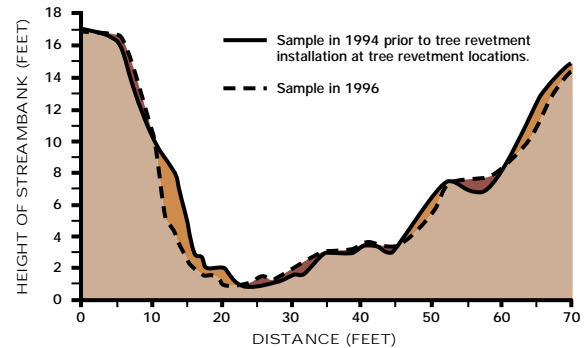
- The control sites all had well-developed riparian corridors, as shown in the photo above. There was little change in the channel cross-section at the controls sites from 1994 to 1996, as shown by the representative cross-section in the graph.

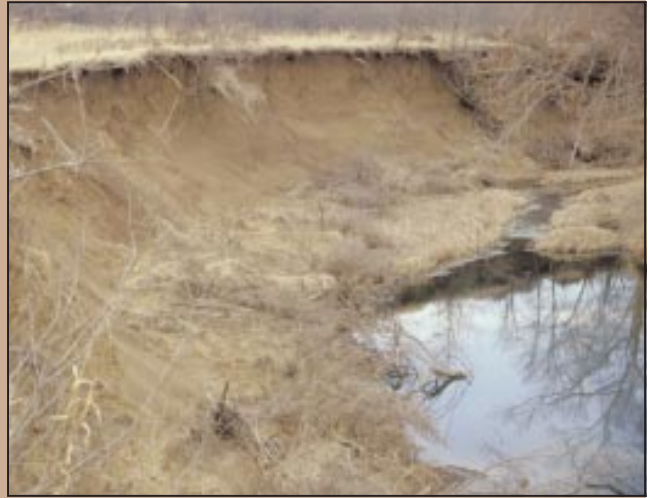
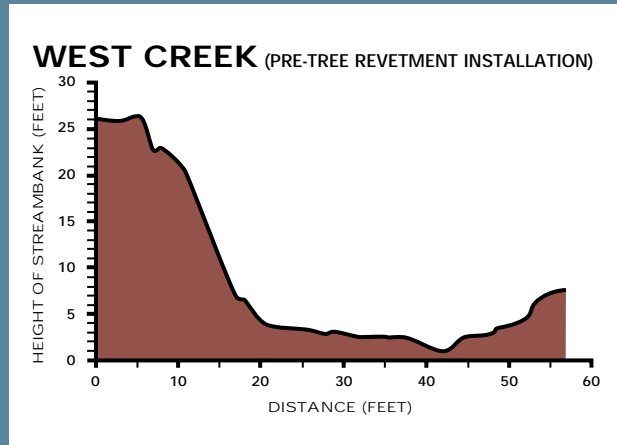
■ The tree revetment sites lacked a riparian corridor and had accelerated erosion problems, as shown in the photo above. The corresponding graph shows the eroding outside bend at 26 feet in height.

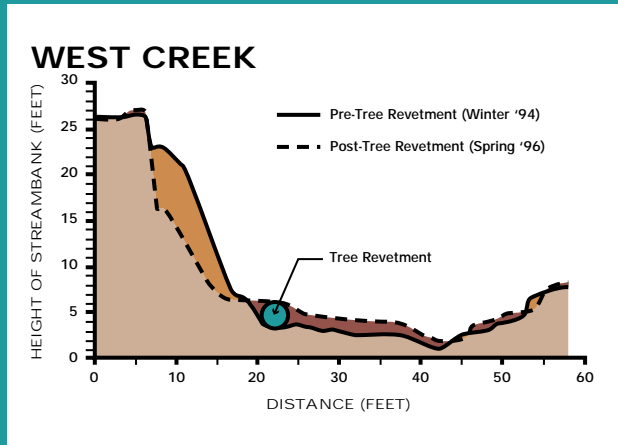
■ After tree revetment installation, banks became more gradual and the main channel of the stream was moved away from the eroding bank, protecting the streambank from excessive erosion. The corresponding graph illustrates how the slope of the eroding streambank decreased, and how silt increased within the tree revetment.

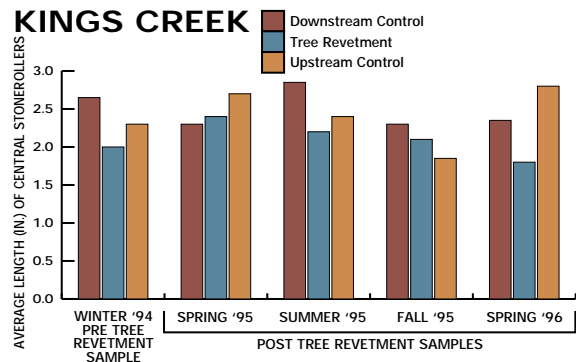
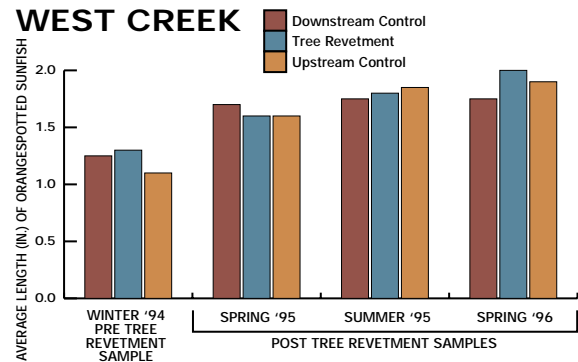
■ Catch of central stoneroller declined slightly after installation of the tree revetment at the tree revetment and upstream control locations. Thus, it is likely that catch of central stonerollers was influenced by a factor other than the tree revetment. Average length of central stonerollers remained similar at all locations before and after installation of the tree revetment.

■ Catch of orangespotted sunfish declined at all locations after installation of the tree revetment. Similar to catch of central stonerollers in Kings Creek, catch of orangespotted sunfish was not influenced by the tree revetment. Average length of orangespotted sunfish remained similar at all locations before and after installation of the tree revetment.

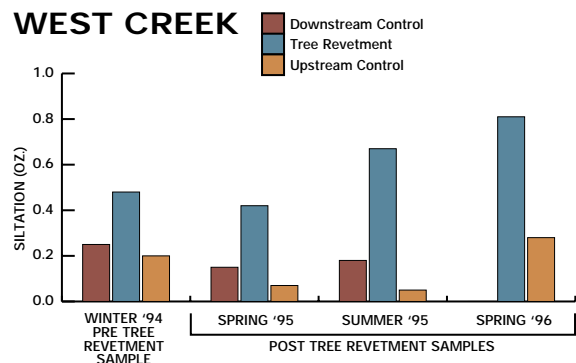
■ The amount of siltation within Kings Creek (left) was generally lower at all locations after installation of the tree revetment. Conversely, siltation increased in West Creek at the tree revetment location after installation. This is likely caused by the tree revetments trapping sediment. Sediment trapping did not occur on Kings Creek because the tree revetment was slightly above the water level during normal flow.
