National Oceanography Centre
Research & Consultancy Report No. 66

WireWall – a new approach to measuring coastal wave hazard

September 2020

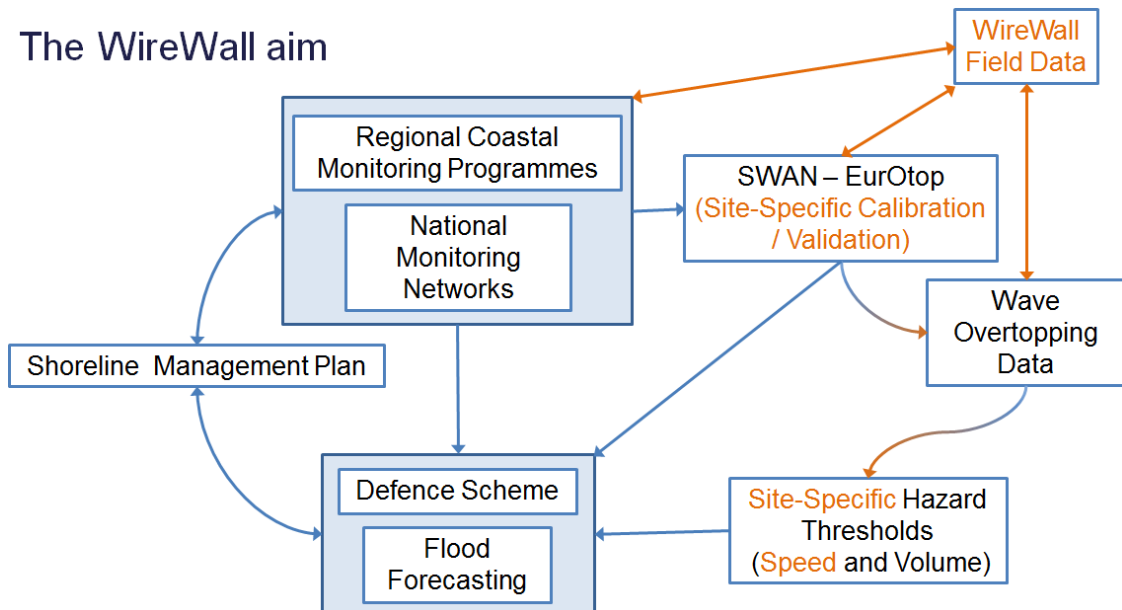
Figure 1.1: WireWall's intended integration with existing shoreline management practices.

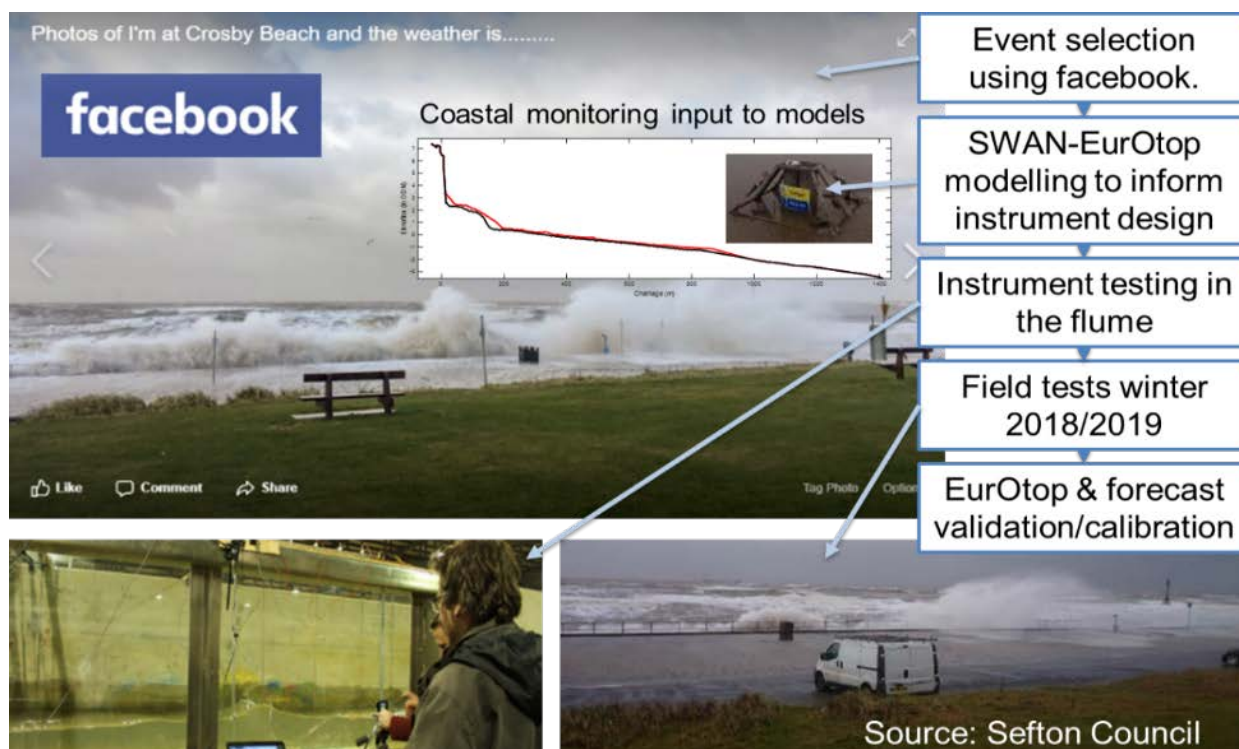
Figure 1.2: The WireWall approach to collect new observations required to identify site-specific safety thresholds & calibrate models used in scheme design.

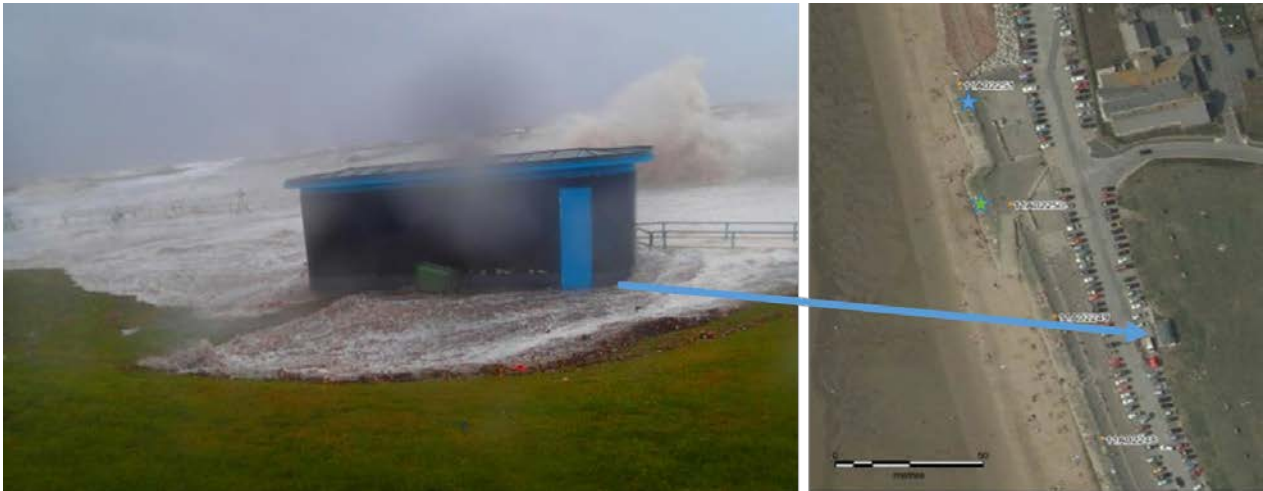
Figure 2.1: The Crosby sea wall frontage, 5 December 2013 (left) and the northern section of the car park at Hall Road (right). Images provided by the Sefton Council. The blue star marks the WireWall deployment location on the promenade and the green star the start of the survey line where numerical estimates were generated on the slipway. The slipway has a similar cross-shore profile to the promenade but is advanced slightly seaward of the main defence line.

The prototype WireWall instrument was trialled at our case study site Crosby, north of Liverpool (England). This location, situated in the eastern Irish Sea, faces west-south-west (about 245 degrees) and is impacted by fetch limited waves from westerly to north westerly directions. The offshore significant wave heights can reach up to 5.5 m and the longest periods reach around 10 s. During large storm events the surge can be up to 2 m with skew surge values over 0.8 m (Brown et al., 2010 a and b). The large tidal range (8.27 m mean spring tidal range, <http://www.ntsif.org>) means hazard from overtopping is limited to a few hours either side of high water when waves are able to impact the existing sea defence (Figure 2.1).

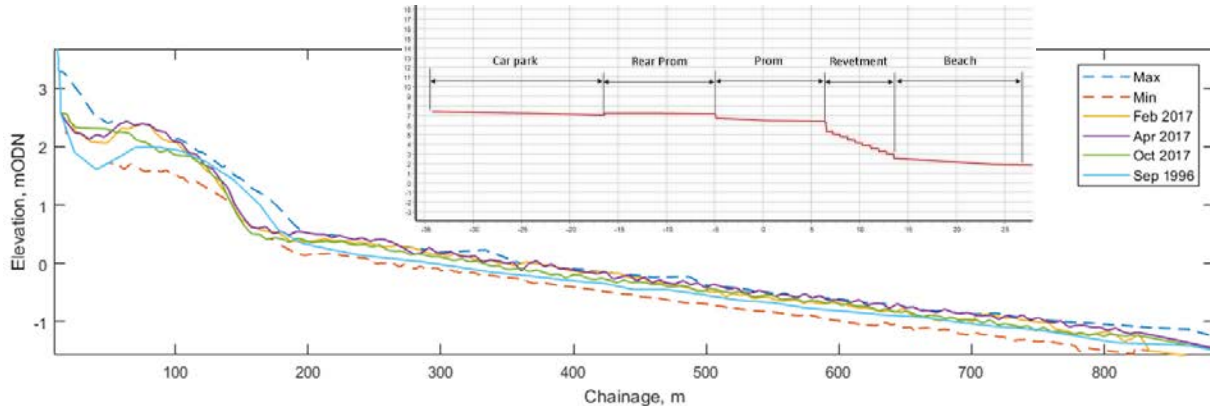
Figure 3.1. Beach survey data used in model calibration and sensitivity analysis of beach level. The max/min values represent the upper and lower bounds of variability in the beach levels between 1996 and 2017. The insert shows the beach-structure-car park profile, provided by Sefton Council.

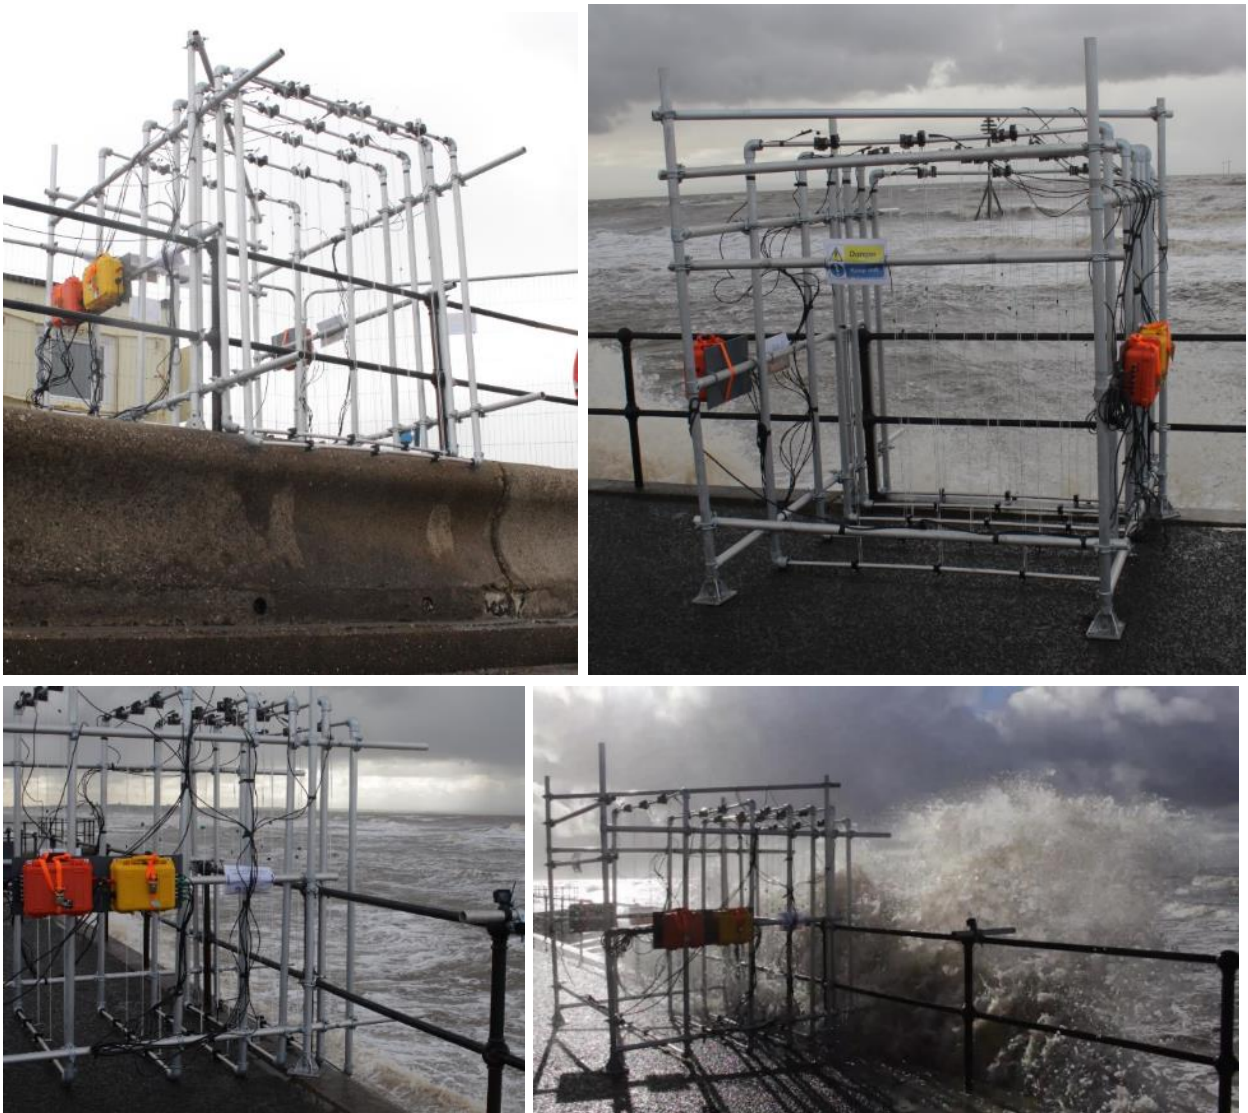
Figure 3.10: The first WireWall field deployment with overtopping examples taken during high tide on the 26th October 2019.

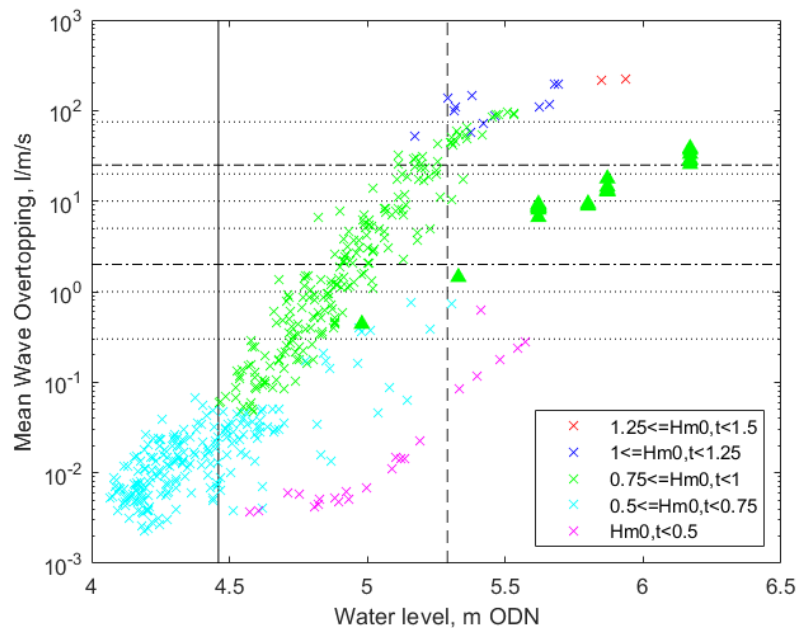
Figure 4.13: Comparison of the tank measurements collected in HRW's flume (triangles) compared to the BayonetGPE (O19) estimates (crosses) for the photographic evidence shown in Figure 4.6a. The colours indicate wave heights at the structure toe, as estimated by the SWAN model (for the past events) and by the wave gauges (for the flume data).

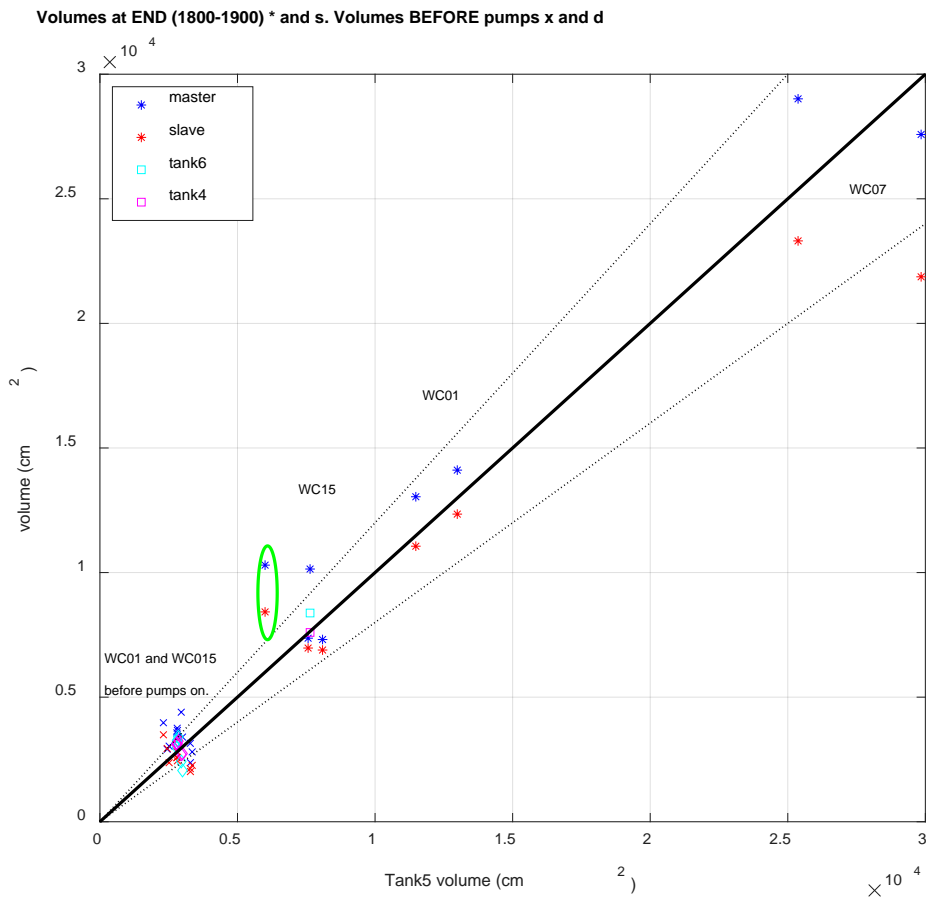
Figure 4.16. Volumes from WireWall Master and Slave units, plus volumes from the outer NOC tanks ("tank6" was nearest Master, "tank4" nearest Slave) when they were against the sea wall, against the middle tank ("tank5") which was always against the sea wall. Volumes towards the end of long runs are shown by * (WireWall) and open squares (tanks): these volumes are all > 5,000 cm². Those obtained during short runs or longer runs BEFORE pumps were turned on are shown by open diamond (WireWall) and are all < 5,000 cm². Green circle highlights the WireWall values for run 148 when the pump was turned on late. The black line indicates 1:1 agreement, and dotted black lines show +/-20% uncertainty in the volumes from the middle tank. NOTE the volumes are "as measured", i.e. are not scaled up to real-world values. The volumes are given in cm², where 10 cm² = 1 L/m. Scaled up to real world, 1x10⁴ cm² as measured = 5.625x10⁴ L/m or 56.25 m³/m.

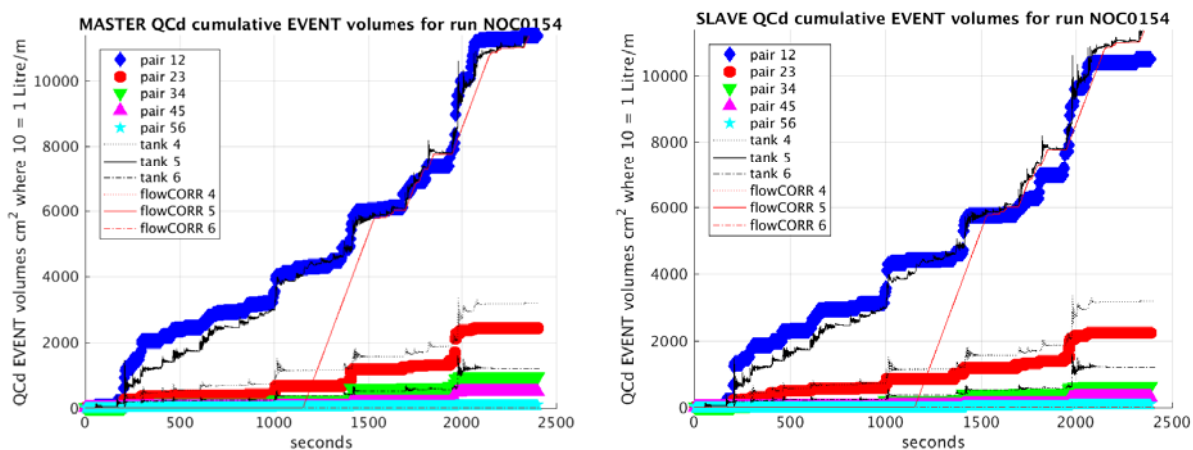
Figure 4.17: Cumulative volumes for run 154, WC15. Left: results from the Master unit (next to tank6). Right: results from the Slave unit (next to tank4). The colours indicate which pair of wires were used in the

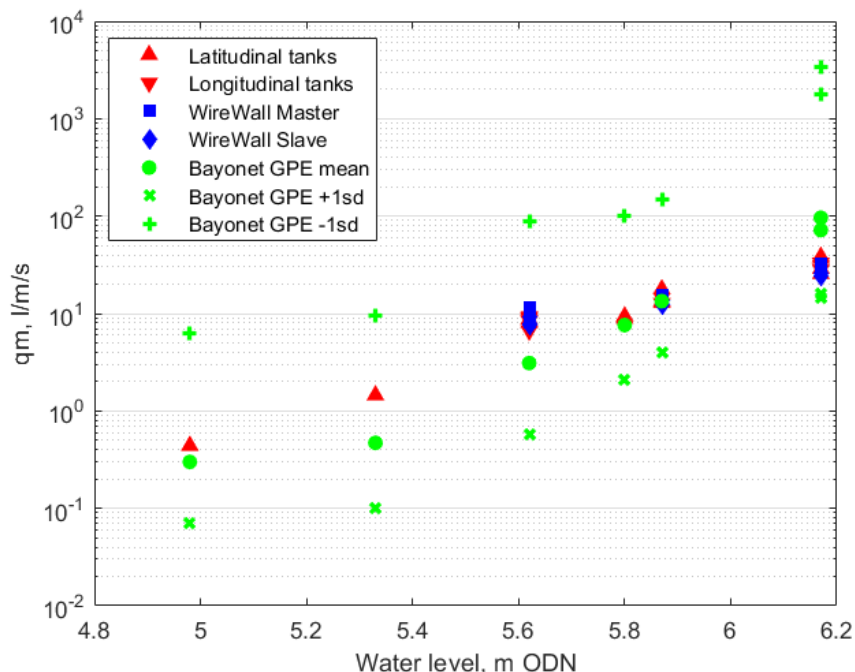
Figure 4.18: BayonetGPE (O19) validation using data from the tanks (red, both NOC and HRW) and from the WireWall system (blue). The ± 1 s.d. estimates for BayonetGPE (O19) are shown along with the mean values. The discharge rates and water levels are scaled up to real-world values.

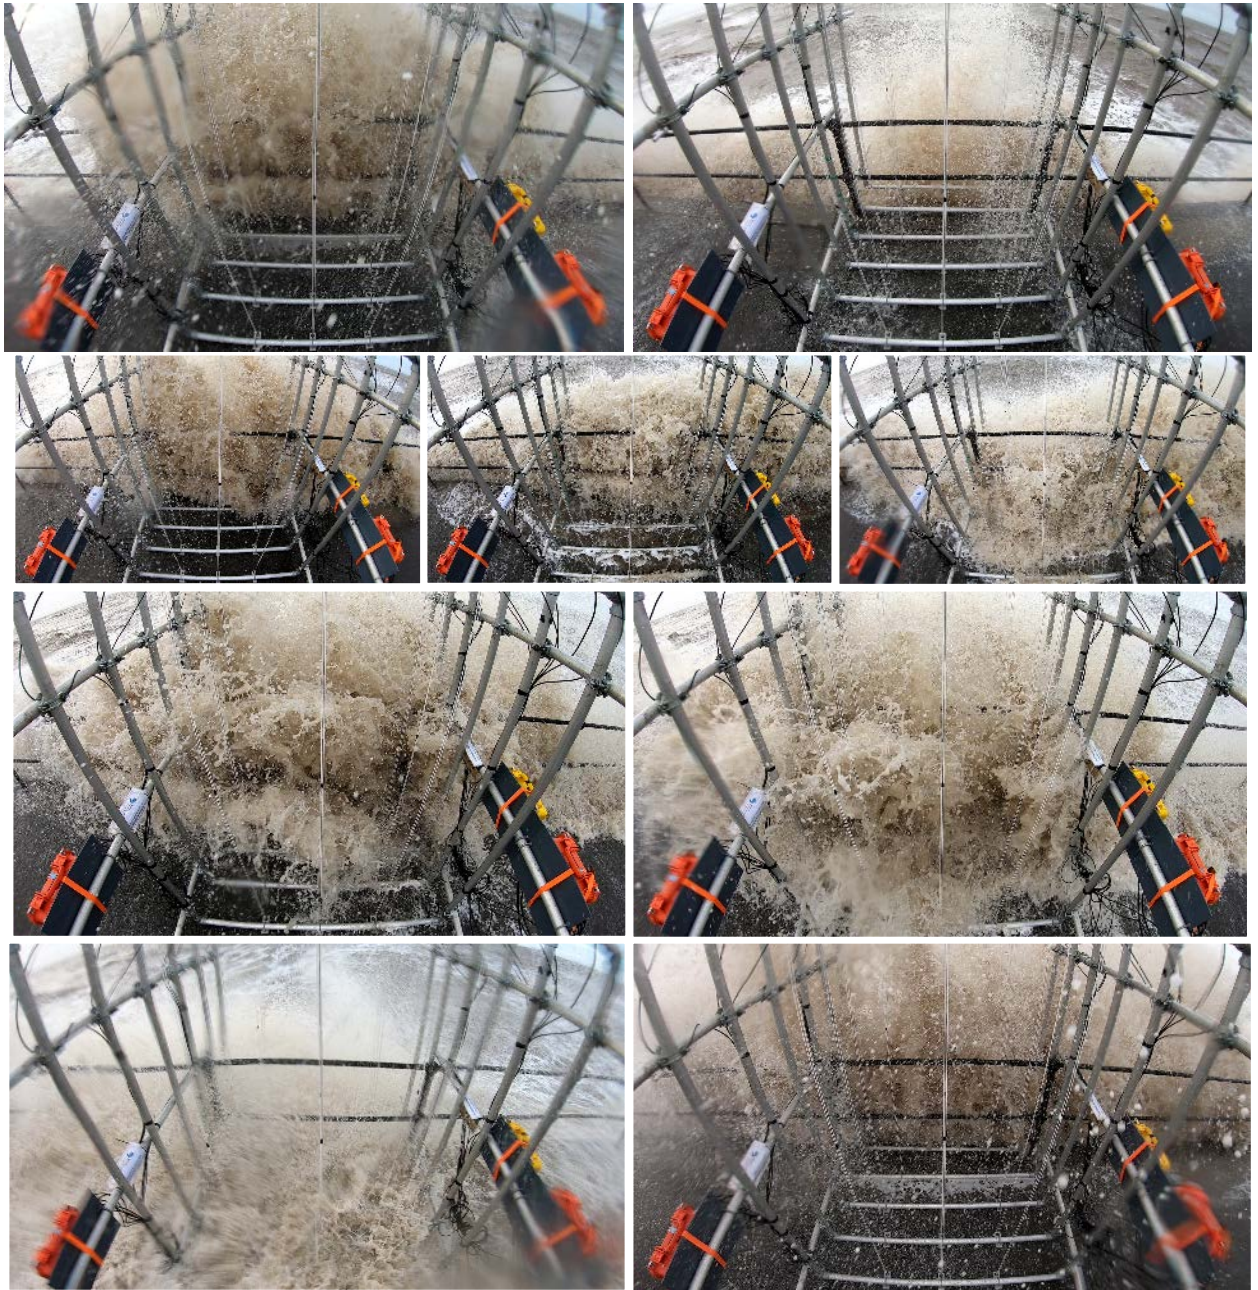
Figure 4.19: Example photos from the rear rig mounted GoPro collected during the January 2019 deployment.

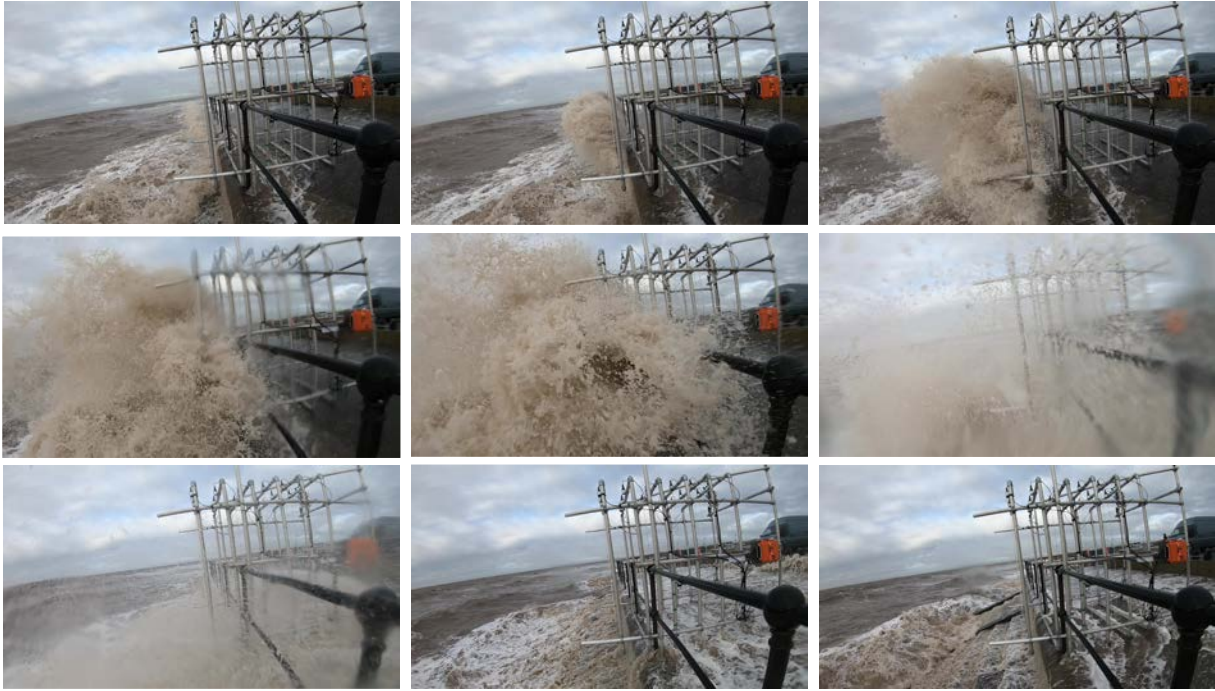
Figure 4.20: Example photos from the side mounted GoPro (south of the rig) collected during the January 2019 deployment.

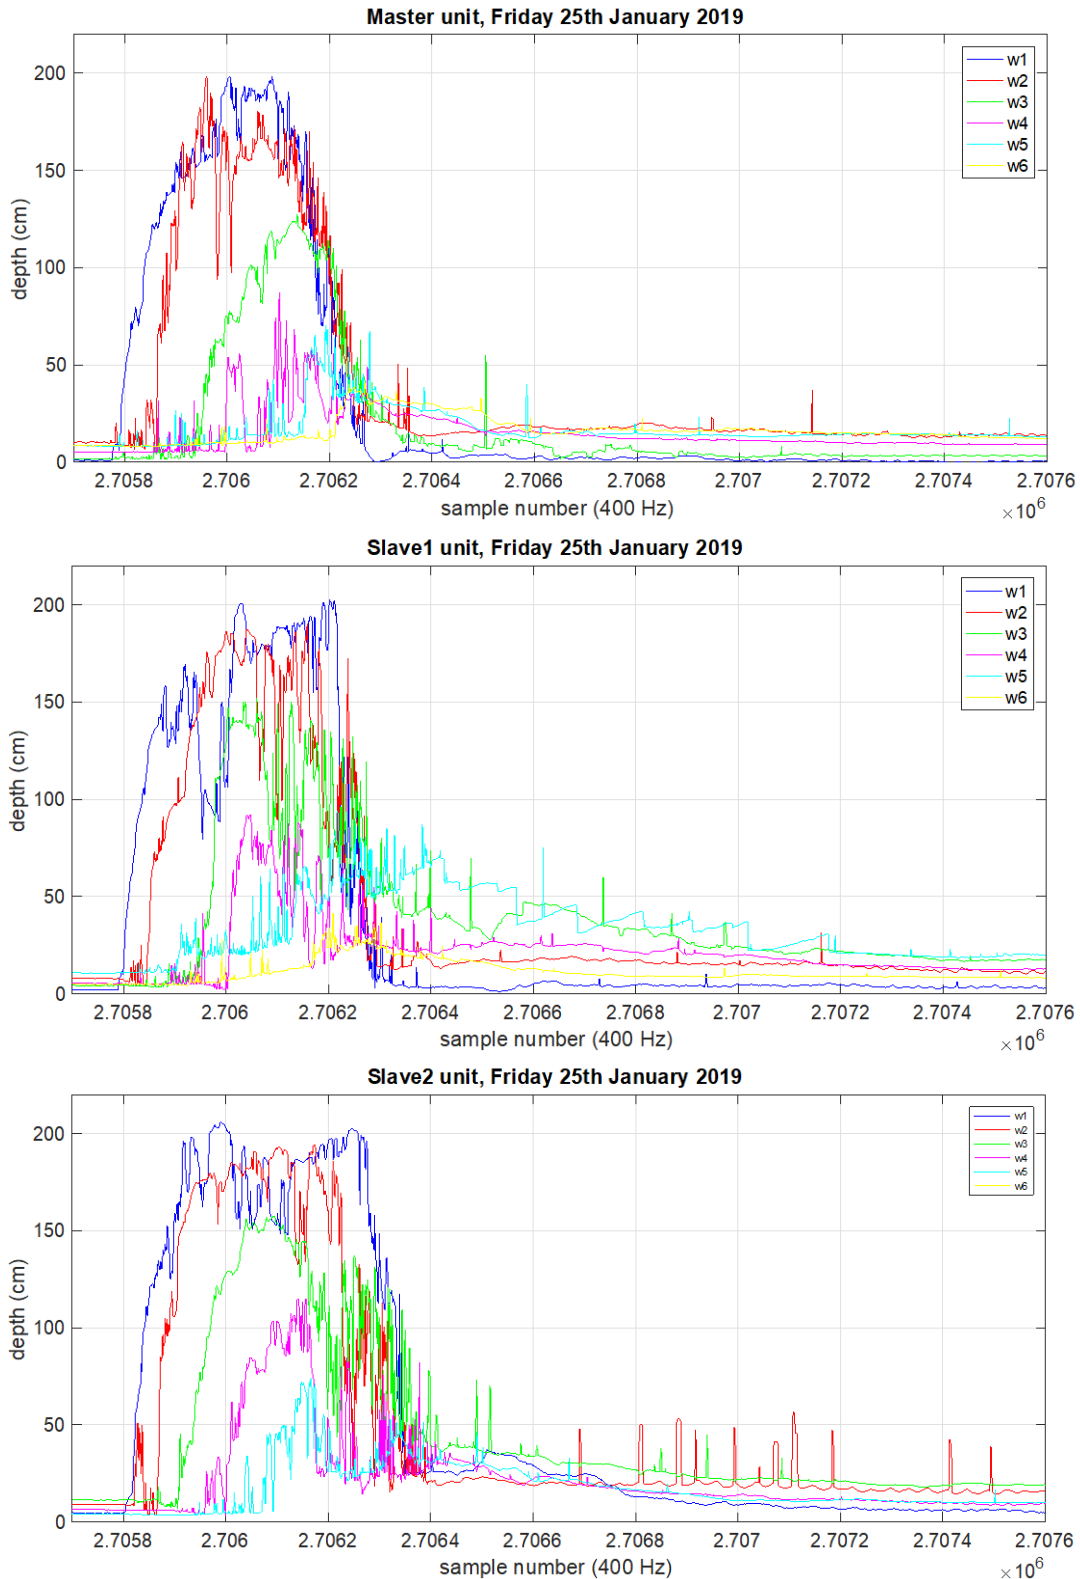
Figure 4.22: An example of one of the larger wave plumes on the 25th January 2019, showing time series data from each of the three WireWall units: the Master (top plot, north row of wires), Slave 1 (middle plot, middle row of wires) and Slave 2 (bottom plot, south row of wires). The lines represent each of the 6 wires in the row (wire1 to wire6) and show the wave passing from the sea (wire1 left) towards land (wire6 right) with time. The data were collected at 400 Hz: the plots show 4.75 seconds of data and the plume lasted for about 1.5 seconds. Note that wire3 and wire5 on the Slave1 unit were not working well (as indicated by their very slow and erratic decrease after the plume has passed). Similarly, wire6 on Slave2 failed

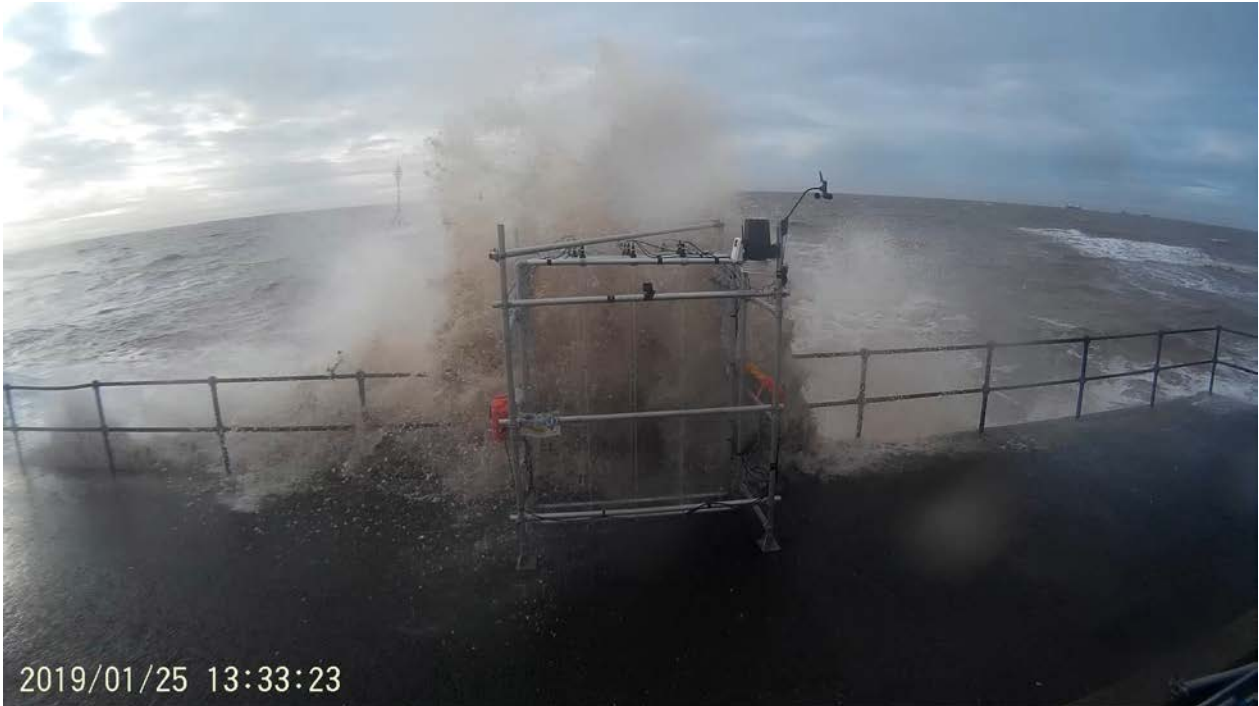
Figure 4.23: Still image of one of the very largest plumes observed during the deployment on Friday 25th January 2019. It can be seen that the seawards part of the plume is taller than the rig. However, the upper part of the plume is made up of quite fine spray compared to the much denser spray/solid water lower down. In addition, the height of the plume reduces as it travels through the rig.

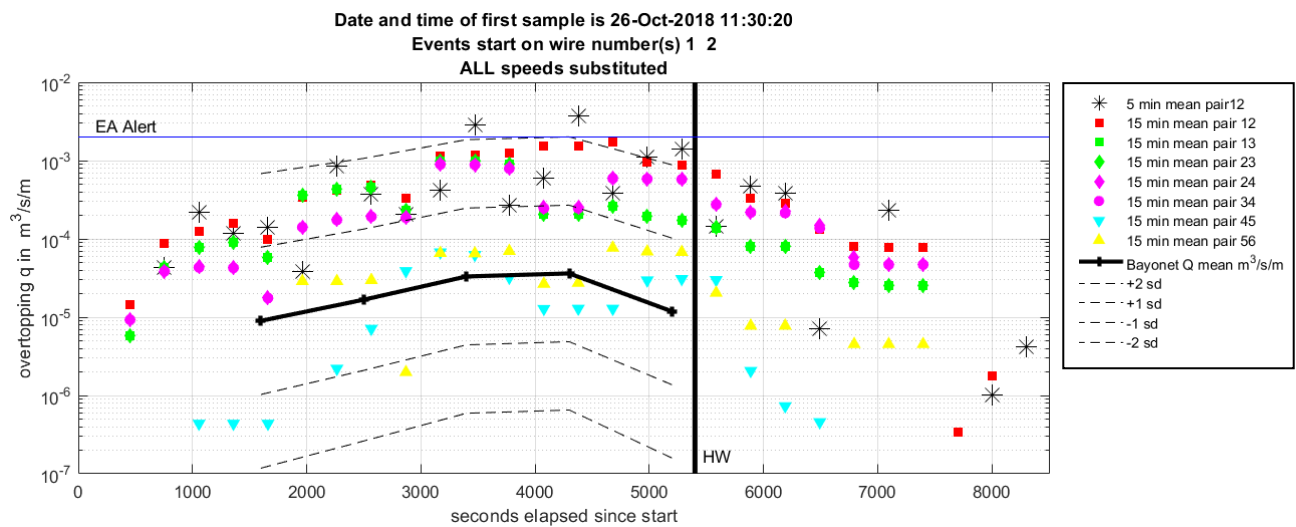
Figure 4.31: Overtopping measured by WireWall and estimated by SWAN-BayonetGPE (O19) 26th October 2018. The WireWall data are presented as 5 minute averages and 15 minute running means at 5 minute intervals. The SWAN-Bayonet (O19) data are calculated using 15 minute interval input data from the local tide gauge, wave buoy and weather station and shown as grey scale lines. Note that wire4 (magenta) is damaged before high water (vertical line) and is biased very high thereafter. The EA alert threshold is given (blue line) for comparison.

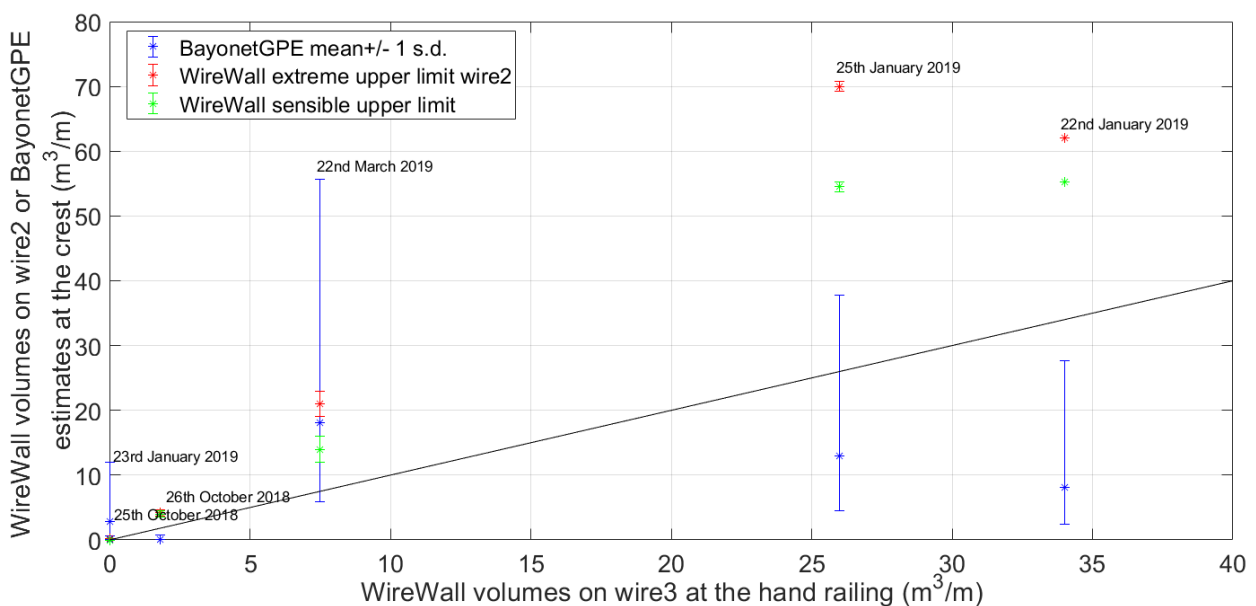
Figure 4.34 Comparison of WireWall data with the mean volume estimated from BayonetGPE (O19). The dates of the four most-energetic deployments are shown. Error bars indicate the +/- 1 s.d. estimate for the

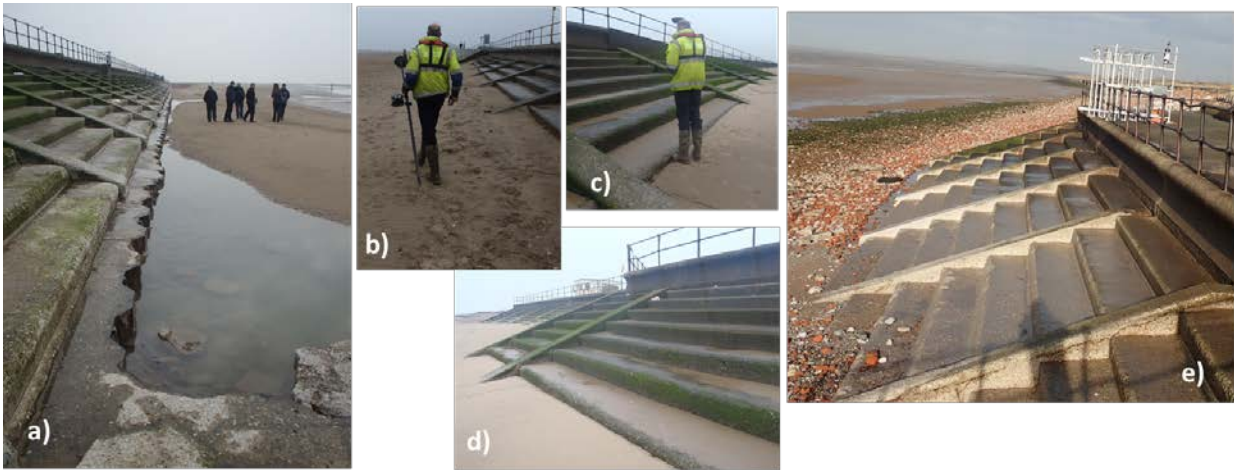
Figure 4.40: a) Looking south from the bottom of the slipway along the Crosby sea wall 17th March 2015. The beach level during a SC survey 13th April 2018 a) just south of the slipway b) seaward of the slipway and c) at the slipway looking north. c) The beach level prior to high water on the 25th January 2019 with the sheet piling just exposed in front of the 3 most northern stepped revetment sections.
