10.1029/2020SW002594

Geomagnetically Induced Currents and Harmonic Distortion: High Time Resolution Case Studies

Abstract High time resolution (1–5 s) magnetometer, geomagnetically induced current (GIC), and mains harmonic distortion data from the Halfway Bush substation in Dunedin, New Zealand, are analyzed. A recently developed technique using very low frequency (VLF) radio wave data provides high-resolution measurements of mains harmonic distortion levels. Three case studies are investigated, each involving high rates of change of local geomagnetic field, but with different timescales of magnetospheric driver mechanisms, and different substation transformer configurations. Two cases of enhanced GIC during substorm events are analyzed, and one case of a storm sudden commencement. Time delays between magnetic field fluctuations and induced transformer currents are found to be ~100 s for substorm events, but only ~20 s for the storm sudden commencement containing higher-frequency variations. Boxcar averaging of the magnetic field fluctuations using running windows of ± 2 min leads to spectral power profiles similar to those of GIC profiles, with reduced power at frequencies >0.00

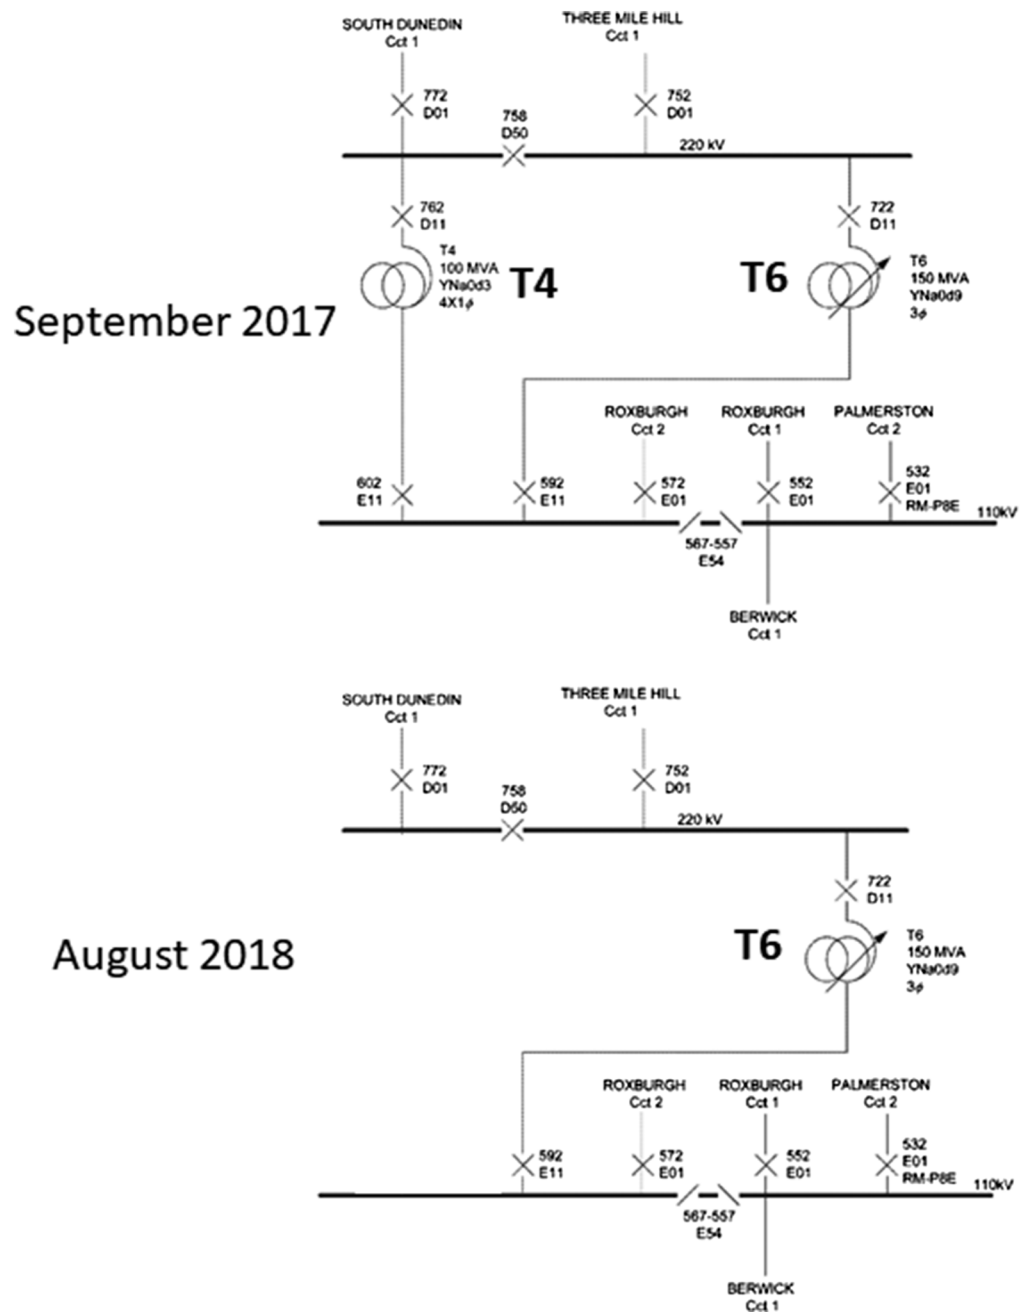
Figure 1. Two configurations of the single line diagram of the Halfway bush substation high-voltage connections in Dunedin, South Island, New Zealand. Upper panel shows the configuration during September 2017. Lower panel the configuration during August 2018. Transformer HWB T4 was withdrawn from service at the end of 2017.

Previous studies of GIC from the Halfway Bush substation have concentrated on the HWB T4 transformer there (e.g., Clilverd et al., 2018). This was primarily because of the historical importance of that particular transformer, which suffered a failure in November 2001 (Béland & Small, 2004; Marshall et al., 2012) caused by high levels of GIC (Rodger et al., 2017). In this analysis we concentrate on measurements from the HWB T6 transformer due to the fact that in the 11-month interval between the two geomagnetic storms that are analyzed here, the HWB T4 transformer was decommissioned, that is, in December 2017. We note, however, that during the GIC events in September 2017, the HWB T4 and HWB T6 transformers experienced very similar GIC levels, both in magnitude and time variation. Figure 1 shows two single line diagrams of the Halfway Bush substation high-voltage connections, with and without the HWB T4 transformer in the configuration. One of the questions addressed here is as follows: Did the removal of the HWB T4 transformer from the substation result in significant reductions in measured harmonic distortion during subsequent GIC events?

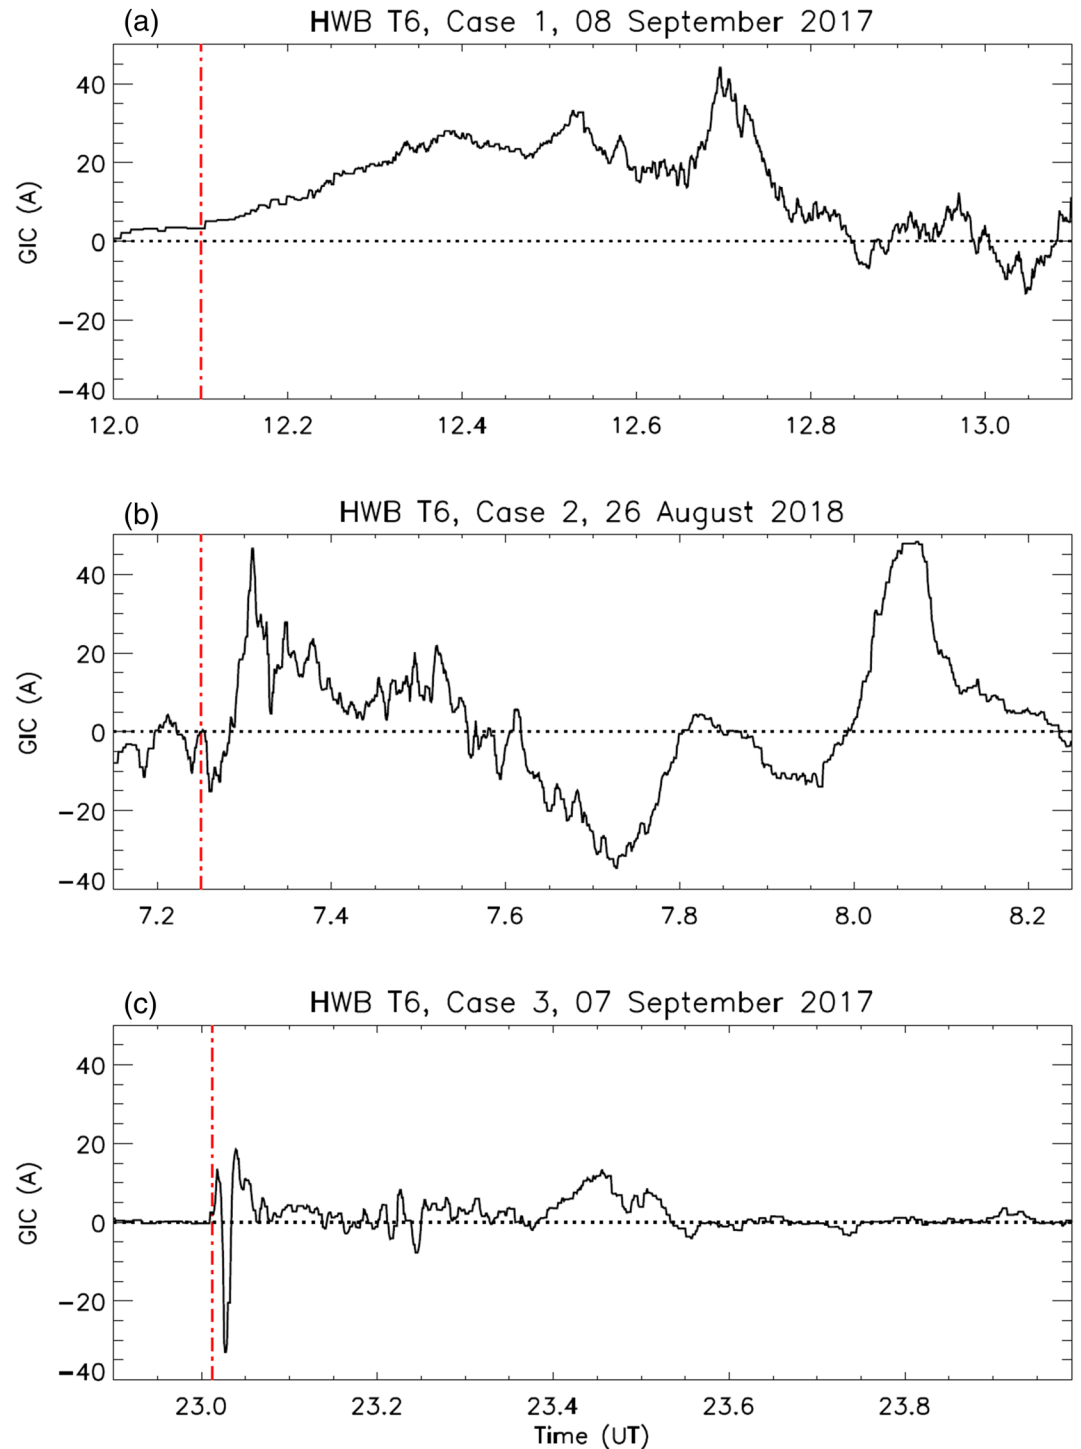
Figure 2. GIC variations during the three case study periods. Vertical dash-dotted lines (red) indicate approximate start times of each event shown. Each panel has the same x axis period, that is, just over an hour.

Figure 2 provides an overview of the GIC levels in the three cases analyzed. Panels (a)–(c) show the cases in the order that they are described in the rest of this manuscript. Each panel has the same x axis period (just over an hour) and has the same y axis range of induced current. An observed start time of enhanced GIC is given by a vertical red dash-dotted line in each panel, arranged such that the start times of each case are aligned within the plot window. Start times are indicated where the GIC exceeds ± 5 A (Rodger et al., 2017), or when rapid fluctuations of the local magnetic field are observed. Induced currents are shown to exhibit distinct differences from case to case, in terms of time variations and the sign of the currents. Panels (a) and (b) are long-lasting events that occurred during the main/recovery phase of their respective storms, while panel (c) was caused by a storm sudden commencement and shows large induced currents predominantly at the very start of the event.

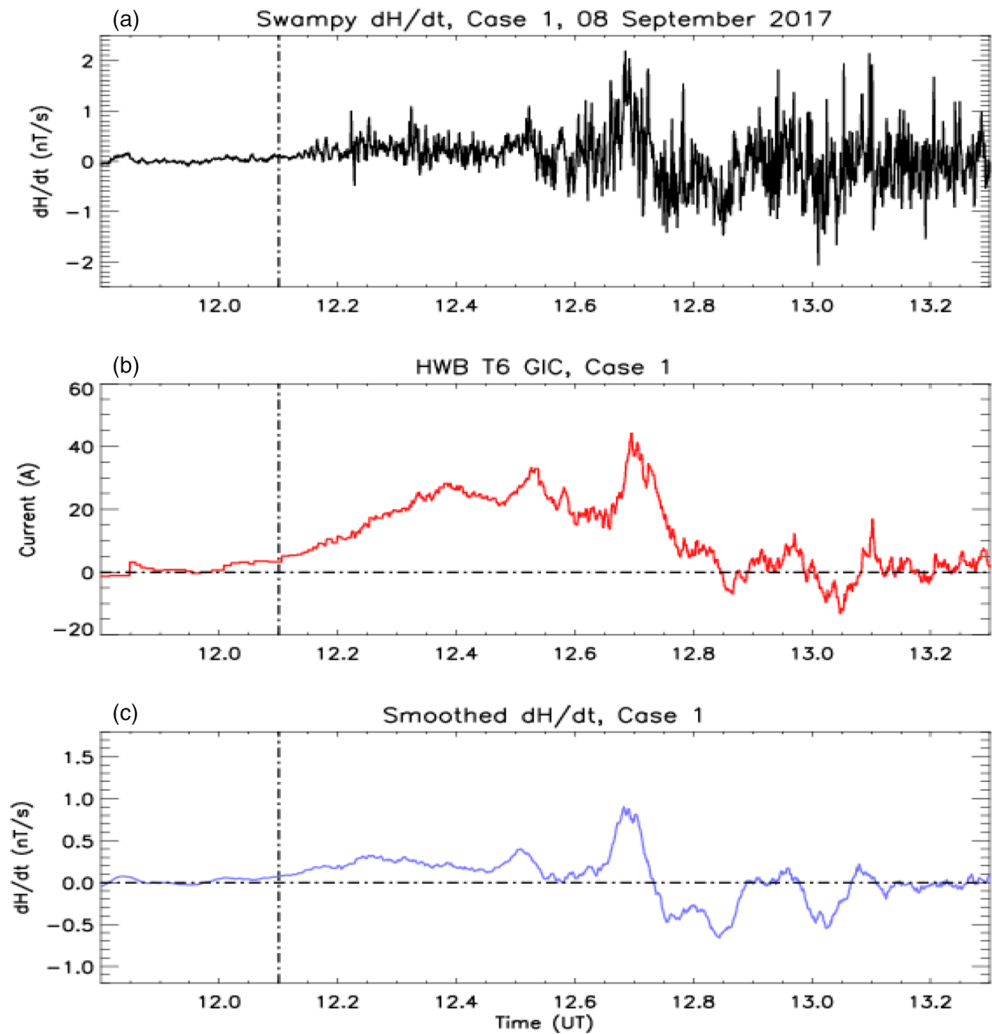
Figure 3. Case 1. Panel (a) shows variations of the horizontal component of the 1-s sampled magnetic field (dH/dt) recorded at Swampy Summit, Dunedin, subsampled to 4-s resolution. Panel (b) shows the variation of the GIC measured in transformer T6, located at Halfway Bush substation. Panel (c) shows a 40-point boxcar-averaged dH/dt that gave the maximum Pearson correlation coefficient with the GIC shown in panel (b). Vertical dash-dotted black line indicates the approximate start of the event. See text for more details.

provides a comparison between the local horizontal magnetic field variation (panel a) and the GIC recorded on HWB T6 (panel b). The time sampling for both panels is 4 s as previously discussed in section 2. The vertical dash-dotted line indicates the event onset time. Prior to this time the dH/dt fluctuations are near zero, which is consistent with the near-zero GIC levels. After the event onset, rapid fluctuations in the magnetic field H component occur, with both positive and negative gradients. By the end of the plotting period the dH/dt is oscillating around zero again with no significant offset, but still exhibiting high-frequency variations. The HWB T6 GIC panel shows less high frequency variations, with large positive currents occurring during the first hour of the event, followed by some negative current swings before the values return to near-zero levels at the end of the plotting window. Panel (c) shows dH/dt fluctuations again, but this time the plotted data has been smoothed with a running 40-point boxcar average, which has the effect of reducing the power of the high-frequency variations above 0.002 Hz (<500 s) by a factor of ~10 (see discussion in section 4.1). The similarity of the time variations of the GIC in panel (b) and the low-band-pass-filtered dH/dt in panel (c) are notable, particularly regarding the peaks, and the negative-going swings. The 40-point boxcar average was determined through an analysis which was undertaken of the time delay between the magnetic field variation and the consequent GIC

response, as well as the dH/dt smoothing level required. All combinations of the two parameters (i.e., time delaying and smoothing) were varied to determine largest Pearson correlation coefficient between the two data sets. A time delay of 76 s, combined with a 40-point boxcar average, gave a Pearson correlation coefficient, which peaked at 0.74 (significance $<10^{-44}$ using 1,260 data points). For comparison, no time shift, and no smoothing, gave a correlation coefficient of 0.37 for the same data set. No time shift, combined with a 40-point boxcar average, gave a correlation coefficient of 0.64. A time shift of 76 s with no boxcar averaging gave a correlation coefficient of 0.42.

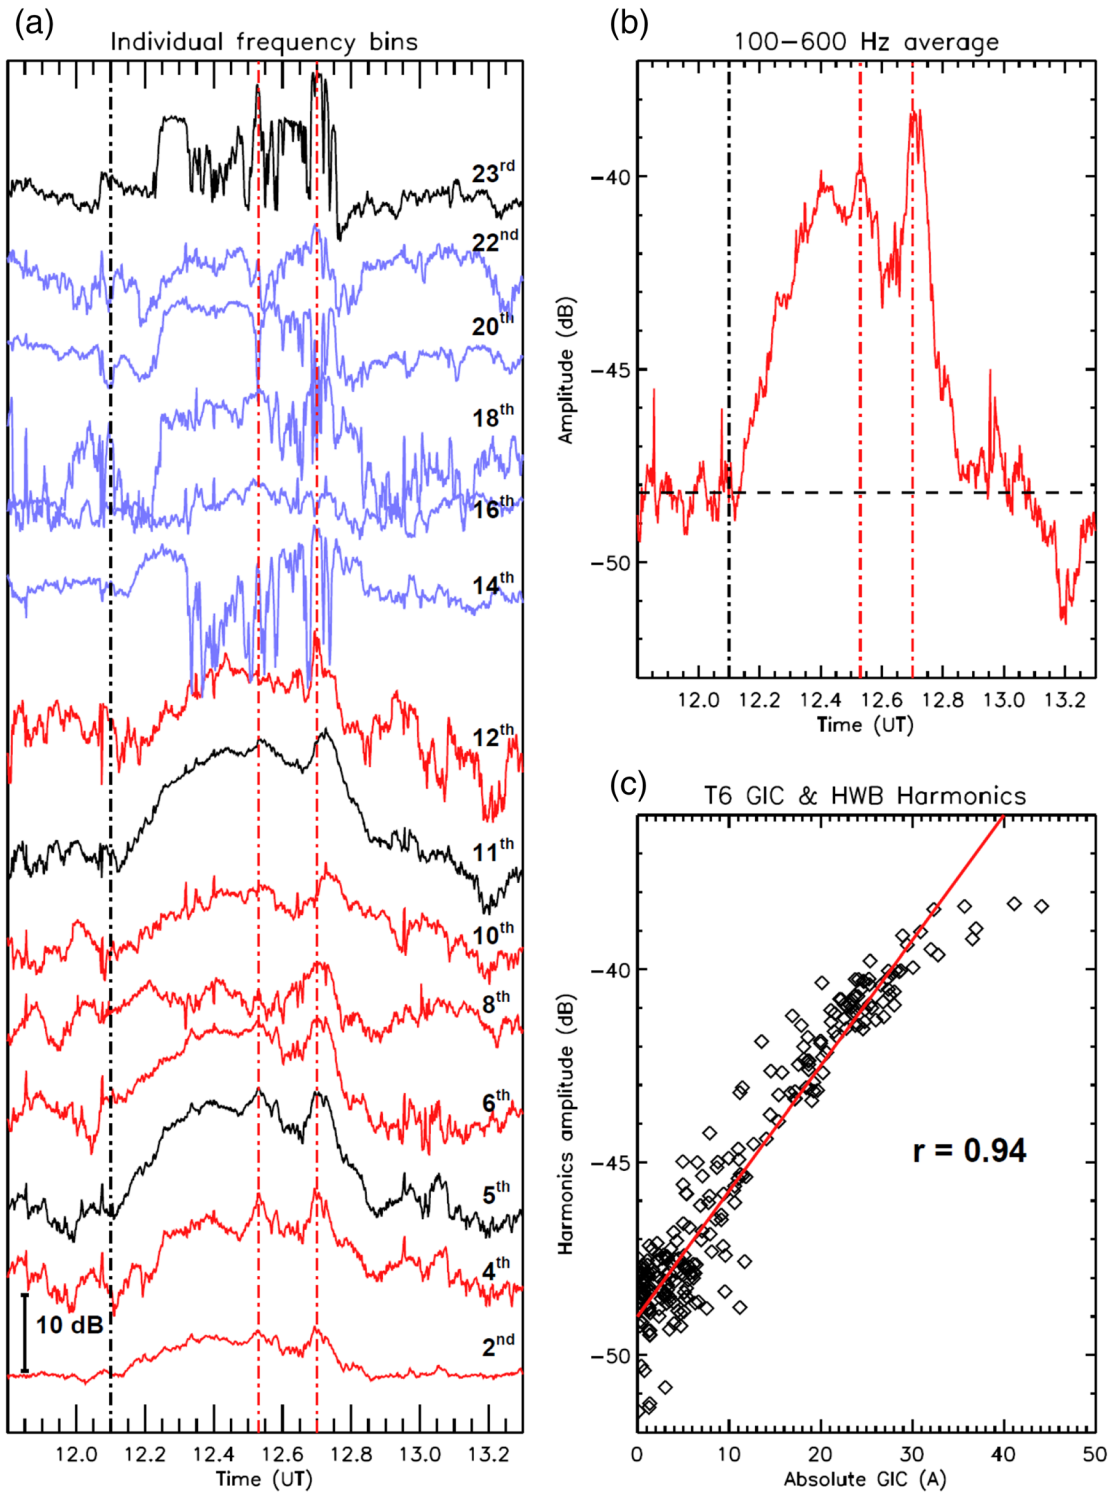
Case 1, 08 September 2017

Figure 4. Halfway Bush harmonic amplitude variations during Case 1 during 8 September 2017. Panel (a) shows the individual even harmonic frequency bins from 0–1,200 Hz, and three representative odd harmonic bins (black lines). Harmonic order is indicated from 2nd to 23rd. Each frequency bin is offset in amplitude for clarity of plotting. Frequency bins shown by red lines indicate those in the 100- to 600-Hz range used in panel (b) average variation, and panel (c) comparison with GIC level. Vertical dash-dotted lines indicate the times of peaks in GIC. Blue lines indicate even harmonics which do not clearly show the same variation pattern (14th to 22nd). The best fit between absolute GIC level and average harmonic amplitude is shown as a red line in panel (c), with a gradient of 0.33 dB/A.

Large GIC levels occurring in the Halfway Bush substation have the potential to generate harmonic distortion through half-wave saturation within a transformer (see the description in Rodger et al., 2020). The wideband VLF radiowave instrument located at Halfway Bush can observe enhancements in the intensity of mains frequency harmonics as a result of harmonic distortion, although it is not possible to distinguish which of the nearby transformers is generating the distortion signatures. Given transformer HWB T4's history of a previous failure during large GIC (Béland & Small, 2004; Marshall et al., 2012; Rodger et al., 2017), it would seem reasonable to assume that it may be the cause of the harmonics, but the perimeter VLF observations cannot answer that riddle alone. Figure 4 shows the time variation of a selection of the frequency bins associated with mains harmonics, plotted during the time period covered by Case 1. The frequency variation of the harmonics during the disturbed period can be contrasted with a nearby quiet time period, shown in Figure S1 in the supporting information. Panel (a) shows the amplitude of even harmonics from 100 to 1,100 Hz (red and blue lines) with the harmonic order labeled in black. In this panel there are three odd harmonics that will be shown consistently in all cases studied here (plotted as black lines representing 250, 550, 1,150 Hz). Each bin is offset by typically 10 dB to separate the lines, which are identified by the 50-Hz mains frequency harmonic that occurs within the 46-Hz-wide bin. The signal amplitude (vertical) scale in dB is the same for every harmonic, and the vertical offset between each pair of adjacent harmonics has been chosen to minimize overlap (while trying not to make the figure impractically tall). This leads to a typical offset of 10 dB between each harmonic, which is indicated on the figure by a vertical bar. Red lines indicate even harmonics (second to twelfth) that show variations with time that are consistent with the GIC variations shown in panel (b) of Figure 3. Blue lines indicate even harmonics which do not clearly show the same variation pattern (14th to 22nd). We note that this is somewhat subjective, but the aim is to help simplify the panel. The black vertical dash-dotted line indicates the start of the event as identified in Figures 2 and 3, while red dash-dotted vertical lines are plotted to facilitate easier comparison of the timing of amplitude peaks in different frequency bins and represent times of peaks in GIC as described in the next panel, below.

Building on panel (a) of Figure 4, panel (b) shows the variation of the average signal intensity in all bins from 100 to 600 Hz, including all even and odd harmonic channels. A horizontal black dashed line is plotted to indicate the preevent intensity levels. The same levels occur at the end of the event at about 13 UT, followed by a sharp decrease below the line. It is unclear if this is a result of the GIC event but is more likely to be associated with an occasionally observed dip in noise levels coming from the substation which occurs approximately every 2 hr, is centered on the twelfth harmonic and lasts about 5 min. The variation in the average signal between 100 and 600 Hz is compared with the absolute T6 GIC variation in panel (c). A common time sample interval of 20 s was made by subsampling each data set in order to make the figures and undertake correlation analysis. The Pearson correlation coefficient was calculated, varying the time delay between the harmonic distortion and GIC data sets. The maximum correlation coefficient was 0.94 (significance $<10^{-44}$, for 252 data points), which was achieved when there was no time shift between the two data sets, that is, less than 20 s. The best fit is shown as a red line in panel (c), with a gradient of 0.33 dB/A.

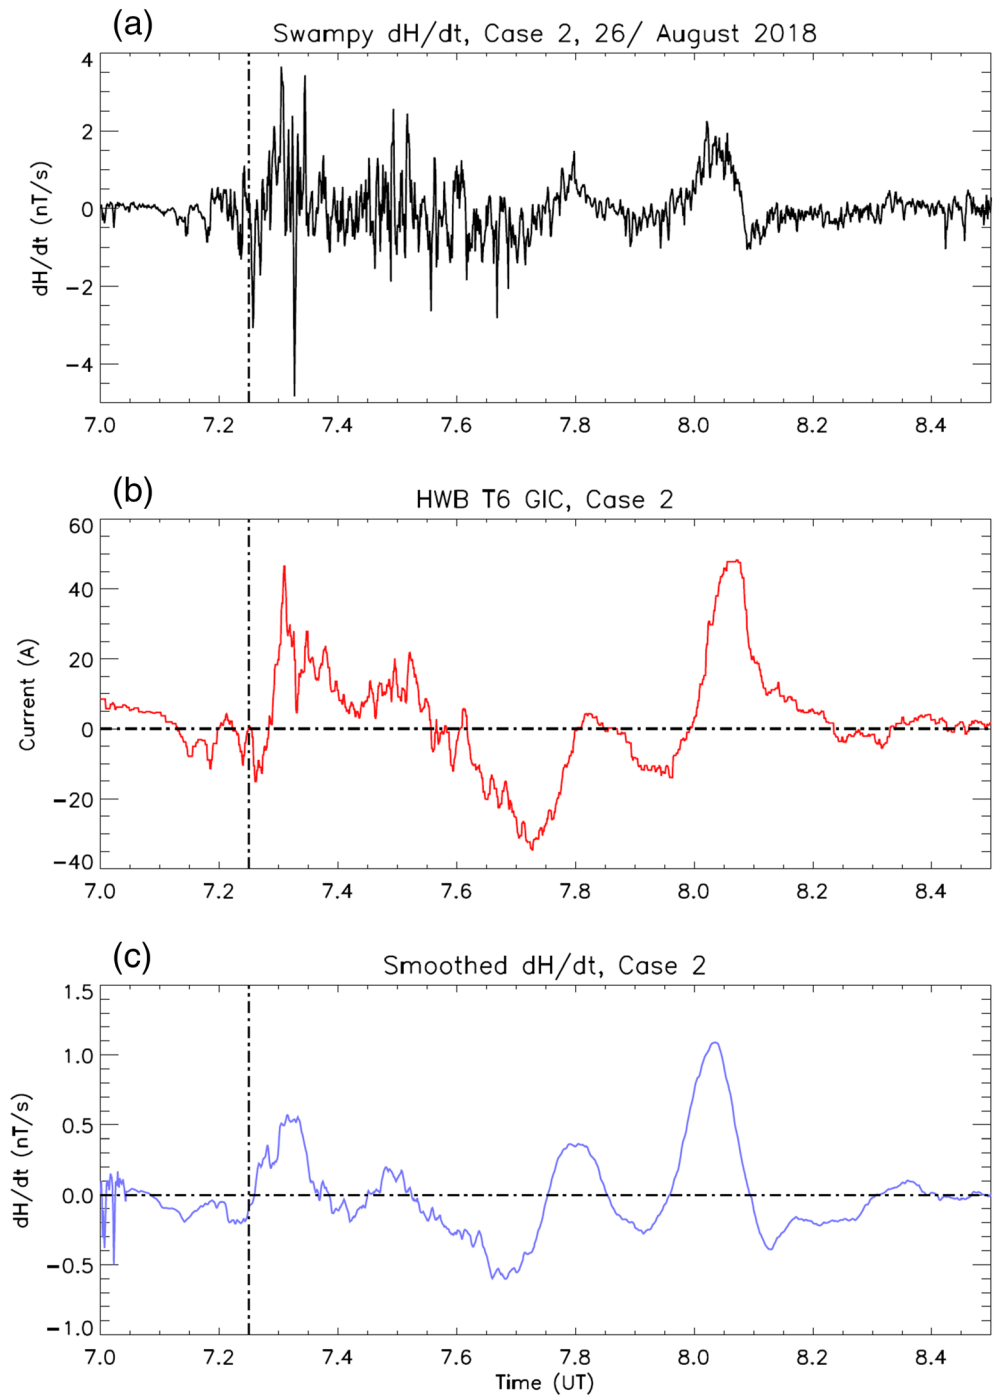
Figure 5. Case 2 from 26 August 2018. Same format as Figure 3. Panel (c) shows a 78-point boxcar-averaged dH/dt that gave the maximum Pearson correlation coefficient with the GIC shown in panel (b).

event occurred between 07 and 0830 UT, when Dst was at its most extreme, during which there was a large substorm (indicated by enhanced AE and AL indexes, not shown). Figures 5a and 5b present the Case 2 magnetometer dH/dt and T6 GIC respectively in the same format as Figure 3. As in Case 1 the dH/dt variations show more high time resolution variations than the GIC. Panel (c) shows dH/dt fluctuations plotted with a running 78-point boxcar average, which has the effect of reducing the power of the high-frequency variations, and as a result, exhibiting similar time variations to those in the GIC panel.

The 78-point boxcar average of dH/dt was determined through the same analysis technique approach that was used for Case 1. All combinations of time shift and boxcar filtering factor between the dH/dt and GIC data sets were analyzed to find largest Pearson correlation coefficient. A time delay of 128 s, combined with a 78-point boxcar average, gave a Pearson correlation coefficient which peaked at 0.83 (significance $<10^{-44}$ using 900 data points).

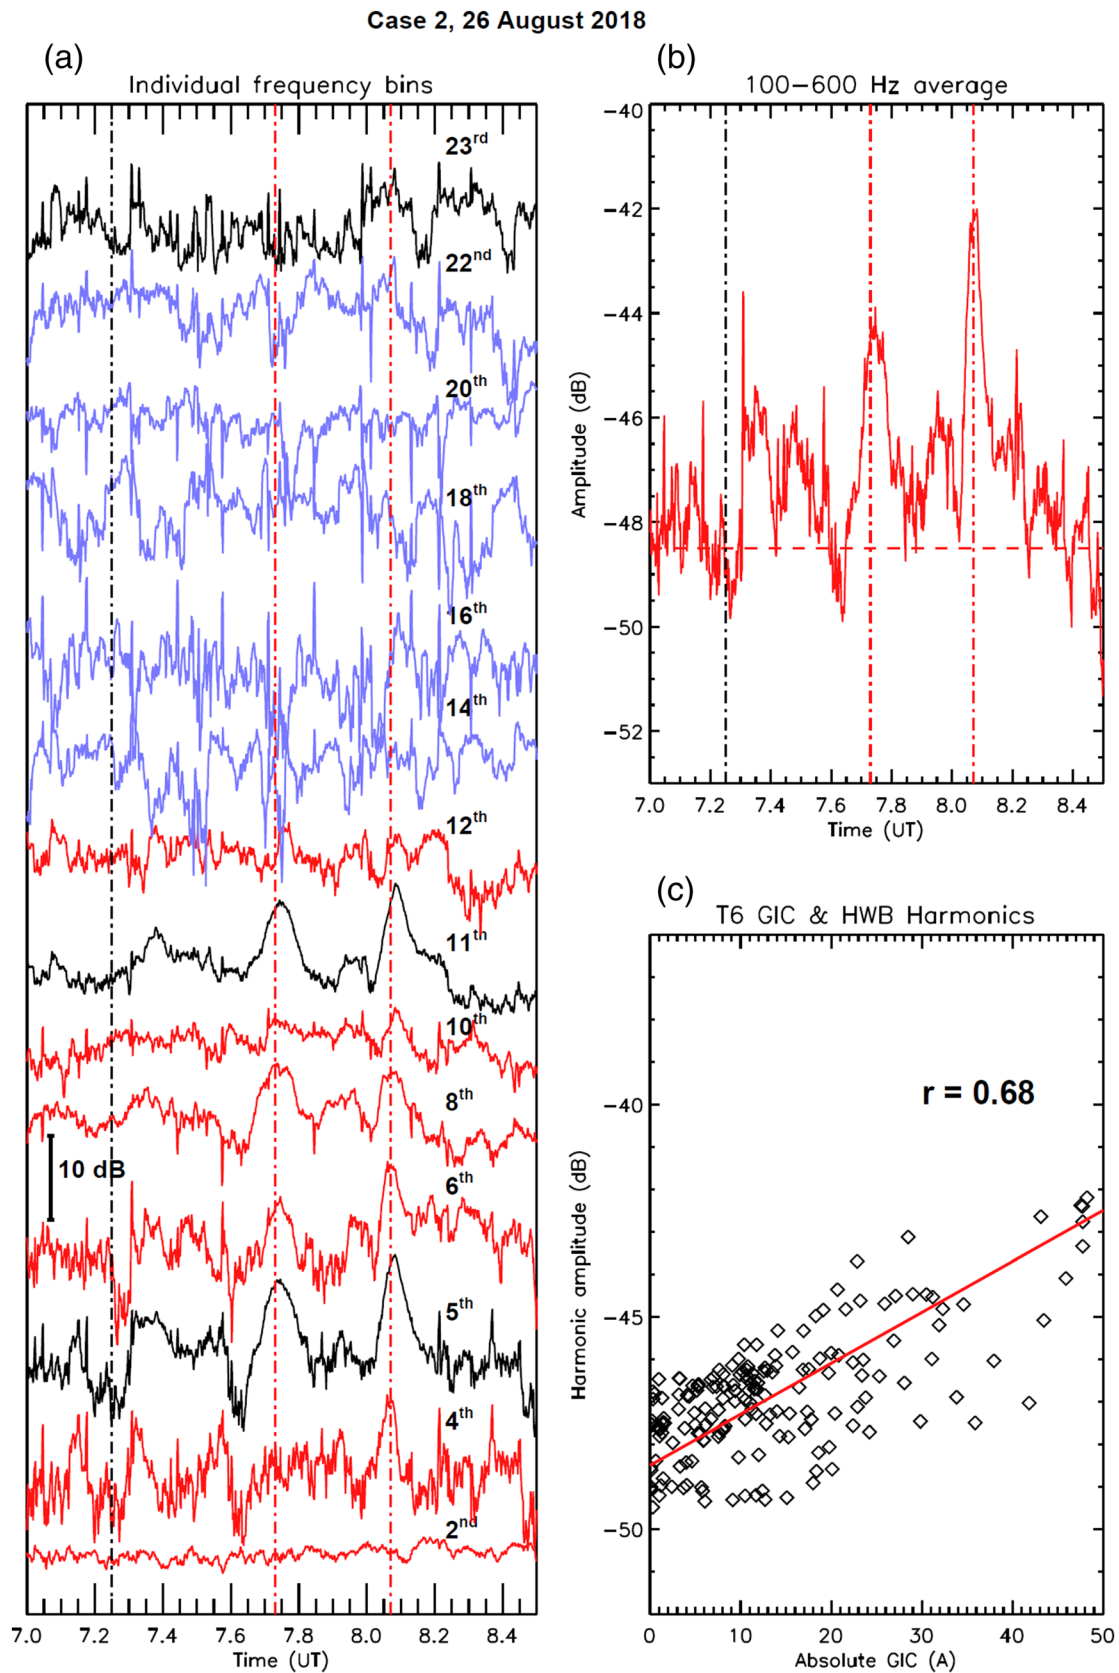
Figure 6. Halfway Bush harmonic variations during Case 2 during 26 August 2018. Same format as Figure 4.

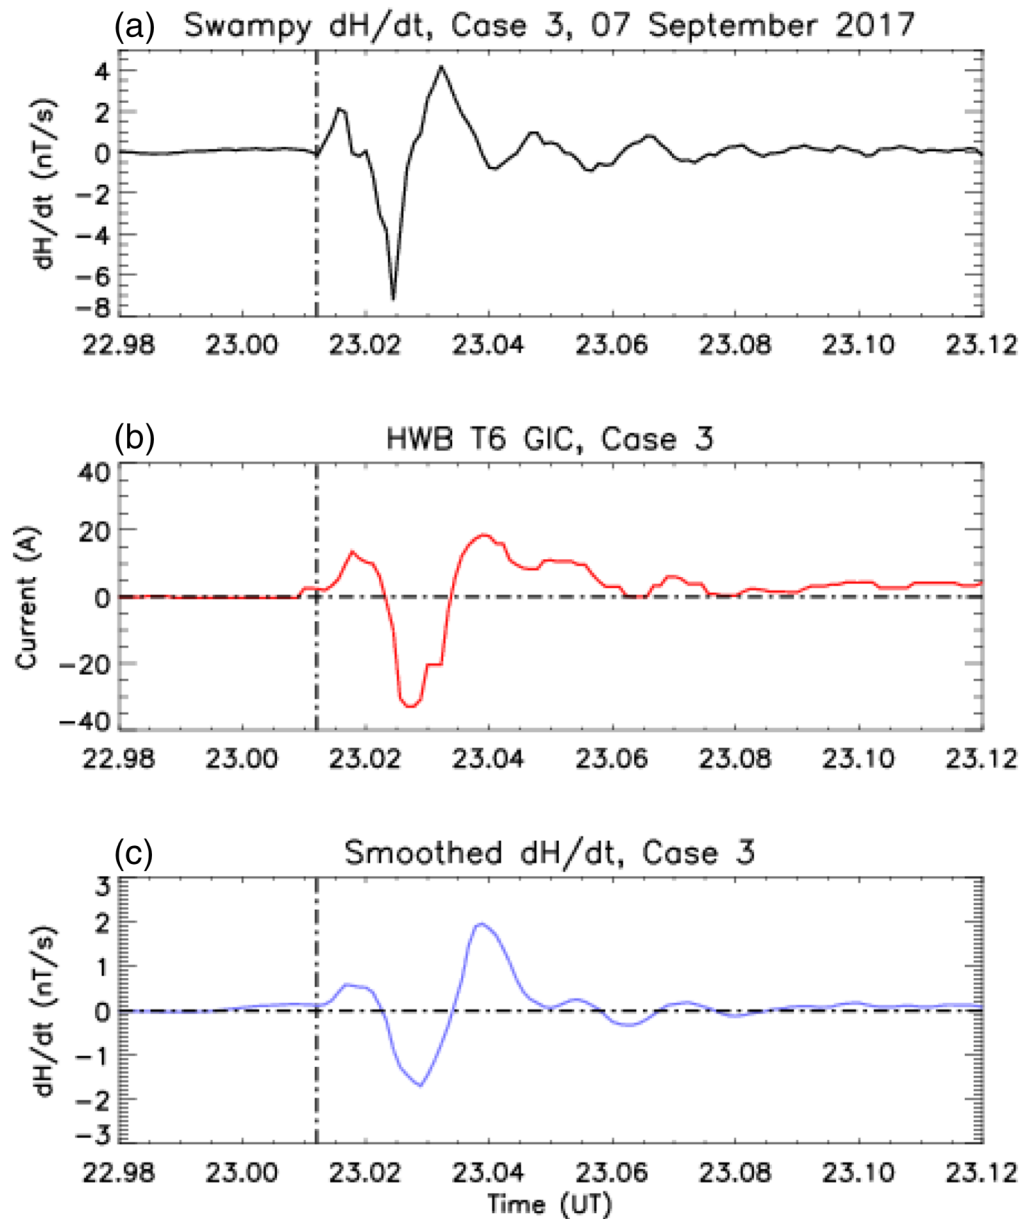
Figure 7. Case 3 from 7 September 2017. Same format as Figure 3. Panel (c) shows a 10-point boxcar-averaged dH/dt that gave the maximum Pearson correlation coefficient with the GIC shown in panel (b).

The third case study event comes from 7 September 2017 and is associated with the arrival of a solar wind pressure pulse just after 23 UT. The shock was identified by the SOHO satellite at L1 at 2238 UT [umtof.umd.edu/pm/FIGS.HTML] with the solar wind suddenly increasing from ~ 450 to ~ 700 km s $^{-1}$. This particular case study event has been discussed by Clilverd et al. (2018) as “Event 3” and Rodger et al. (2020) as “Event 3a”, where the apparent absence of harmonic distortion even in the presence of large induced currents was noted. During this event both HWB T4 and HWB T6 were operational at Halfway Bush substation. Figure 2c showed more than an hour of HWB T6 GIC data during this event. However, in this Case 3 we concentrate on only the initial short period following the arrival of the pressure pulse where large negative currents were measured as part of a rapid response to the solar wind shock arrival. Figures 7a and 7b show the magnetometer dH/dt and HWB T6 GIC, respectively, during the short period following the start of the event, indicated by a dash-dotted vertical line. Large negative rates of change of magnetic field correspond to large negative induced currents in HWB T6. The panels cover a period of 8 min, although the duration of large GIC values only lasts 3 min. Panel (c) shows dH/dt filtered by a boxcar average using 10 points. As in previous analysis, the maximum Pearson correlation between the dH/dt and the HWB T6 GIC data over this short period was determined. A maximum correlation coefficient of 0.89 (significance 4×10^{-25} using 80 data points) was found, associated with a delay of 20 s between the magnetic field fluctuations and the resultant GIC level, and filtering provided by 10-point boxcar averaging (40 s). The similarities between the filtered dH/dt and the GIC variations are notable.

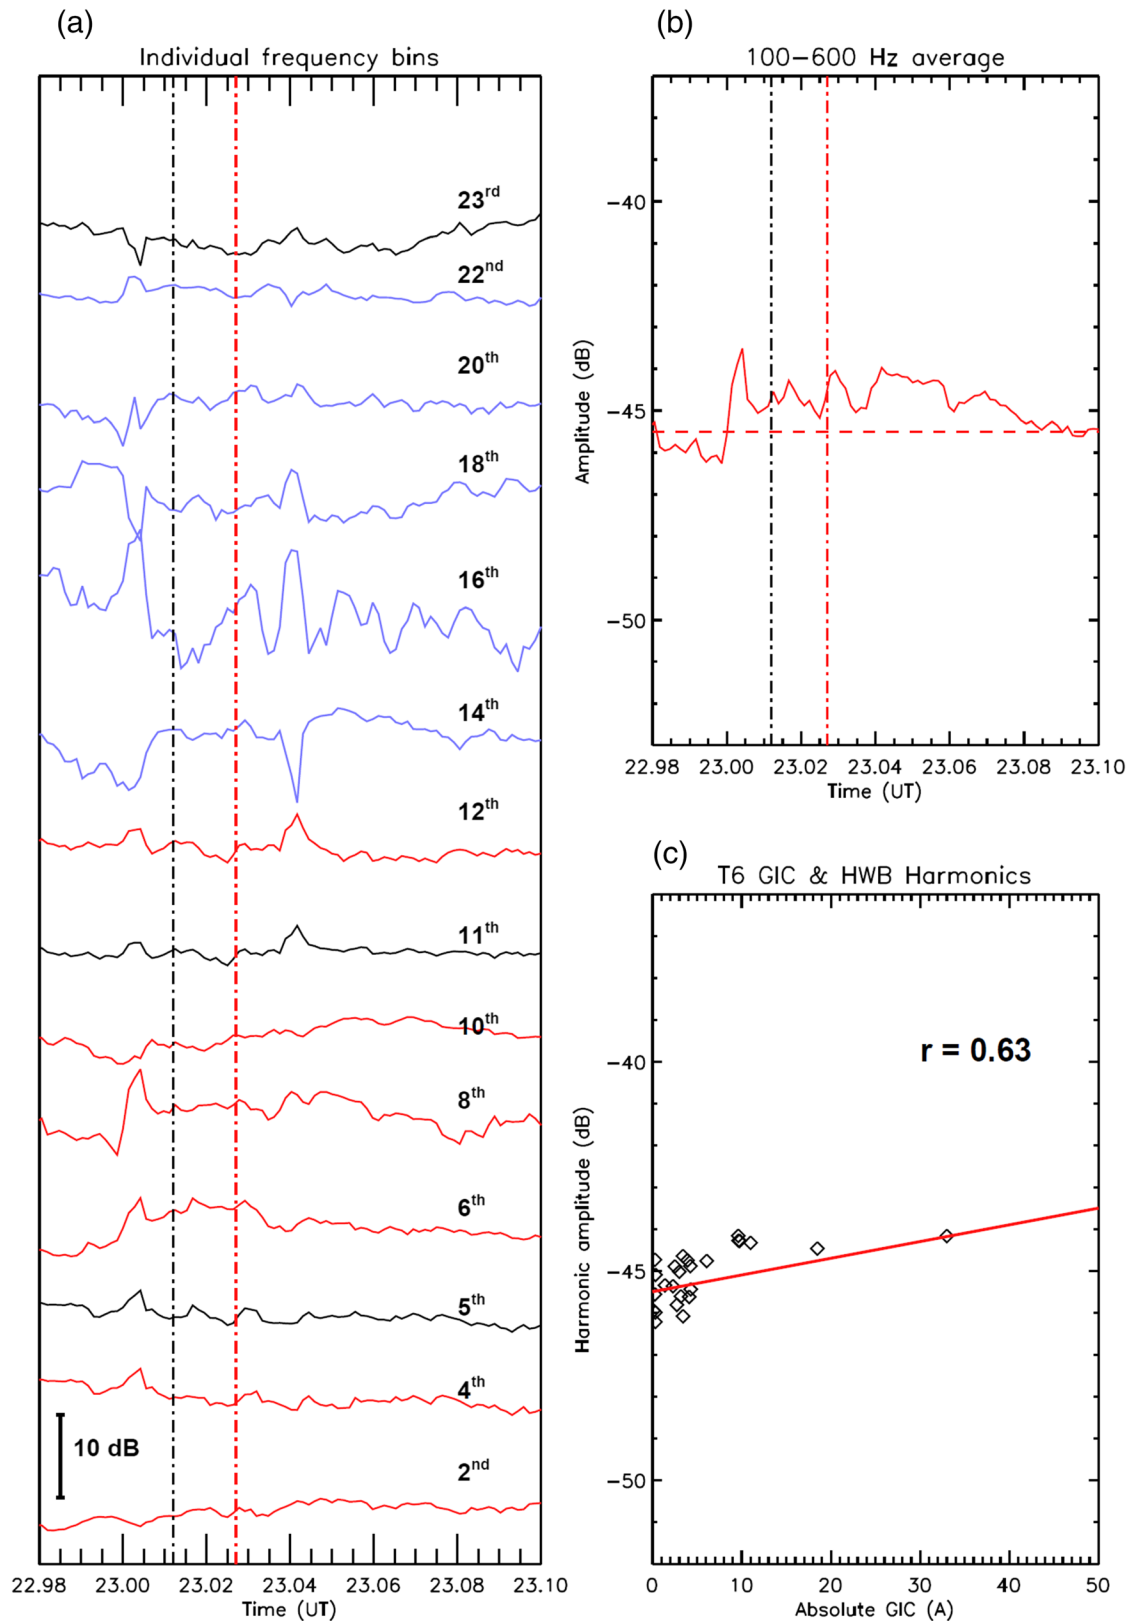
Case 3, 07 September 2017

Figure 8. Halfway Bush harmonic variations during Case 3 on 7 September 2017. Same format at Figure 4.

Harmonic distortion levels are shown in Figure 8, following the same format as Figures 4 and 6. In panel (a) it is difficult to identify any clear amplitude enhancements in the individual channels. The frequency variation of the harmonics during the disturbed period can be contrasted with a nearby quiet time period, shown in Figure S3 in the supporting information. The average harmonic distortion shown in panel (b) shows a small enhancement in amplitude above the indicated baseline, although the largest peak occurs prior to the onset of the event. Panel (c) shows that there is little harmonic response to a relatively large range of current values. The Pearson correlation coefficient of 0.63 is the lowest of all cases, and the significance, $p = 0.002$, is the largest. The best fit is shown as a red line in panel (c), with a gradient of 0.04 dB/A, that is, about eight times lower than seen for Case 1, which occurred only 13 hr later.

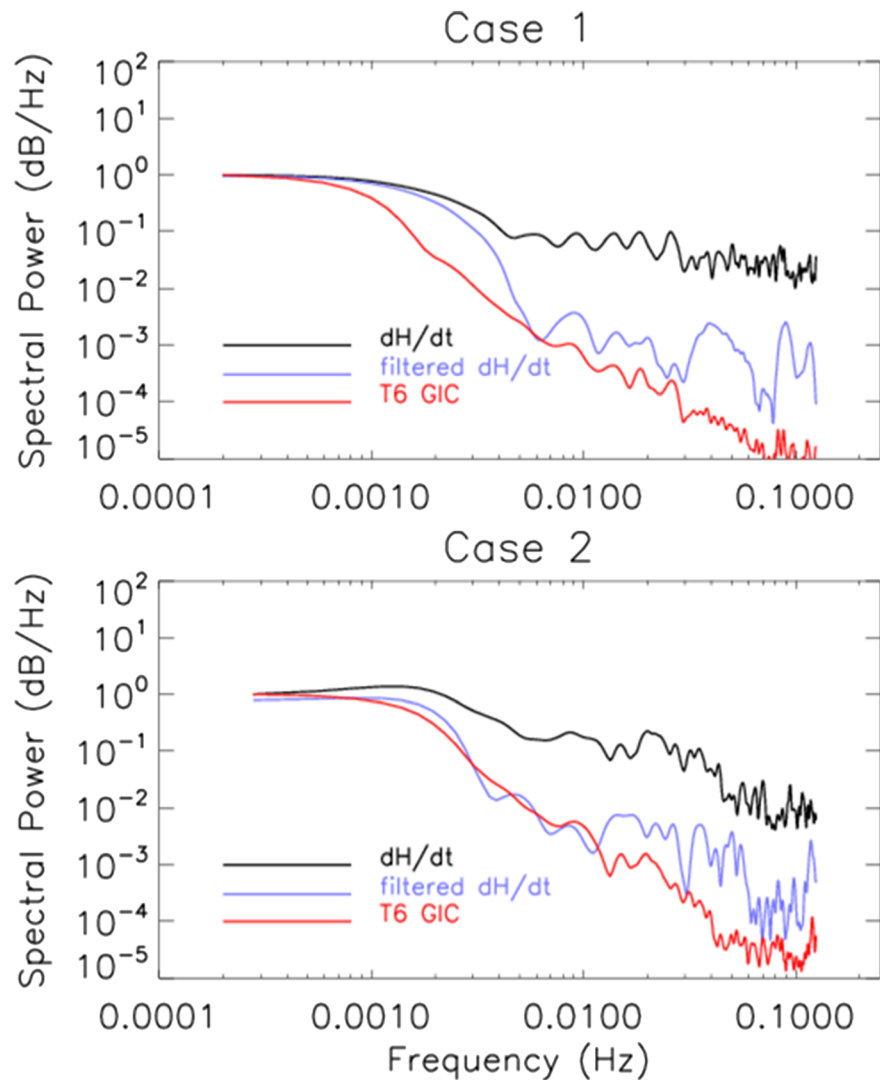
Figure 9. Upper panel: Normalized power spectra for Case 1. The spectrum for the HWB T6 GIC (red line) is compared against dH/dt (black line) and the boxcar-averaged dH/dt (blue line) shown in Figure 3. Lower panel: Normalized power spectra for Case 2. Same format as upper panel.

The effect of boxcar filtering on the power spectra is shown in Figure 9. Panel (a) shows the normalized power spectrum for dH/dt (black line) and filtered dH/dt (blue line) for Case 1. Also shown is the HWB T6 GIC normalized power spectrum (red line) for comparison. Panel (b) shows the same format but for Case 2. The highest frequency of 0.125 Hz is determined by the 4-s sampling period, while the lowest frequency of 0.0002 Hz is determined by the ~ 1 -hr duration of the events. For Case 1 the filtering is achieved by using 160-s boxcar averaging as found in section 3.1, while Case 2 uses the 312-s boxcar average found in section 3.2. Both panels show that the effect of the filtering is to reduce the power in the high-frequency dH/dt components. For Case 1 reductions in spectral power by a factor of 10 occur at about 0.005 Hz (a period of ~ 3 min), while for Case 2 the reductions occur at 0.003 Hz (~ 6 min). This analysis suggests that dH/dt variations with periods longer than 3–6 min are likely to dominate the GIC response and will provide more accurate power system modeling than if the high-frequency dH/dt components are included in such modeling. Case 2 is notable in that the filtered dH/dt has a very similar spectral variation to the power spectrum of the GIC during the event.

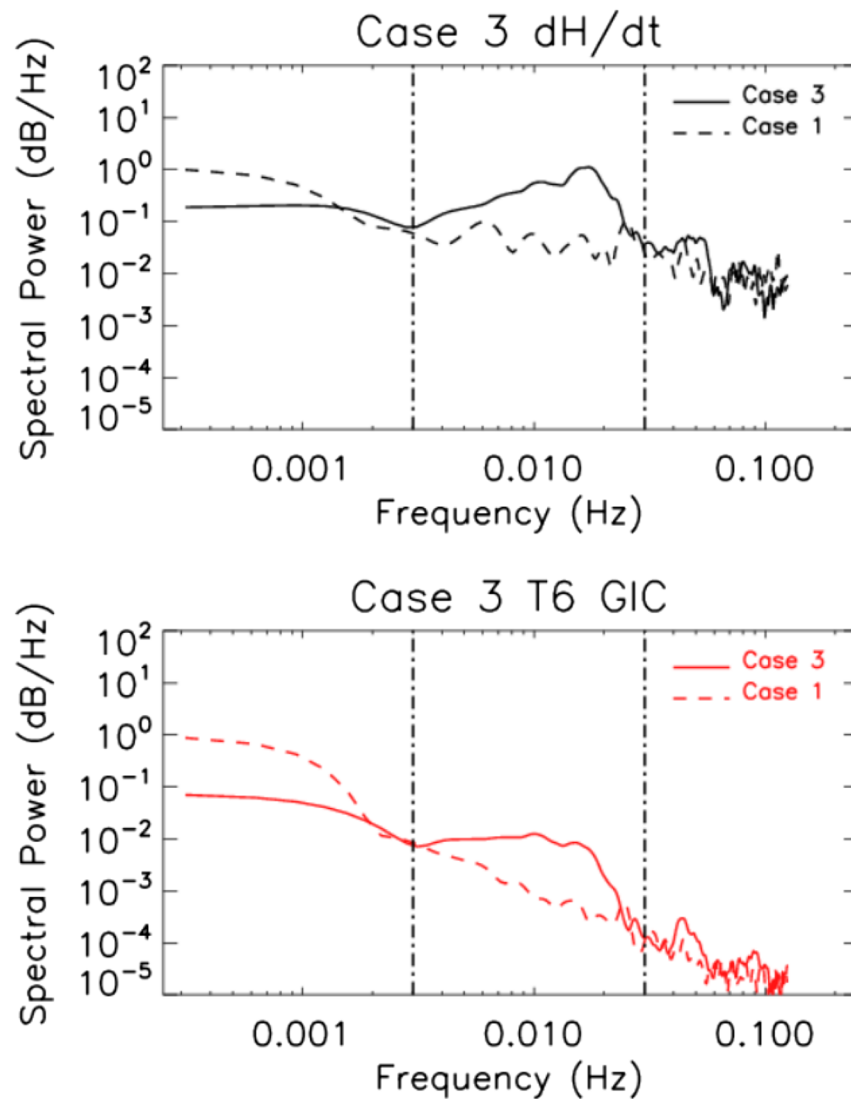
Figure 10. Upper panel: Spectral power for dH/dt in Case 3 (solid black line) compared with Case 1 (dashed black line), highlighting spectral differences between substorms and sudden commencements. Lower panel: Spectral power for GIC in Case 3 (solid red line) compared with Case 1 (dashed red line). In both panels power is normalized to the maximum power in Case 1 (dH/dt or GIC). Vertical dash-dotted lines indicate frequencies where levels are similar during the two case events. See text for more details.

In the previous substorm analysis we found that dH/dt variations with periods longer than 3–6 min (< 0.003 – 0.005 Hz) are likely to dominate the GIC response. This is investigated for the Case 3 sudden storm commencement event via Figure 10. The upper panel shows the spectral power for dH/dt during the whole event period (as shown in Figure 2c) plotted in comparison to the substorm, Case 1. The lower panel of Figure 10 shows the GIC power spectra for Case 3 compared with Case 1, in the same format. Comparisons are made with Case 1 rather than Case 2 (or both) because these events are within hours of each other and have the same substation configuration. The power values are normalized to the maximum power observed in Case 1. Both parameters show similar spectra for both Case 3 and Case 1. Vertical dash-dotted lines indicate two key frequencies. The highest frequency identified in the panels is 0.03 Hz (33-s period). Above this frequency the power spectra for Case 1 and Case 3 are similar, for both the dH/dt and GIC panels. The lowest frequency indicated is 0.003 Hz (333-s period). Between 0.003 and 0.03 Hz the Case 3 spectral power is noticeably higher than for the substorm Case 1, suggesting that this is a significant characteristic of the storm sudden commencement. Below this frequency the power in Case 3 is lower than for Case 1, suggesting that the sudden commencement does not generate low-frequency fluctuations in the same way as substorms. Additionally, our earlier analysis picked out frequencies below 0.003 Hz as being particularly important in the coupling between magnetic field perturbations and GIC that resulted in harmonic distortion. This suggests that the explanation for the lack of harmonic distortion response to the storm sudden commencement is due to less excitation of longer period perturbations (> 5 min) both in local magnetic field variability, and the resultant GIC variations. Five-minute periods are likely to represent the characteristic response time of the transformer, where the slow variation allows magnetic flux to build up, and push a core into saturation thus generating harmonic distortion (Albertson et al., 1992; Viljanen et al., 2001).
