VEGETATION CONTROLS ON CHANNEL STABILITY IN THE BELL RIVER, EASTERN CAPE, SOUTH AFRICA

Kate M. Rowntree and Evan S.J. Dollar

Department of Geography, Rhodes University, P.O. Box 94, Grahamstown, 6140, South Africa

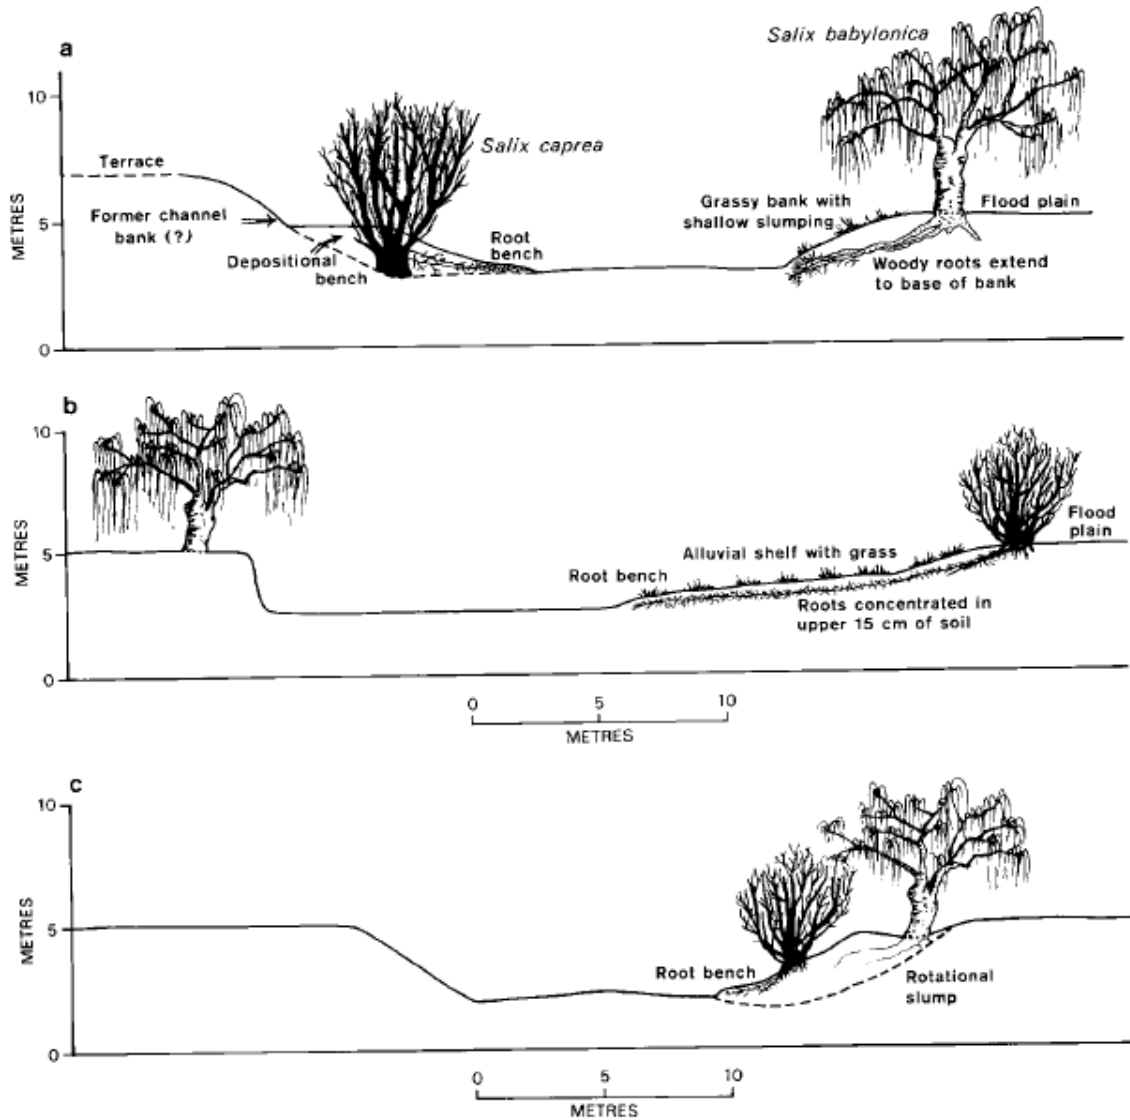
It was noted that many of the former banks of cutoff meanders had been lined with mature *S. caprea* so that, although promoting bank stability, the presence of trees clearly had not prevented channel straightening. *S. babylonica* tends to grow as isolated trees on the bank tops and has a more massive growth form. Although its roots do offer some protection to the bank they do not form the dense mats characteristic of *S. caprea*. Where bank undercutting occurs the trees will topple into the channel, causing obstructions and possible further instability. Another effect of *S. babylonica* noted in the field was bank slumping due to the increased weight of the tree (Figure 2c).

Figure 2: The effects of *Salix* species on channel cross-section form.

Channel vegetation surveys have shown that where *S. caprea* has colonized the bank, dense root matting has led to bank stabilization. Bank vegetation has stabilized the channel banks and induced bank accretion, resulting in the formation of channel benches. The end result is a reduction in the form ratio and channel cross-sectional area, reducing the channel capacity and increasing the frequency of overbank flooding. This effect is aggravated wherever woody debris falls into the channel, causing further obstructions. Chute formation can be explained as the logical progression as the water scours a more efficient channel across the grassed floodplain. The new channel would lack woody vegetation, have a steeper gradient than the meander, and often be formed on the coarse sublayer of the alluvium constituting the floodplain. The release of fine sediment from the upper strata of the floodplain alluvium into the sections downstream of the cutoff would have further implications for sediment loading and channel stability.
