# Corrosion and stray currents at urban track infrastructure

Subject review

rails, corrosion, stray currents, rail potential, rail-to-earth electrical resistance

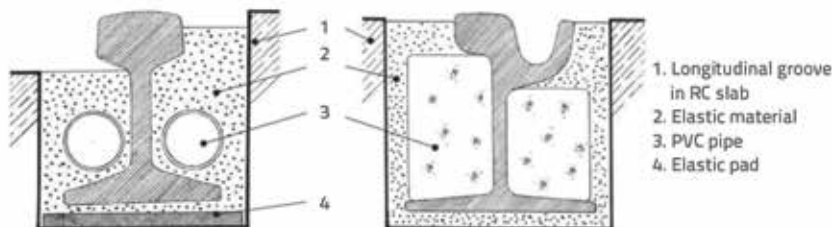
Figure 1. Example of continuously insulated rails in an embedded track [2]

Tram systems and light urban railway systems are the main form of transport in urban areas of many European metropolitan centres. They are realized within the roadway or form a separate right-of-way, and their structures may vary to a great extent. When considering corrosion processes that affect rails, it must be noted that the most important characteristic of the track is the way in which rails are insulated, which in turn depends on the way in which rails are fastened to their support. In the case of continuous fastening, rails are placed into grooves realized in the load-bearing concrete support and, after the track is positioned along the length and height, the free space is filled with an elastic material. In order to save on material used, PVC pipes are very often used for this purpose (Figure 1) [1]. In these tracks, rails are fully separated from the surrounding structure by elastic material, and are hence protected against corrosion processes.

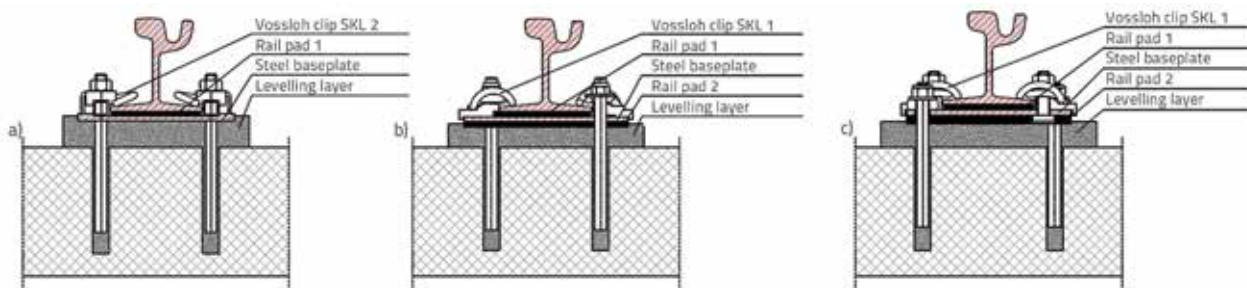
Figure 2. Cross section of fastening systems ZG 3/2, PPE, DEPP [8]

In the case of individual supports, rails are fastened onto the support via fastening systems. These are mostly track systems without individual sleepers where concrete support layers are used, and rail fastening positions are integrated into the load bearing layer [1, 3]. Tram infrastructure realised in Zagreb is an example of such structures where the rail leans via a neoprene setting pad onto the steel support plate and the synthetic composite bearing at every one-meter intervals [4]. One of the first fastening systems applied on tram infrastructure in Zagreb was the single elastic fastening system ZG 3/2 (Figure 2a). However, due to deficiencies of this system, other systems have been introduced in the meantime and the system that has most frequently been used over the past twenty years is the enhanced-elasticity fastening accessory (the PPE system) and the double elastic fastening accessory (the DEPP system) [5]. Unlike the ZG 3/2 system, PPE and DEPP systems feature a ribbed neoprene pad under the steel support plate. This pad provides for better elasticity and insulation of the fastening accessory (Figures 2.b and 2.c) which will be shown further on in this paper as an advantage with regard to the influence of stray currents. The basic difference between the DEPP and PPE systems is in separation of the anchoring screw from the elastic clip and in greater thickness of the ribbed neoprene pad in case of the DEPP system [6, 7].

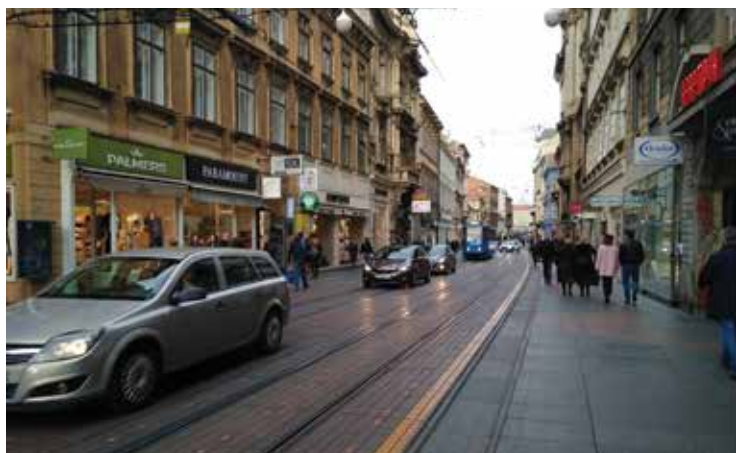
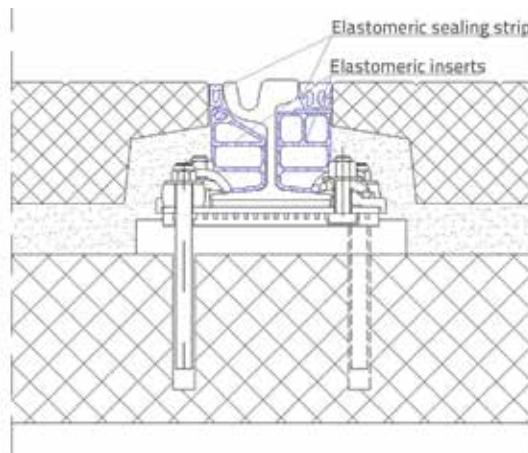
Figure 3. Example of track as a part of roadway (left), cross section of fastening point in case of tracks in roadway zone, DEPP fastening system (right)

If tracks are situated within the roadway zone they are closed with asphalt, reinforced-concrete slabs or in some other way, and are in this case called embedded tracks (Figure 3, left). In the city of Zagreb, rails for embedded tracks are insulated via elastomeric inserts at rail neck, while the bond between the rails and cover plates is ensured via elastomeric sealing strips (Figure 3, right) [7, 8]. As the road vehicle traffic is also operated on such embedded tracks, the tracks gradually deteriorate as can be seen through damage to reinforced-concrete slabs, deterioration of neoprene inserts next to rail web, and detachment of elastomeric sealing strips (Figure 4). Such damage results in penetration of water into the track system, and hence conditions favourable to the development of corrosion processes are created.

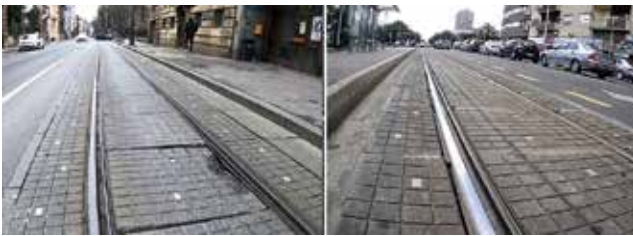
Figure 4. Reinforced concrete slab damage in track zone within a road system (left), deteriorated neoprene inserts next to rail web, absence of elastomeric sealing strip (right) [6]

It is not easy to prevent water penetration at urban track structures, and especially at on-street running track structures. The most frequent example of a track element degradation at tram infrastructure in Zagreb is shown in Figure 4. This degradation permits free penetration of water into the track structure. As can be seen in that figure, the reinforced-concrete cover slab is damaged, and elastomeric sealing strips that are placed next to rail have fallen out. Water can be stopped from penetrating into track structure over a longer period of time through implementation of new sealing technologies. Thus, in case of track rehabilitation at the Savska cesta road section in Zagreb, a fill material was used instead of traditional elastomeric sealing strips (Figure 28) [9]. This material is bonded on the one side with the rail, while on the other side it is connected with the reinforced-concrete cover slab and, hence, the rate of water pouring along the rail into the track structure is reduced, and so

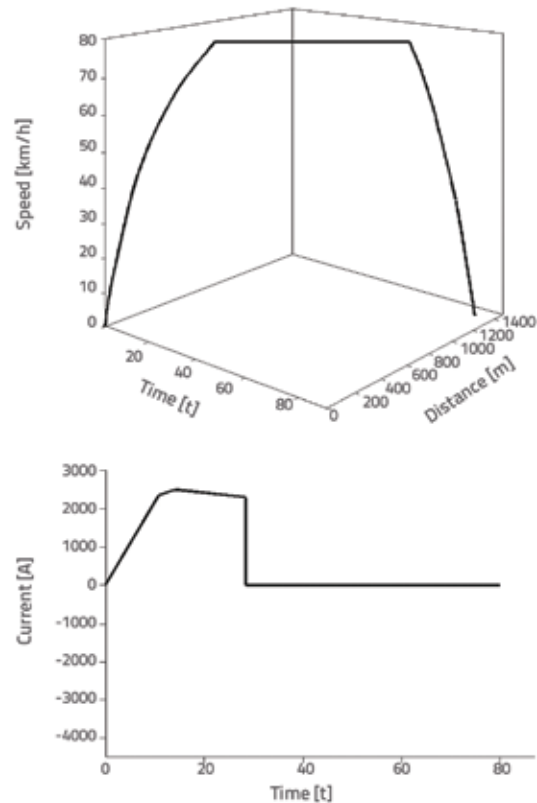
Figure 5. Diagram showing dependence between time, speed and distance covered during operation of a rail vehicle (top), intensity of current required by vehicle depending on type of operation (bottom), according to [17]

The electricity coming from the power supply grid is carried to the electrical substation where it is converted via transformers and rectifiers into direct current with voltage as required for vehicle operation [10–12]. Each electrical substation supplies power to its part of the overhead contact line regardless of other parts, and the electricity is carried from the overhead line to the vehicle via pantograph [14]. In the same time interval, only one electrical substation can supply electricity to a vehicle on a tram infrastructure [5]. In most cases, the electricity is carried back to the electrical substation by rails and return lines forming connection between rails and the electrical substation. The use of rails to carry back electricity reduces track construction costs and makes unnecessary installation of an additional return conductor [10, 13]. The electricity required for tram operation is dependent on the way in which the vehicle is operated. Figure 5 (top) shows the diagram presenting dependence between the time, speed and distance travelled during vehicle operation, and Figure 5 (bottom) shows the current needed by the vehicle depending on the way it is operated. Three cases are analysed in this diagram: the vehicle accelerates in the time interval from 0 to 28 seconds, from 28 to 63 seconds the vehicle moves

at a uniform speed, and from 63 to 84 seconds the vehicle decelerates and finally stops. If a vehicle moves at uniform speed or decelerates without the possibility for regenerative braking (return of electricity to the supply grid using engine as generator during braking activity [16]), its electricity consumption will be minimum, and hence stray currents will also be minimum. On the other hand, the consumption of electricity increases with acceleration, which will result in higher stray current values [17, 18]. When a vehicle accelerates, the quantity of stray currents will also depend on vehicle acceleration rate, i.e. the values will be greater with stronger acceleration.

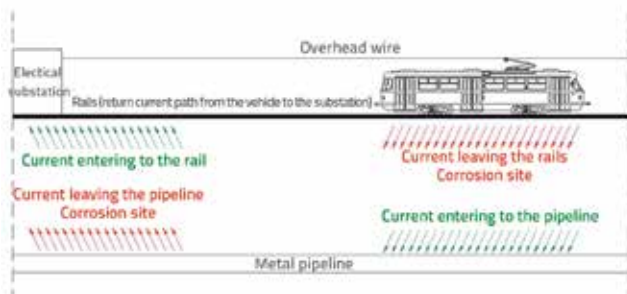
Figure 6. Development of stray currents on rail infrastructure

When the current returns through rail from vehicle to electrical substation, an electric resistance is created in the rail (the resistance through which conductor material opposes the flow of current) and this resistance causes the difference in electric potential in the rail [24]. The difference in potential in the rail will depend on the way the rail is earthed. In the case of a floating system, which is nowadays in common use, the potential assumes positive values at the vehicle positions, and negative values in the vicinity of the electrical substation. If the rail is not fully insulated from soil, a part of the current will flow out of the rail at places of positive potential. This current, called stray current, finds the way of lower electrical resistance by which it will return to the source of electricity (Figure 6) [23, 24].

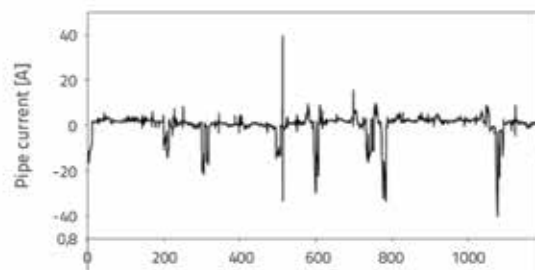
Figure 7. Results obtained by field measurement of current in buried pipelines, high values correspond to the passage of tram vehicles [28]

Out of all types of electrochemical corrosion, the corrosion due to stray currents is the greatest danger that may cause rail degradation in the track system, as well as degradation of municipal infrastructure situated in the vicinity of the track structure. For that reason, a special attention must be paid to the monitoring of track parameters that can provide information about the quantity of stray currents at a particular segment of the track [13]. These parameters are described in detail in Section 3. Although the stray current occurring on rail track is extremely difficult to measure directly, various devices are currently available to make such measurements on municipal infrastructure situated near the railway track. In their paper [28], Mujezinović A. et al. describe field measurements of stray current at buried pipelines situated in the vicinity of tram infrastructure. The analysis of results has shown that the passage of tram vehicle causes high current values in pipelines. A diagram showing the current measured in a pipeline over a time interval of 1000 seconds is shown in Figure 7. Narrow peaks correspond to the passage of tram vehicles. The passage of seven tram vehicles can clearly be observed in the figure. In addition, in the case of the 24-hour measurement, the analysis of data points to an increase in the quantity of stray currents on pipelines in morning and afternoon hours when the rail system is subjected to highest loads [29]. Results obtained by the 24-hour measurement of pipeline potential are shown in Figure 8. This figure clearly shows that there is a significant increase in potential during peak hours [29].

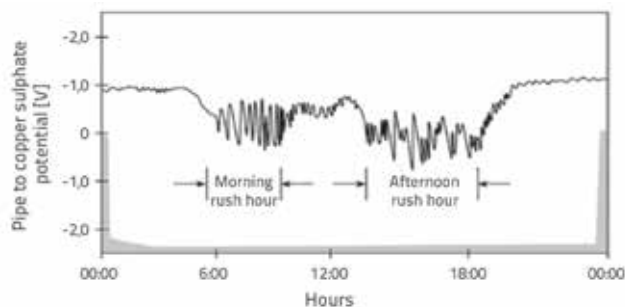
Figure 8. Pipeline potential measured during one day [29]

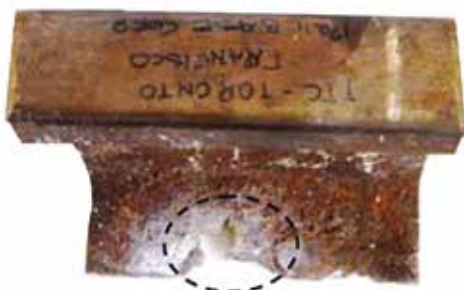
Figure 9. Tested sample of corroded rail, loss of material from the side and top part of the rail foot: circled points are the points of concentration of highest normal stresses [31]

Corrosion at rail foot edges is manifested in the form of sharp edges, as can be seen in figures 9-12. The rail cross section is reduced due to loss of material at rail foot, which results in the accumulation of stress due to load, and in the widening of cracks. The resistance to shear and bending is reduced, and dynamic strength of the rail is impaired, which is why the rail becomes susceptible to fracture due to fatigue [27, 30]. In addition, the rail fastening force weakens, which increases the possibility of rail rollover or track widening in small radius curves. These occurrences can be detected by measuring track geometry under load using the track recording vehicle [30, 31]. Using a digitizer, Robles Hernandez F.C. et al. [21] created a digital image of rail samples, as shown in figures 9 and 10. The image was stored in the ANSYS software and a reliable numerical model was created. The model characteristics correspond to the characteristics of the corroded rail samples. The finite element analysis was conducted in order to determine stress distribution in rail samples. It can be seen on the sample shown in Figure 9 that great stress concentration is formed on corroded, sharp edges at the rail foot (Figure 13a and b) [21]. These values attain the elastic limit for rail steel and so corrosion damage at rail foot can result in rail foot rupture [19, 28]. In case of sample shown in Figure 10, the greatest stress concentration was observed at the start of narrowing of the rail foot, but stress values registered at this samples are much smaller compared to the first one (Figure 13c and d).

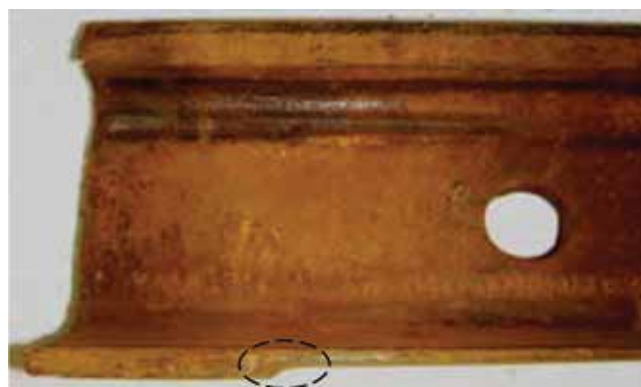
Figure 10. Tested sample of corroded rail, loss of material from the bottom side of the rail foot, circled points are the points of concentration of highest normal stresses [31]

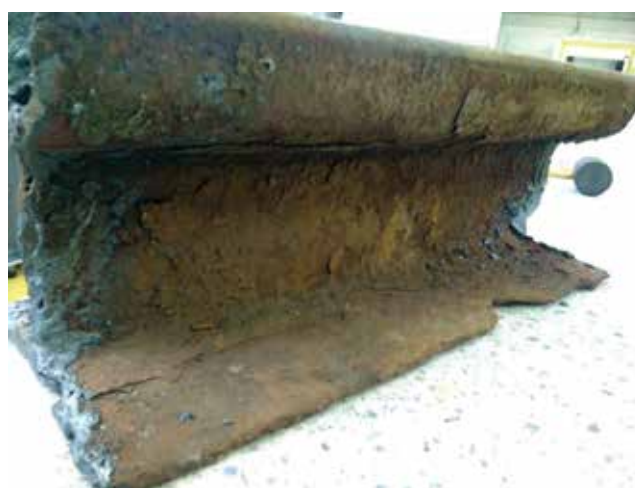
Figure 11. Corrosion affecting the entire length of rail foot and web, rail sample from street-running track

A rail sample extracted from the on-street running track embedded in the roadway, where rail corrosion has affected the entire surface of the foot, head, and web of the rail, is shown in Figure 11, while rail foot destruction at the fastening point is shown in Figure 12.

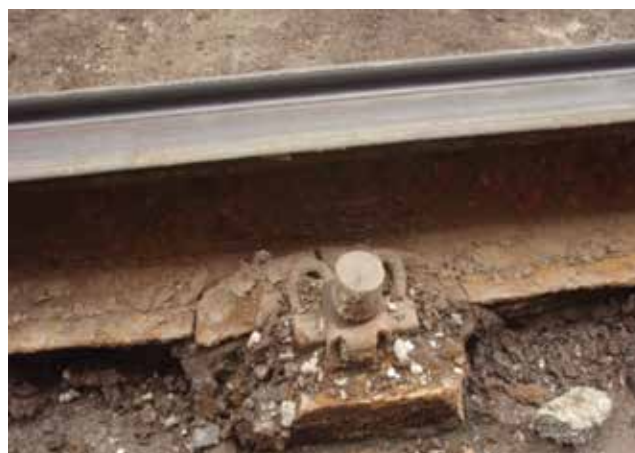
Figure 12. Rail foot rupture at fastening point on the street-running track

Zaboli, A. et al. [13] used a numerical model to analyse distribution of stray currents at the rail ballast interface. They assumed in the model that the rail leans directly onto the ballast, and that the ballast rests on soil (Figure 26, left). It was established that the greatest quantity of stray currents occurs in the middle of the rail foot (Figure 26, right). This distribution of stray currents across the rail foot occurs at rail fastening points, where rail leans via fastening system onto sleepers. Places of the highest quantity of stray currents obtained by the model correspond to the line of rail-foot failure at the fastening position, as shown in Figure 12.

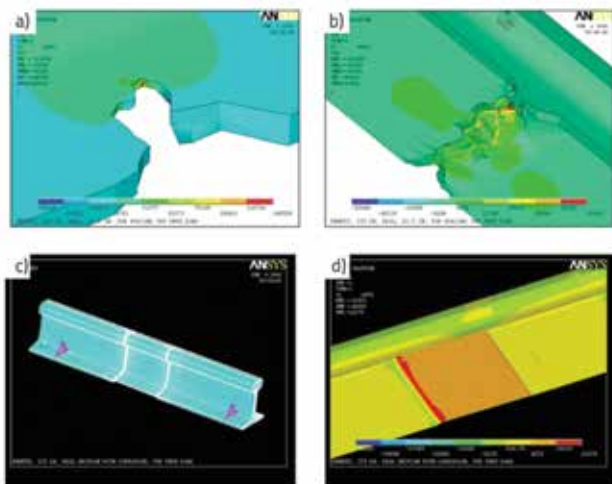
Figure 13. Stress distribution at the corroded rail foot, a) and b) first sample, c) and d) second sample [21]

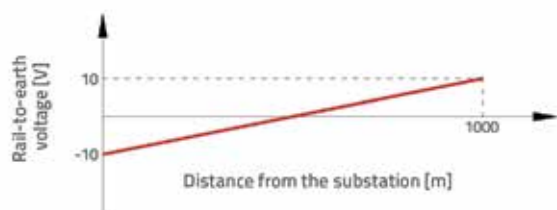
Figure 15. Difference in rail potential when one vehicle is 1000 m away from the electrical substation

along the entire section is assumed. It amounts to  $40 \text{ m}\Omega/\text{km}$  for the track, and  $20 \text{ m}\Omega/\text{km}$  for the rail, which means that voltage in the rail falls by  $1 \text{ V}/\text{km}$  for every  $1 \text{ m}\Omega/\text{km}$ . Thus, the voltage difference of  $20 \text{ V}$  occurs on the observed section for the current intensity of  $1000 \text{ A}$ . In case of the floating system, this voltage difference will be manifested as  $+10 \text{ V}$  at the vehicle position and  $-10 \text{ V}$  at the position of the electrical substation (Figure 15) [25].

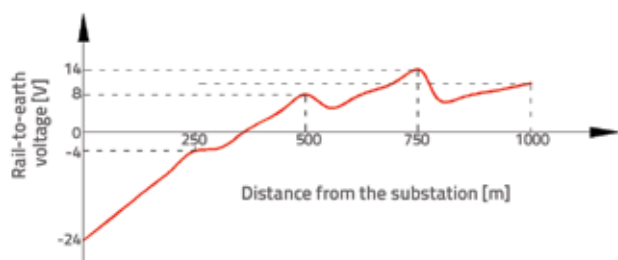
Figure 17. Distribution of potential along rail, vehicle at every 250 m from electrical substation

If several vehicles are situated in the analysed zone, the potential in rail will be greater, which will result in greater value of stray currents. The case in which one vehicle is situated at every 250 m of the 1000 m section is considered (Figure 16). The distribution of potential valid in this case is presented in Figure 17.

As shown in figures 14-17, the rail voltage toward the soil that will develop along the observed track segment, and thus also the quantity of stray currents, also depends on the number of vehicles situated at the analysed segment at a given moment. In case of a greater traffic load, greater potential in the rail is registered, which also results in greater quantities of stray currents.

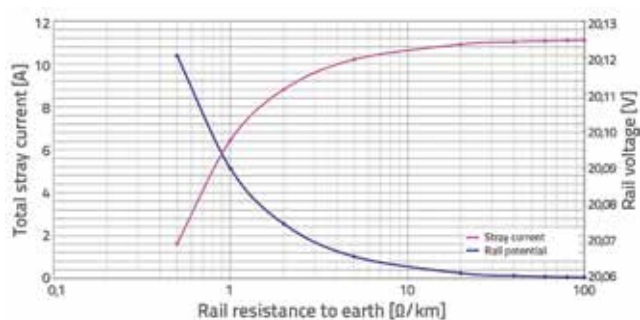
Figure 18. Relationship between electrical potential of rails and stray currents, as related to electrical resistance of rail toward soil [20]

The rail-to-earth resistance defines the intensity of stray currents at a particular segment of a track, and is defined by the way rails are insulated from fastening systems and sleepers. This insulation is realised via rubber pads positioned under rails at points in which rails are fastened to sleepers. However, as the water presence in track is more frequent in the case of embedded tracks, the level of track insulation must be continuous, and the insulation must cover the entire surface of the rail. This prevents contact between the rail and electrolyte such as moisture, water or chlorides that will linger in the track structure, and thus the electric resistance assumes high values. In many cases, rails are not sufficiently insulated so current leaks from rails and passes through the load bearing layer, where this layer behaves like an electricity conductor or electrolyte [39]. The standard [40] defines values of rail-to-earth resistance per unit of length. In the case of open tracks, the specific rail-to-earth resistance amounts to  $R_{RE} \geq 2 \Omega/\text{km}$ , while in the case of embedded tracks it amounts to  $R_{RE} \geq 0,4 \Omega/\text{km}$ . The quantity of stray currents reduces with an increase in rail-to-earth resistance. However, high values of electric potential can be created in rail which can jeopardise safety of rail infrastructure users. It can be seen in Figure 18 that the quantity of stray currents will increase significantly if the value of rail-to-earth resistance falls below  $10 \Omega/\text{km}$ .

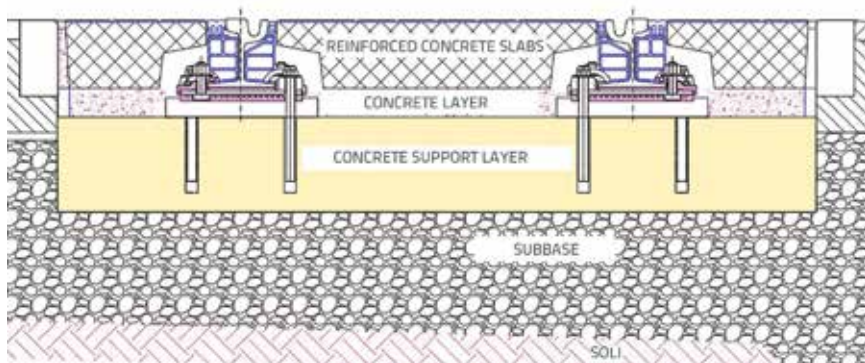
Figure 19. Cross section of track structure with the mentioned elements that define the level of electrical resistance between rail and soil in case of embedded track structure

quantity of stray currents to form so as to avoid achievement of high electric potential in rails. If rails are insufficiently insulated, the occurrence of stray currents will also be affected by electrical resistance of concrete in supports and concrete base courses, and by electrical resistance of subbase and the surrounding soil (Figure 19).

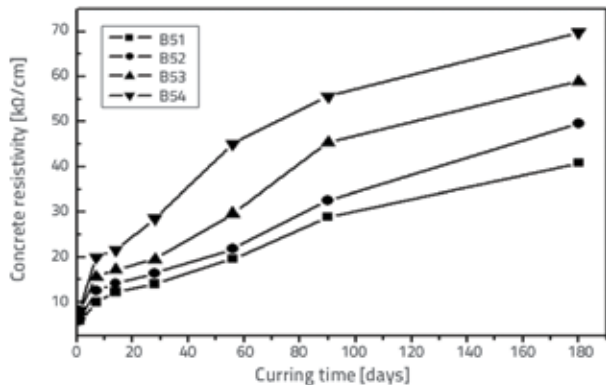
Figure 20. Specific electrical resistance of concrete with fly ash; samples: B51 (0 % of fly ash), B52 (10 % of fly ash), B53 (20 % of fly ash), B54 (25 % of fly ash) [44]

Specific electrical resistance was measured during 180 days, and the corresponding results are presented in diagrams shown in figures 20 and 21. The mentioned studies show that specific electrical resistance of concrete increases with the proportion of mineral content in binder.

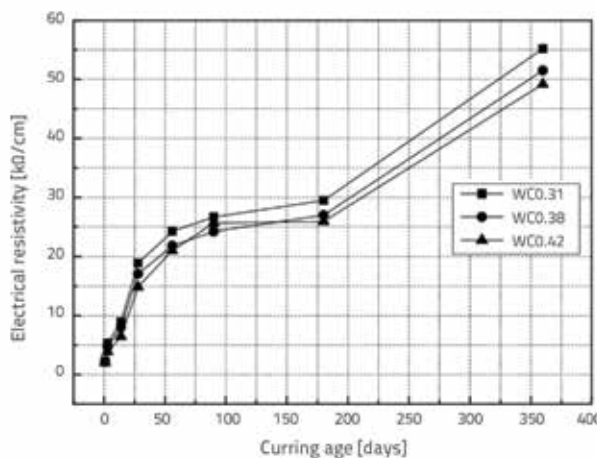
Figure 22. Specific electrical resistance of concrete at various water/cement ratios (0.31 %, 0.38 %, 0.42 %) [45]

0.42). Their study reveals that electrical resistance reduces with an increase in water/cement ratio (Figure 22).

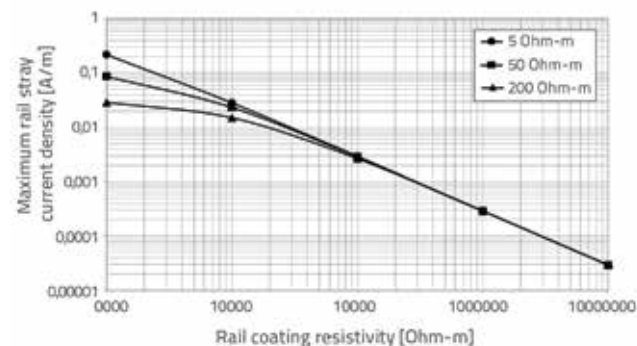
Figure 23. Quantity of stray currents as a variable of specific electrical resistance of insulation material of rail and specific electrical resistance of soil [20]

In case of insufficient insulation of rails and other elements of the track structure, an increase in current leakage will also greatly be influenced by specific electric resistance of soil that reduces with an increase of moisture content in soil (Figure 23).

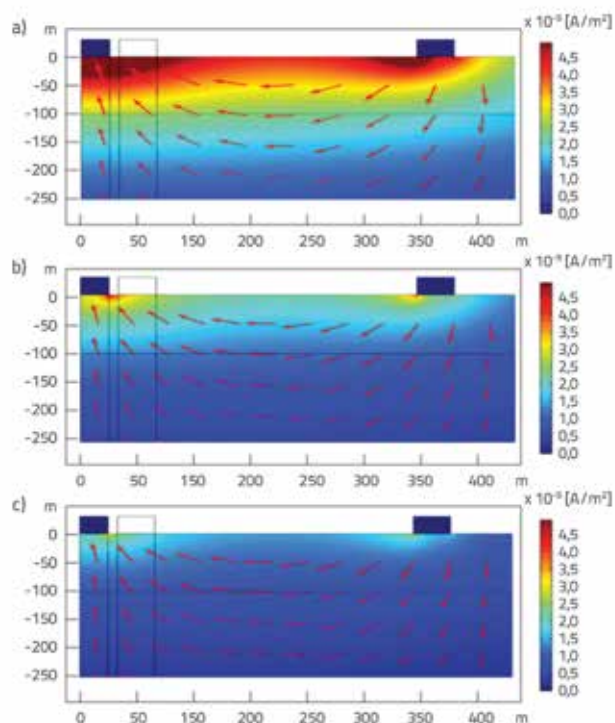
Figure 24. Distribution of stray currents in various moisture conditions: a) wet soil, b) moist soil, c) dry soil [17]

The influence of moisture content in soil on the quantity of stray currents is shown in Figure 24. Electric resistance of soil is influenced by moisture, and the following three samples were examined: wet soil (50  $\Omega/m$ ), moist soil (100  $\Omega/m$ ), and dry soil (150  $\Omega/m$ ). It can be seen that smaller electrical resistance results in greater stray current values [17]. The mentioned studies have also shown that the specific resistance of soil increases by adding some materials (such as fly ash) to soil. This also results in the reduction of the value of stray current and electrical potential during acceleration of vehicles, when the value of stray currents is the greatest [17].

the quantity of stray currents is reduced as well. Just like wet soil (Figure 24), wet track surface is also a good electrical conductor and, if rail is not fully insulated, stray currents will flow through the rail and fastening systems and into the support structure and further down into the soil, as shown in figures 26 and 27. However, stray currents will be reduced if adequate measures are taken to reduce penetration of water into track, and if water lingering is prevented by appropriate drainage.

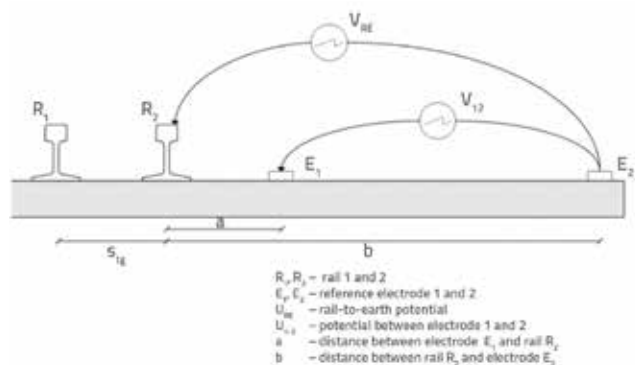
Figure 25. Measurement of potential between rail and soil [40]

obtained by linear regression represents the stray current transfer ratio  $m_{SE}$ . Before this measurement, it is also necessary to define the electric resistance of soil  $\rho_E$  near the electrode  $E_1$ . The distance  $a$  from the rail  $R_2$  to the electrode  $E_1$  must be at least 1 m, and the distance  $b$  must be so great that the electrode  $E_2$  is not influenced by voltage gradient. The distance of 30 m usually suffices for this type of measurements in urban areas. However, it is necessary to check during the measurement whether the distance  $b$  is sufficient, or it has to be increased. In order to analyse insulation of rail from soil the measurement must be made at several locations, especially at places where track infrastructure intersects buried metal infrastructure facilities.

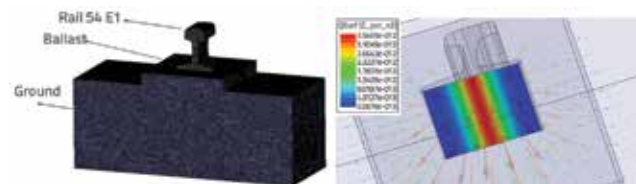
Figure 26. Numerical model used in the analysis of stray currents (left), distribution of stray currents across rail foot according to numerical model (right) [13]

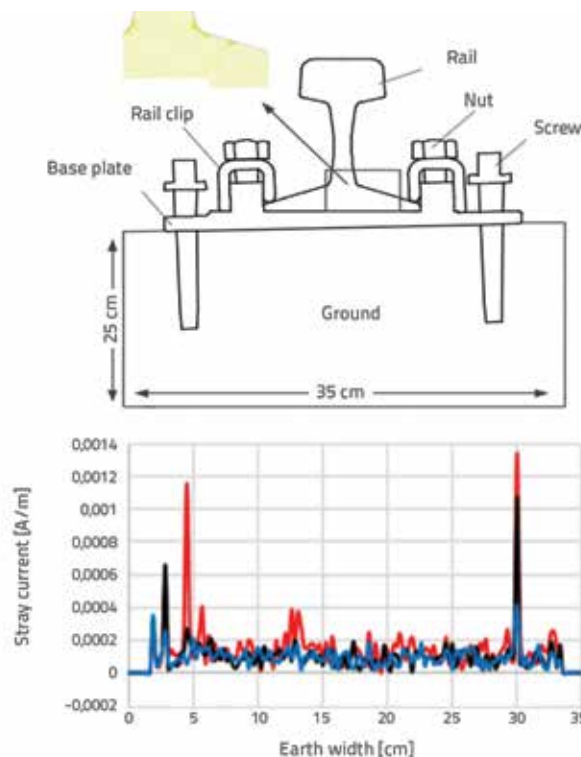
Figure 27. Distribution of stray current at rail fastening points for various values of electrical resistance of soil [49]

The same team of authors analysed in [49] the distribution of stray currents across individual elements of fastening accessories, for various types of soil under the fastening system, with regard to specific electric resistance values: 100  $\Omega$ m (model A), 300  $\Omega$ m (model B), and 1000  $\Omega$ m (model C). It was established that the quantity of stray currents that leaves the rail will vary depending on the electrical resistance of soil, and that the highest values of current will be at positions of anchoring screws (Figure 27).

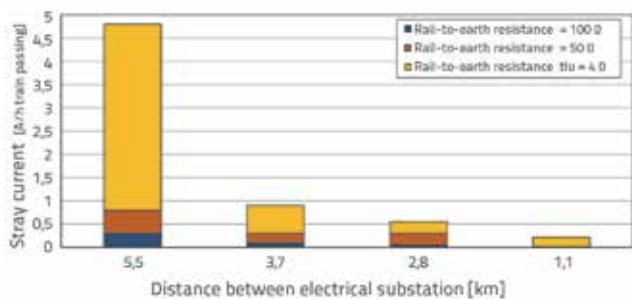
Figure 29. Reduction of stray currents through increase in rail-to-earth resistance and through smaller distance between electrical substations [20]

Reduction of distance between electrical substations, i.e. the use of several return cables between rail and electrical substation, is also recommended as a measure for reducing the quantity of stray currents. In this way, the return path of current from vehicle to electrical substation is reduced and the creation of high voltage in rail, and hence also of stray currents, is prevented. However, the quantity of stray currents is not greatly affected by the distance between electrical substations in the case of high electric resistance between rail and soil (Figure 29).
