Ahmed, N. and Bakare, M.S. and McCartney, D.G. and Voisey, K.T. (2010) The effects of microstructural features on the performance gap in corrosion resistance between bulk and HVOF sprayed Inconel 625. *Surface and Coatings Technology*, 204 (14). pp. 2294-2301. ISSN 0257-8972

**The effects of microstructural features on the performance gap in corrosion resistance between bulk and HVOF sprayed Inconel 625**

**N. Ahmed, M.S. Bakare, D.G. McCartney, K.T. Voisey\*.**

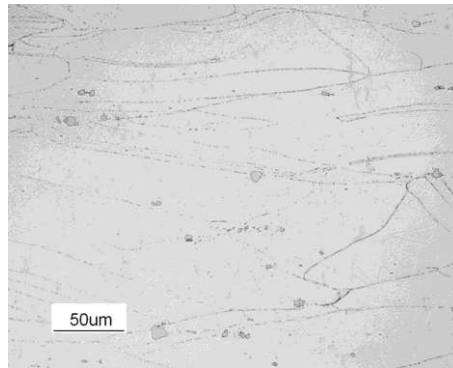
**1a**

The microstructure of the wrought alloy is shown in the optical micrograph of Figure 1. Heavily etched grain boundaries are clearly visible along with sub-grains and twins present due to the prior cold rolling and annealing. A small quantity of second phase particles was

Figure 1: Optical micrograph of etched wrought Inconel 625; (a) low magnification showing grain structure (b) higher magnification.

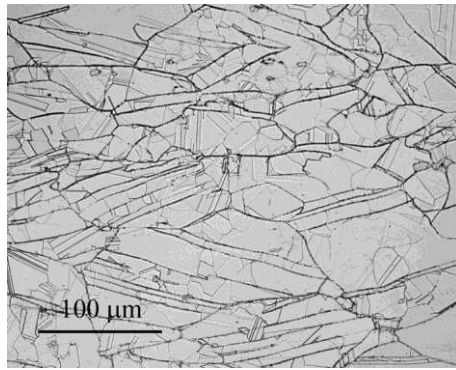
**1b**

also found to be present as shown in Figure 1b. Energy dispersive X-ray analysis (EDX) in the SEM indicated that these were rich in Ti and Nb and so were most likely to be carbides, nitrides or carbonitrides.

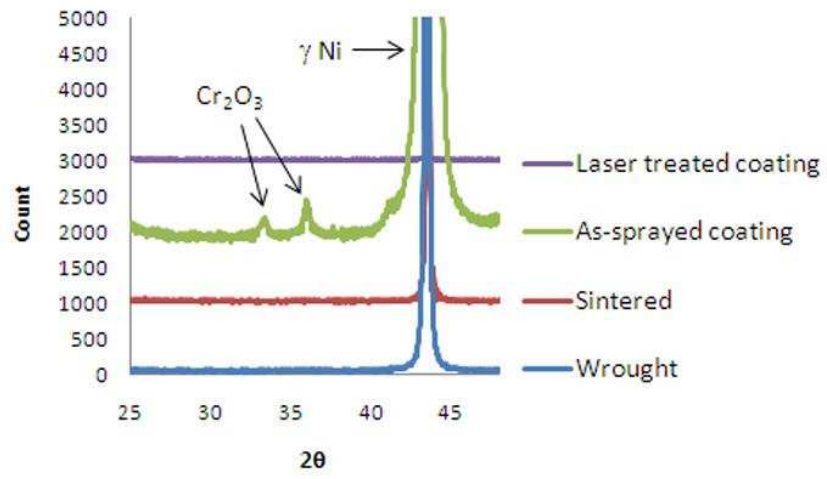
The XRD pattern obtained from the wrought sheet is shown in Figure 2 and the peaks can be indexed as a face centred cubic structure, this is  $\gamma$ -Ni as expected for a Ni-based alloy. The peaks are seen to be of small angular width and no other phases could be detected in the XRD pattern.

Figure 2: XRD patterns of the different forms of Inconel 625 used: wrought, sintered, as-sprayed HVOF coating, laser treated HVOF coating after surface grinding to remove accumulated oxides.

The XRD pattern of the laser melted coating (after the top surface had been removed by grinding) is shown in Figure 2. No oxide peaks are evident, confirming that the oxide present in the as-sprayed coating was removed.

The average porosity of the sintered samples was 12% and 6% for isothermal sintering at 1310°C and 1325°C respectively. No oxide peaks were detected in the XRD spectra of the sintered samples (Figure 2). The etched SEM micrograph shown in Figure 7 shows that the marked segregation present in the as-sprayed coating and the laser treated material (Figure 3, Figure 5 Figure 6) is absent from the sintered samples. It is also clear that the pores had a near-spherical morphology with diameters ~15-30 µm. Oxide peaks were not seen in the XRD spectra of the sintered material (Figure 2).

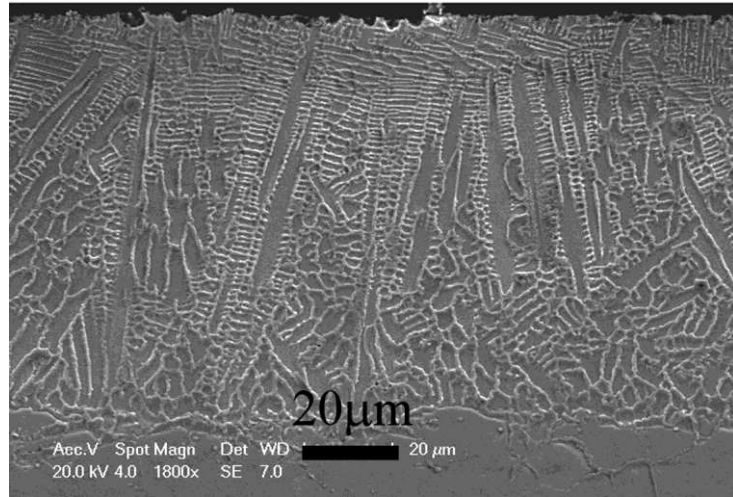
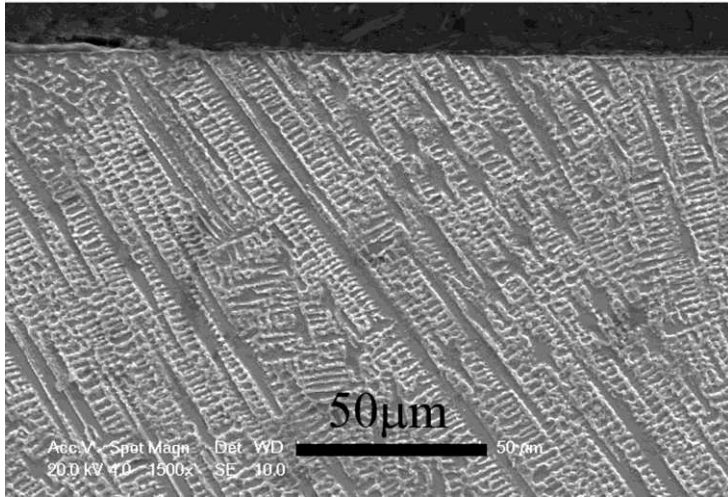
Laser melting of wrought material resulted in the rapidly solidified microstructure featuring aligned dendrites, as shown in Figure 3. The micrographs were obtained from a section taken parallel to the beam traverse direction. Evidently the dendrites have solidified with the  $\langle 100 \rangle$  growth direction tilted towards the moving heat source which is a typical solidification pattern for laser surface melting and welding [12, 13]. The measured secondary dendrite arm spacings (SDAS) are included in Table iii and indicate that, as expected, SDAS decreases with increasing traverse speed i.e. with increasing cooling rate.

Figure 3: SEM secondary electron micrographs showing the rapidly solidified microstructure of laser melted wrought Inconel 625, arrows indicate the beam traverse direction (a) 500 mm min<sup>-1</sup> (b) 2000 mm min<sup>-1</sup>.

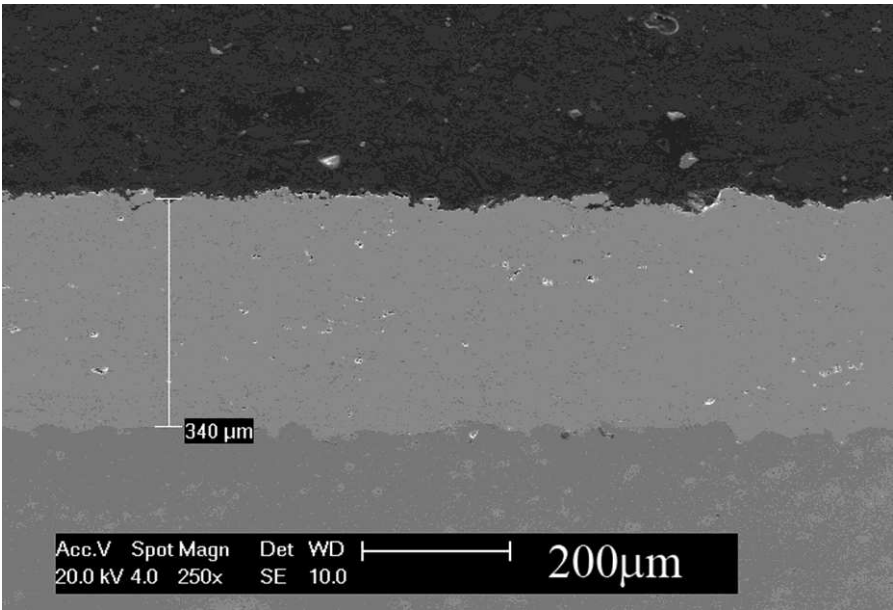
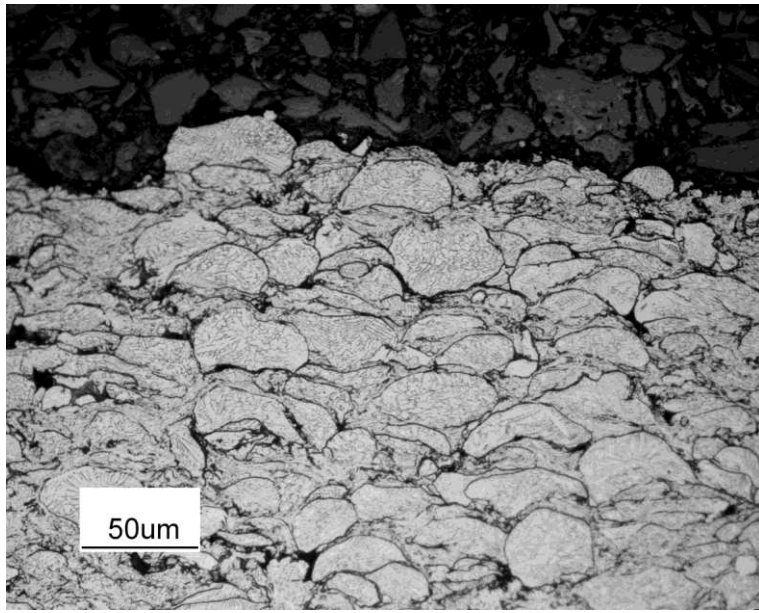
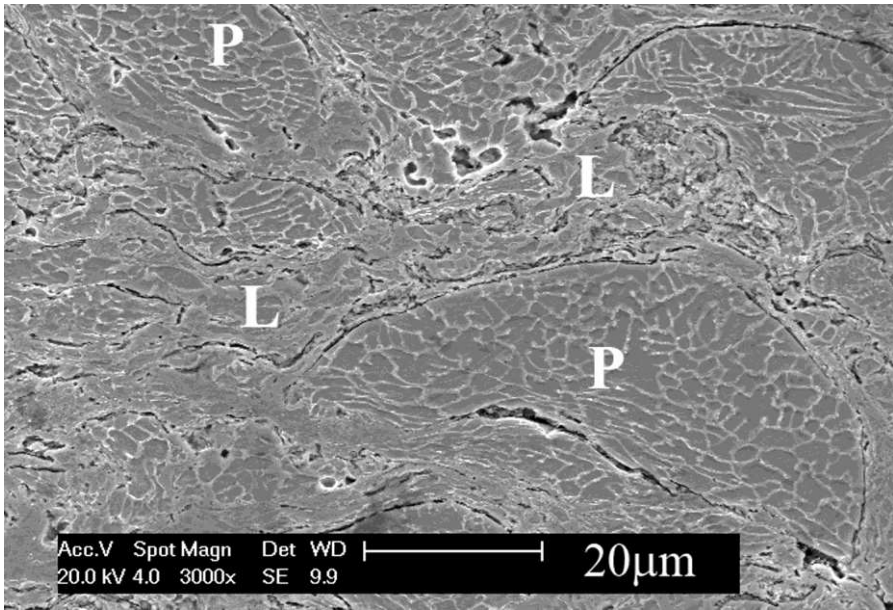
The as-sprayed coating was  $\sim 350 \mu\text{m}$  thick (Figure 4a). The coating had a characteristic thermally sprayed microstructure, resulting from the successive deposition of individual powder particles (Figure 4b). Figure 4 c shows a dendritic microstructure in the deformed particles, this was a retained microstructure from the gas atomised feedstock powder. Figure 4 c also shows that the coating is seen to comprise of deformed, near-spherical particles (P) as well as lamellar splat-like features (L). These arise from the impact and solidification of partially and fully melted powder particles respectively. The microstructure observed is characteristic of coatings produced by this type of liquid fuel gun as discussed elsewhere [3].

Figure 4: HVOF thermally sprayed Inconel 625 coating (a) SEM secondary electron micrograph showing full coating thickness (b) optical micrograph showing the individual splats from which the coating is formed (c) SEM secondary electron micrograph showing the retained dendritic structure in deformed particles (P) as well as lamellar splat-like features (L).

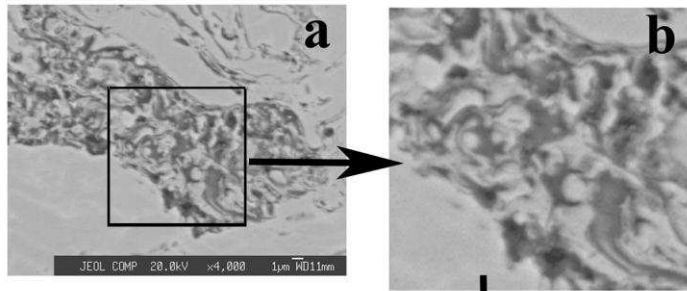
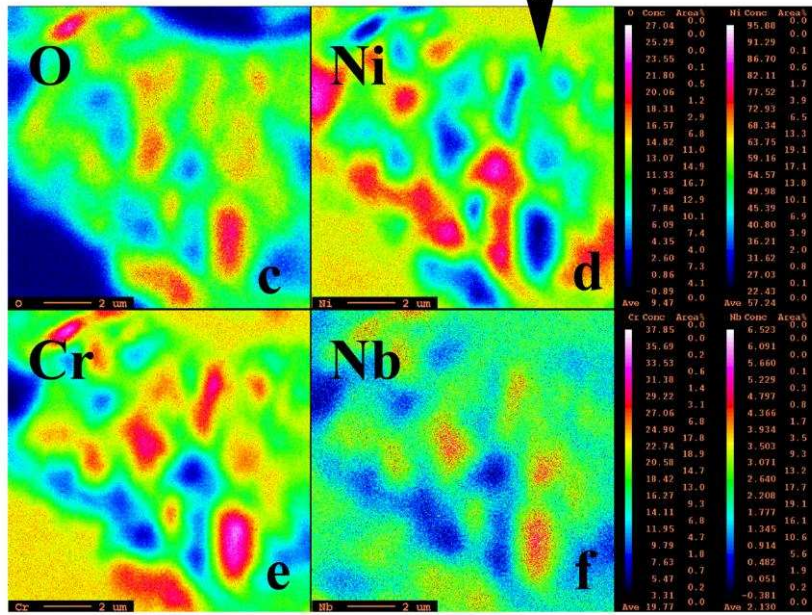
Figure 5 a & b are secondary electron SEM images indicating the oxide rich area of the coating which was examined with EPMA. Figure 5(c) – (f) show elemental concentration maps of this region for the elements O, Ni, Cr and Nb respectively. In the top right and bottom left corners of this region are areas which correspond to unmelted particles. The central region results from resolidification of molten material and is seen to have a non-uniform structure and composition with high levels of oxygen indicating oxide formation. The concentration maps reveal a clear association of high Cr and O concentrations which confirm the location of the  $\text{Cr}_2\text{O}_3$  phase in this interparticle and/or intersplat region. There is also clear evidence for significant Cr and Nb depletion in the metallic regions in this area.

Figure 5: Oxide rich region in as-sprayed coating and EPMA maps for various elements for the same area.

Examination of samples after potentiodynamic testing (Figure 9) clearly show that corrosion is preferentially occurring in the regions between adjacent splats. These regions have a complex heterogeneous microstructure (Figure 5) including a mixture of nonmelted and resolidified material, oxidised regions and porosity. Laser surface melting eliminates all of these features. The extent of the role of porosity has already been identified. The relative effects of the mixture of nonmelted and resolidified material and oxidised regions on the corrosion performance gap now need to be examined.

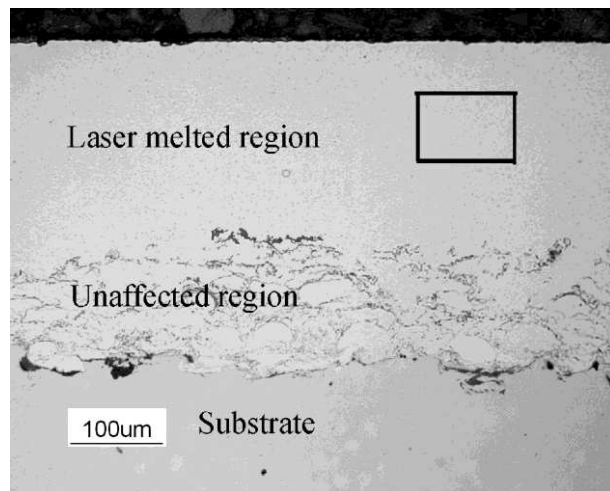
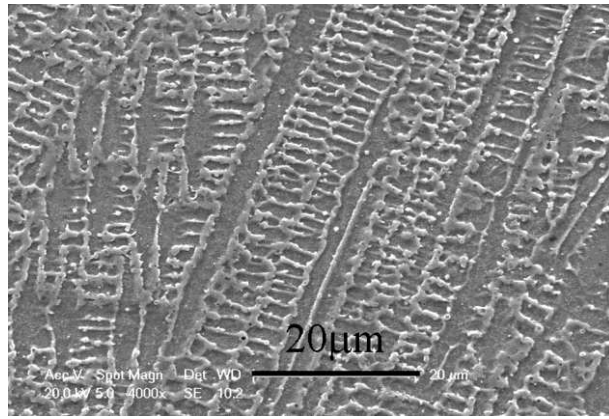
Laser surface melting of HVOF coatings resulted in a structure which was free from the pores and oxides found in the as-sprayed condition (Figure 6). The low magnification optical micrograph in Figure 6a shows that the coating was melted to a depth of approximately  $200\mu\text{m}$  and that melting was confined to the coating, avoiding any coating/substrate mixing. Porosity was eliminated on resolidification and any pre-existing oxides floated and accumulated at the top surface. This top surface, and hence the accumulated oxide, was removed by grinding before corrosion testing. Rapid solidification following laser surface melting produced the dendritic structure as shown in Figure 6b, this is identical to that previously seen in the laser melted wrought material (Figure 3). EDX revealed that bright interdendritic areas were enriched in Nb and Mo, while Cr content remained almost uniform

Figure 6: Microstructure of coating after laser surface melting with a scan speed of 1000 mm min<sup>-1</sup>. (a) optical micrograph, (b) secondary electron SEM image of the area indicated.

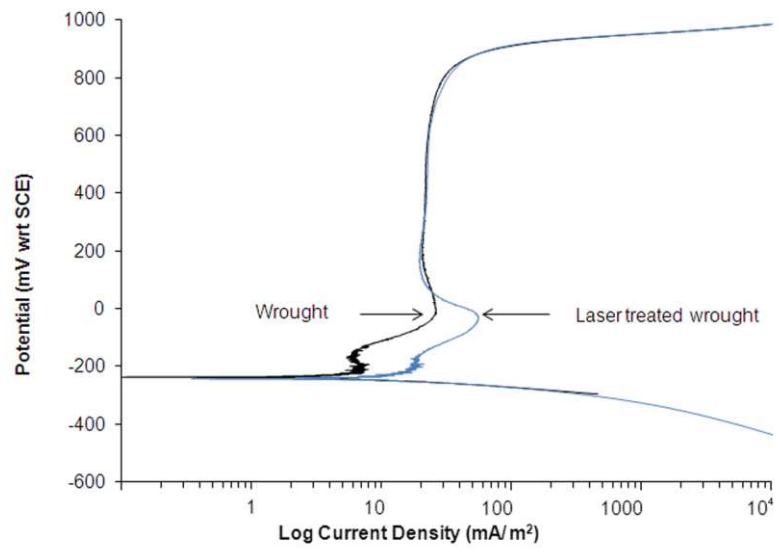
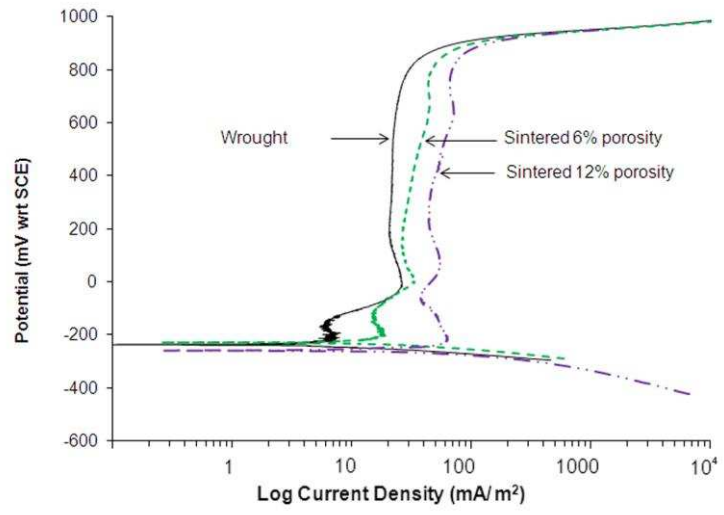
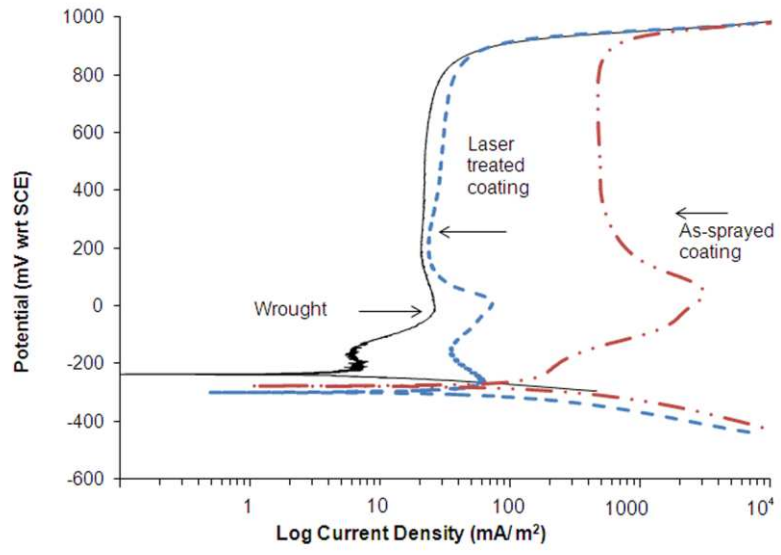
Figure 8 shows potentiodynamic scans in 0.5M H<sub>2</sub>SO<sub>4</sub> for the various forms of Inconel 625. Passive current density values,  $I_p$ , are listed in Table iii the current densities correspond to a potential of 450 mV SCE, within the passive region. **This potential was chosen as it was well within the passive range for all samples considered here.**

In Figure 8a the corrosion behaviour of wrought and laser melted wrought material, **with a traverse speed of 1000 mm min<sup>-1</sup>**, are seen to be almost identical with only a small difference in behaviour just above  $E_{corr}$ . The average passive current density measured for the wrought material was  $22 \pm 9 \text{ mA m}^{-2}$ . This therefore indicates that the fine scale dendritic structure with associated microsegregation had a negligible influence on corrosion behaviour. Figure 8b compares the wrought material with that of sintered samples with different degrees of porosity. The porosity did not affect the  $E_{corr}$  value but is seen to increase  $I_p$ ; increased

porosity caused a greater increase in  $I_p$ . In Figure 8c the behaviour of wrought material, as-sprayed HVOF coating and laser melted coating are compared. **The laser melted coating results are from a sample melted using a traverse speed of  $1000 \text{ mm min}^{-1}$ .** The as-sprayed HVOF coating had a lower  $E_{\text{corr}}$  valued and a significantly larger  $I_p$ ; about 40 times that of the wrought material. This is similar to previously measured differences in  $\text{H}_2\text{SO}_4$  [3]. Finally, in Figure 8d the behaviour of as-sprayed coatings on mild steel and Inconel 625 and a de-bonded coating are compared. All previous coating results relate to deposits on mild steel and the aim of this set of results was to identify any contribution of the substrate to the polarisation results. The differences in behaviour are small and within the experimental scatter observed for a batch of as-sprayed coatings. Therefore, it can be concluded that there is not a significant contribution from a mild steel substrate. For comparison, the polarisation curve for mild steel in the same solution is also displayed.

Figure 8: Potentiodynamic scans (a) wrought and laser melted wrought material, (1000 mm min<sup>-1</sup> traverse speed); (b) sintered samples with different levels of porosity; (c) wrought, as-sprayed HVOF coating and laser melted HVOF coating (1000 mm min<sup>-1</sup> traverse speed); (d) HVOF coated Inconel 625, HVOF coated mild steel, free standing HVOF coating and uncoated mild steel.

The potentiodynamic results shown in Figure 8c confirm the performance gap between bulk Inconel 625 and the HVOF Inconel 625 coating. It can also be seen that laser surface melting of the sprayed coating largely eliminates the performance gap. However, laser melting of the coating, followed by resolidification, simultaneously changes several aspects of the microstructure: porosity is eliminated on resolidification; oxides float and accumulate on the top surface and are thereby removed from the material; the resolidified material gains a

The similarity in behaviour of wrought and laser treated wrought samples (Figure 8a) reveals that the presence of a rapidly solidified microstructure does not have any significant effect on electrochemical behaviour. Therefore it can also be stated that the observed microsegregation (Figure 3Figure 6) resulting from rapid solidification has no significant effect on electrochemical behaviour.

accumulate at the top surface when the coating is melted by the laser. This top, oxide rich, layer is ground away before potentiodynamic testing. The material tested is oxide free but will be uniformly slightly Cr depleted. Figure 8c shows that laser surface melting of coatings largely, but not completely, eliminates the performance gap. The passive current density seen for laser treated coatings is still higher than that of the wrought material. The laser treated coating has a rapidly solidified microstructure and, as explained above, will be slightly depleted in Cr. The presence of a rapidly solidified microstructure has already been shown to have no significant effect on the observed potentiodynamic results. The minor Cr depletion is therefore attributed to be the cause of the higher passive current density of laser treated coatings compared to the wrought material.

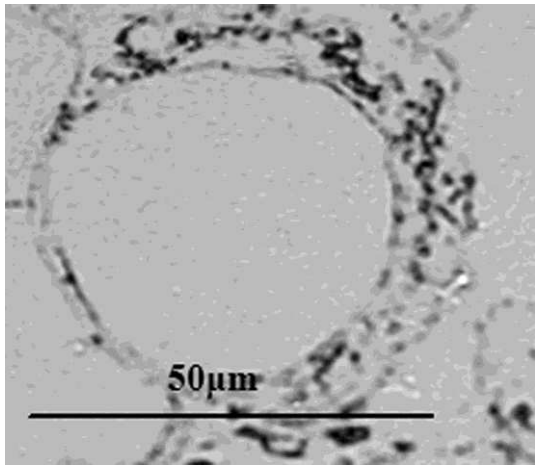
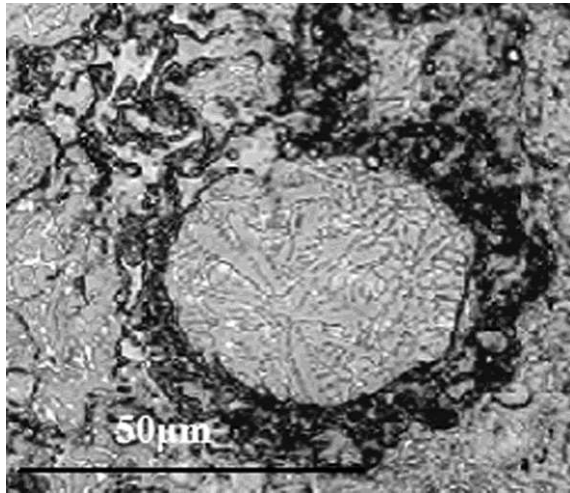
Figure 9 presents as-sprayed coatings after polarisation to  $10^4$  and  $10^5 \text{ mA m}^{-2}$  respectively. In each micrograph the central, circular feature is an unmelted powder particle within the coating. It was observed that the particle boundary regions started to corrode preferentially (Figure 9a). When current density values were increased, these areas became more heavily corroded and corrosion of the internal structure of the splats occurred (Figure 9b).

Figure 9: As-sprayed HVOF coatings after polarisation; (a) to  $10^4 \text{ mA m}^{-2}$ , (b) to  $10^5 \text{ mA m}^{-2}$ .
