Observations on different post-fire bio-engineering interventions and vegetation response in a *Pinus canariensis* C. Sm. forest

Published in:
Annals of Silvicultural Research

ABSTRACT On the Canary Islands, during the 2007 (30 July - 2 August) wildfire, about 18,000 hectares of forest were destroyed. After the event, to avoid erosion, a series of mixed check dams (wooden elements and stones with a core filled with forest residues) were built in the gullies created by the surface runoff. This first study aims to investigate the different responses of vegetation and its recovery after fire, with three different types of structures. We analyzed the performance and evolution of the mixed check dams nine years after their construction and the post-fire response of vegetation with the different types of bio-engineering techniques applied. The effects of the mixed check dams are expressed in terms of plant density, frequency, and cover both in absolute and in relative terms and the same effects were compared with those of the rocks, check dams, wattle fences, and structure in the surrounding areas. Our observations show that fire adaptation in the Canary Islands vegetation (pyrophyte p

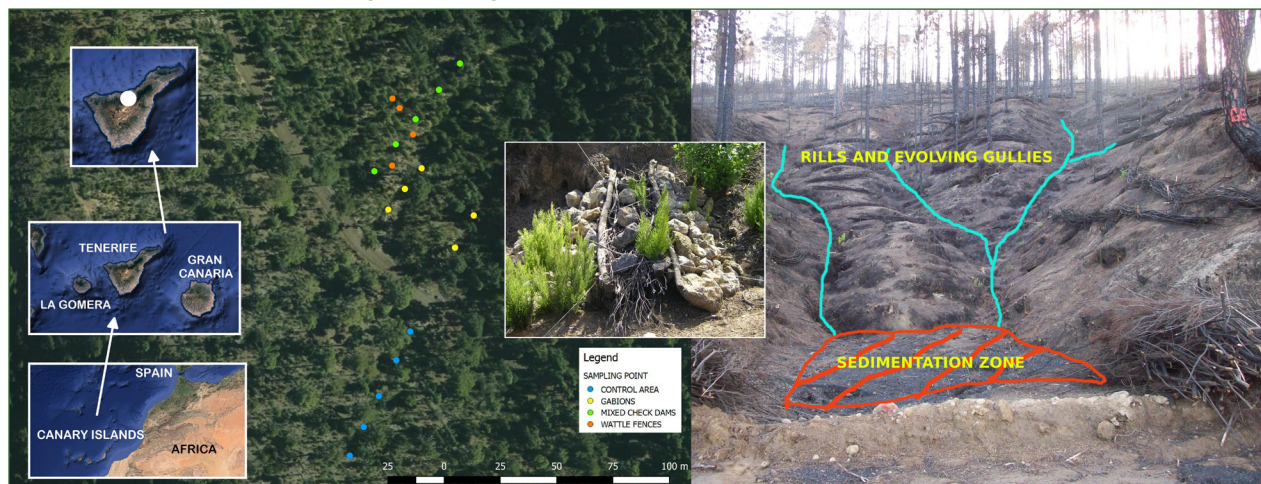
Figure 1 - Location of the sequences of survey points (a). Mixed check dam and wattle fences (b). The first storms after the fire carved a network of channels extending from the ridgetop (c).

High-severity fires have significant impacts on ecosystems. Commonly, the degree of fuel consumption in the understory or canopy layer (Perez and Moreno 1998) or the level of crown damage (Pausas et al. 2003) are considered, but the degree of mortality of trees and shrubs is also used to estimate fire severity (Chappell and Agee 1996). Fire modifies the soil protection provided by plants and consumes the soil surface organic layer (Neary et al. 2005a). High-severity fires may also burn the organic matter in the uppermost layer of the mineral soil, and the resulting loss of soil aggregates can greatly increase the soil erodibility (DeBano et al. 2005). Fires can also induce formation of a water-repellent layer on or near the soil surface (DeBano 2000). The consequences of the latter are low infiltration rates and high overland flow velocities which, in turn, increase the size of peak flows and surface erosion rates by sheetwash, rill, and channel erosion (Shakesby and Doerr 2006). Rills and gullies readily form where there is a surface runoff buildup caused by topography, rocks or logs (Fig. 1c).

Knowing that bio-engineering works can decrease flow speed, increase ground roughness and trap sediments (Vennetier et al. 2014), structures such as mixed check dams and wattle fences were built (Tardío-Cerrillo and Caballero-Serrano 2009) during the post-fire emergency period. These were used as the main treatment to reduce ephemeral or small-order channels or gullies, in combination with complementing treatments such as rock dams and gabions dams in larger channels and road cuts (Fig. 1b).

The study area is located in the Teide Forestry Crown (Tenerife Island, Canary Islands, Spain), at the north-facing side of the island (Fig. 1a). Here, a wide variety of meso- and micro-climates can be found (Del Arco et al. 2006) under a different range of vegetation including grasses, shrubs and trees. The forest is a natural stand dominated by *Pinus canariensis* C. Sm, mixed with *Myrica faya* Aiton, *Cistus symphytifolius* Lam. and *Erica arborea* L.

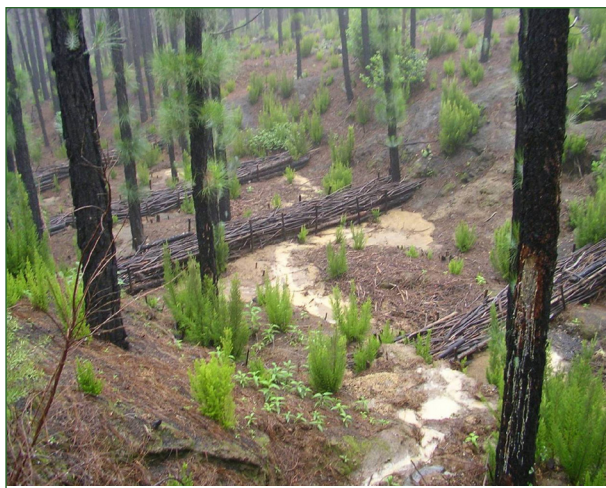
Figure 2 - Re-sprouting *Pinus canariensis* C. Sm trees.

Pinus canariensis C. Sm. has numerous adaptive traits related to fire resistance specifically thick bark, long needles, thick buds, tall growth habit, deep rooting, longevity, and sprouting capability. Serotinous cones ensure post-fire recruitment adding to the sprouting capability of adult trees being one of the most striking characteristics of the Canary Islands pine (Ceballos and Ortuño 1976) (Fig. 2).

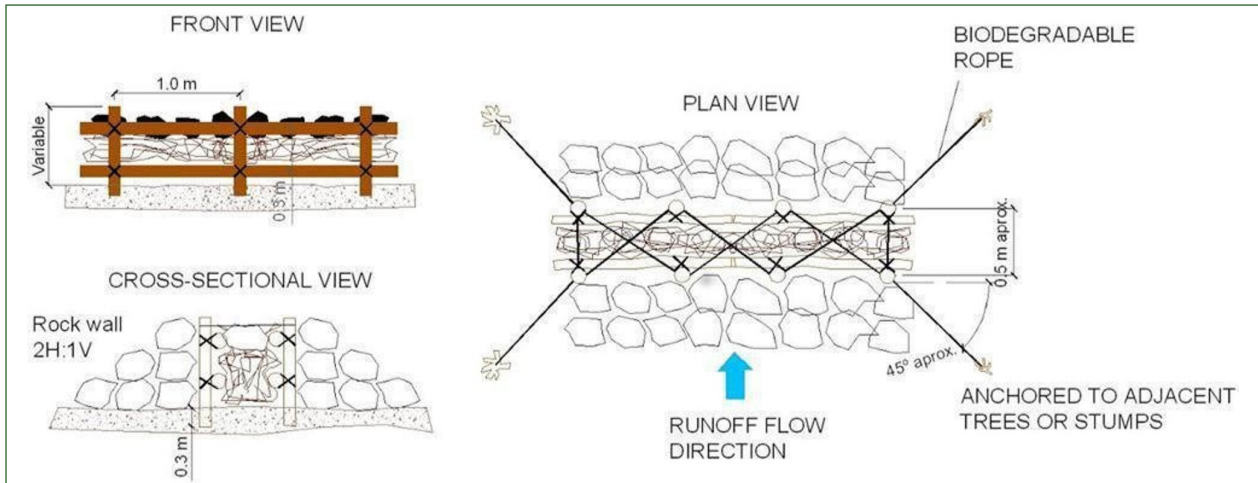
Figure 3 - Schematic of a typical mixed check dam.

with rocks. The dimensions of a mixed dam vary depending on the channel width, ranging from 1 to 2 m in height and 8 to 10 m in length (Fig. 3).

In addition to the traditional channel treatments, an innovative structure adapted to local conditions called rock and biomass mixed check dam, was developed. Due to the severity of the wildfire and the resulting risks, the mixed check dam structure was designed to be low-cost, easily and rapidly implemented to reduce hydrological risks. The mixed check dam is a temporary structure that combines different mitigation techniques such as contour logs, contour trenches, and rock dams. Similarly, to other channel or gully treatments, its main objective and engineering function is to reduce the water velocity and enhance infiltration and sediment deposition. The mixed dam consists of vegetal debris used as vertical stakes (mainly burned logs of *Erica* sp. and *Myrica faya* Aiton), horizontal logs (mainly from burned *Pinus canariensis* C. Sm.), and biodegradable rope to tie the stakes and logs together as a trench while anchoring the whole structure to adjacent trees. The trench is reinforced on the outside by a rock slope (revetment) to gain stability (less than 50% slope angle); the inside is filled with vegetal debris obtained from the local silvicultural work and topped again

This innovative structure can provide several benefits for erosion control such as reduction of the channel slope and, thus, of water speed and detachment capacity; promotion of infiltration and sedimentation; reduction in resources and construction time by using on-site material; enhancement of the colonization of vegetation due to the biodegradable nature of most of its components. The advantages of a mixed check dam are its notable sediment storage capacity, mainly for large material such as vegetal debris or rocks; high adaptability of the design and the components to the environment conditions; notable vegetation recovery and colonization of the channels (Tardío-Cerrillo and Caballero-Serrano 2009, Tardío-Cerrillo and García-Rodríguez 2016).

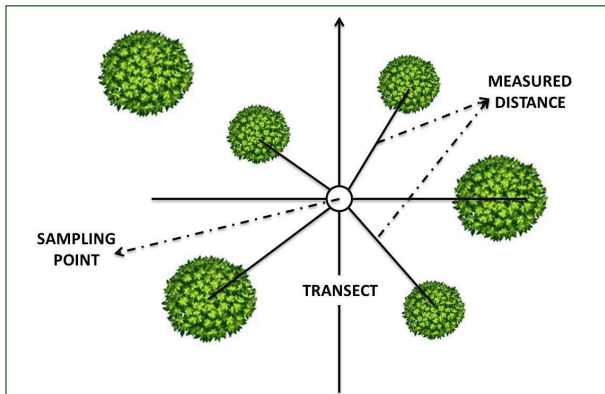
Figure 4 - Sampling design Point Centered Quarter measurements method.

The PCQ is a plot-less distance-based technique. Four quarters are established around a sampling point and four distances are measured from the point to the nearest element being analyzed. The parameters obtained in this distance method can be: species distribution, total and components density; average quantitative characteristics (diameter at

The lengths of the points sequences ranged between 80 and 100 m, with a limited number of survey positions considered for each treatment (5 for all other, 4 for 'wattle fences' sequence). Applying the PCQ approach, four distances, one for each quarter, were measured from the center to the nearest element of each vertical layer (Fig. 4) at each sampling point.

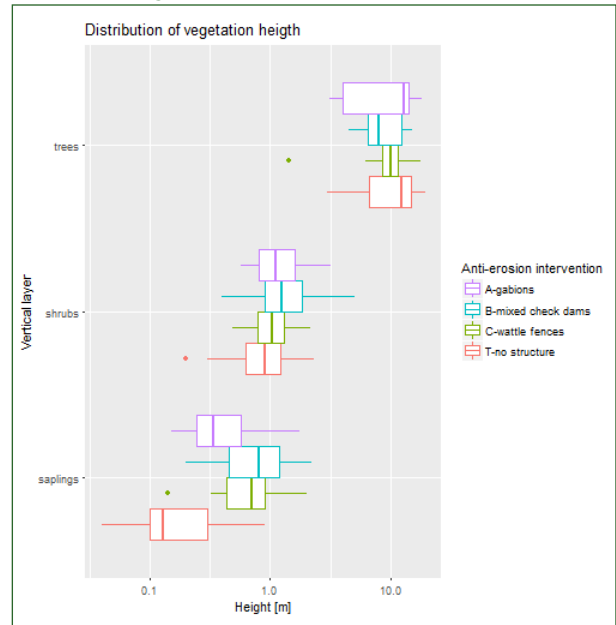
Figure 5 - Basic characteristics: distribution of vegetation heights, by anti-erosion intervention and vertical layer. Height scale is logarithmic. Boxes represent the first and third quartile, with the median in between as bold line, while whiskers are extended 1.5 times the interquartile range.

The three layers considered (saplings, shrubs and trees) are, as expected, vertically stacked and relatively similar, across treatments (Fig. 5), without relevant differences in term of height. Within each layer, heights distributions, syntetised by the box and whiskers, are relatively similar, except in the regeneration born in the controlled area which has low height values compared to the estimated regeneration in the other bioengineering structures.

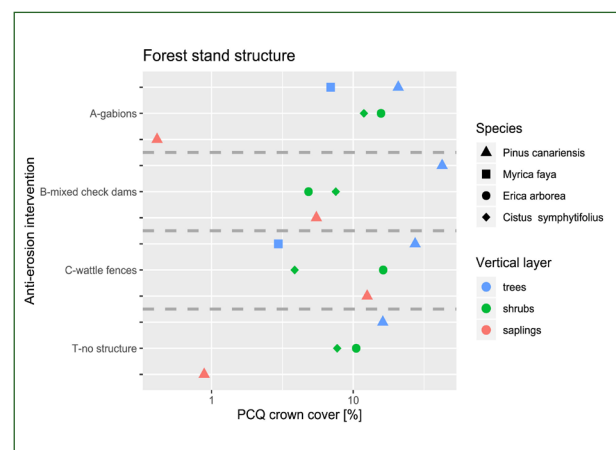
Figure 6 - PCQ estimate of total crown cover by species as percent (logarithmic scale) of the forest area.

res were built. The vegetation cover is assessed by multiplying the average crown area by the species density. This measure, expressed as percent of the terrain area, offers the most significant synthesis of the PCQ based survey (Fig. 6).

The different attributes that were measured are quite tightly correlated (Fig. 6). Some minor diffe-

The analysis showed that *Pinus* trees always provide the most relevant coverage (reaching 42.5%) followed by *Erica arborea* L. Shrubs coverage is significant, though variable in terms of species composition while saplings present quite different coverage values. The presence of anti-erosion structures is associated with larger coverages by saplings of *Pinus canariensis* C. Sm.

Where wattle fences are present, the tree layer (almost exclusively characterized by *Pinus canariensis* C. Sm.) exhibits higher density (Tab. 1) and higher tree cover (Fig. 7). To some extent though, compared to other parts of the study area, here post-fire silvicultural treatment has been less intensive.

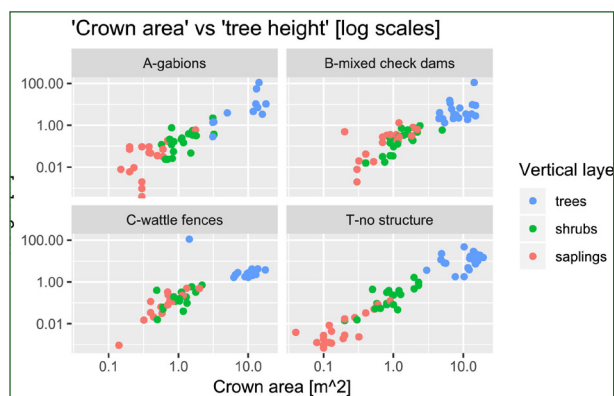
Figure 7 - Basic characteristics: height and crown area (logarithmic scales) are tightly correlated ($p < 0.001$), analyzed conditions present minor differences in values distributions.

rences can be evidenced in the distribution of crown area versus element height. Crown dimensions appear to be reduced for trees in the ‘wattle fences’ area and for saplings in the ‘no structure area’.
