# FRP Confinement of Stone Samples after Real Fire Exposure

Luis Estevan, F. Javier Baeza, Francisco B. Varona and Salvador Ivorra \*

Department of Civil Engineering, University of Alicante, P.O. Box 99, 03080 Alicante, Spain; luis.estevan@ua.es (L.E.); fj.baeza@ua.es (F.J.B.); borja.varona@ua.es (F.B.V.)

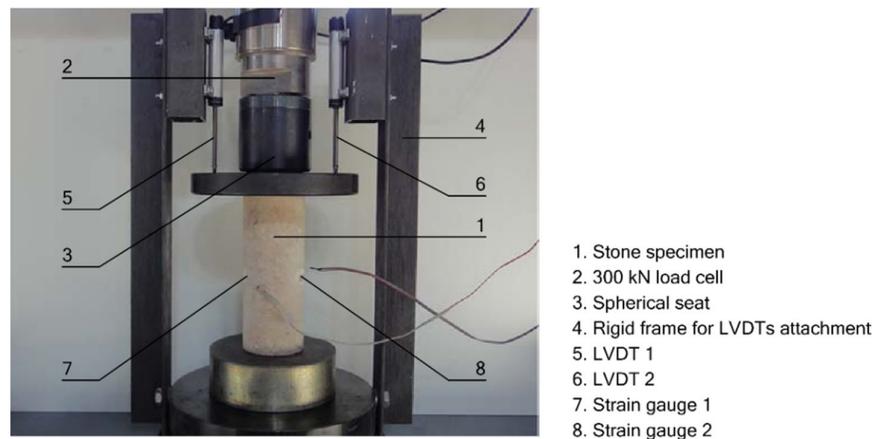
**Figure 1.** Test setup: longitudinal deformations monitored with LVDT and transverse strains with strain gauges.

All samples were tested in uniaxial compression in an electric press equipped with a 300 kN load cell. The lower plate of the press was fixed, while a spherical seat was incorporated in the upper one. The tests were programmed with a constant stress rate of 0.5 MPa/s, until the specimen failed, according to ASTM D7012-14e1 standard [29]. To register the axial strains, a rigid frame was screwed to the lower plate of the press, on which two LVDTs were installed to measure the descent of the upper plate. Transverse strains were measured by means of two strain gauges per specimen, located at mid-height and diametrically opposite points. LVDTs are Novotechnik TEX Series position transducers, with a measurement range of 50 mm; the strain gauges are linear HBM LY Series, with a measuring length of 20 mm and a nominal resistance of 120  $\Omega$ . All tests were recorded with a HBM Spider data acquisition equipment, programmed at 2 Hz frequency. Figure 1 shows a detail of the press used in the tests and the deformation measurement devices.

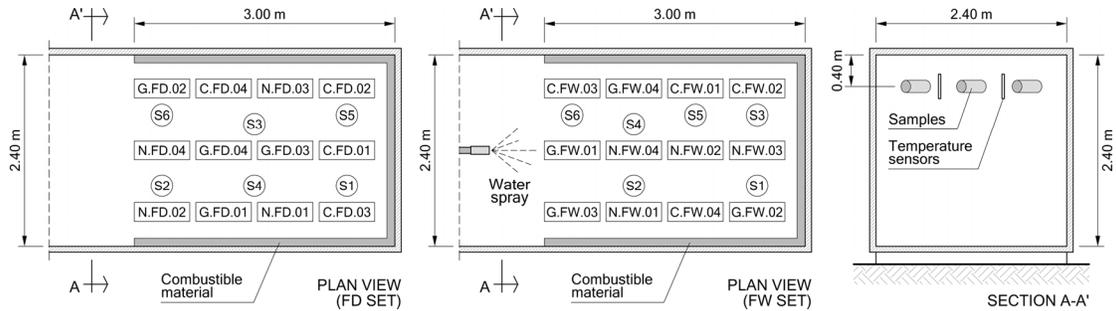
**Figure 2.** Cabin layout, showing the placement of stone samples and temperature sensors for both tests (FD (real fire exposure with slow dry cooling) and FW (real fire exposure and quick cooling by means of water spraying)).

Two different tests were carried out, in order to evaluate the influence of the extinguishing method in case of a fire in a real building. In the first one (FD test, Table 2, series 04 to 06), the fire was naturally put out, keeping the specimens inside the container for 24 h until an ambient temperature of around 20 °C was reached. In the second test (FW test, Table 2, series 07 to 09), the fire was extinguished when the flames were fully developed (approximately 22 min from ignition) with the assistance of a firemen team, who sprayed the specimens with water until their complete cooling.

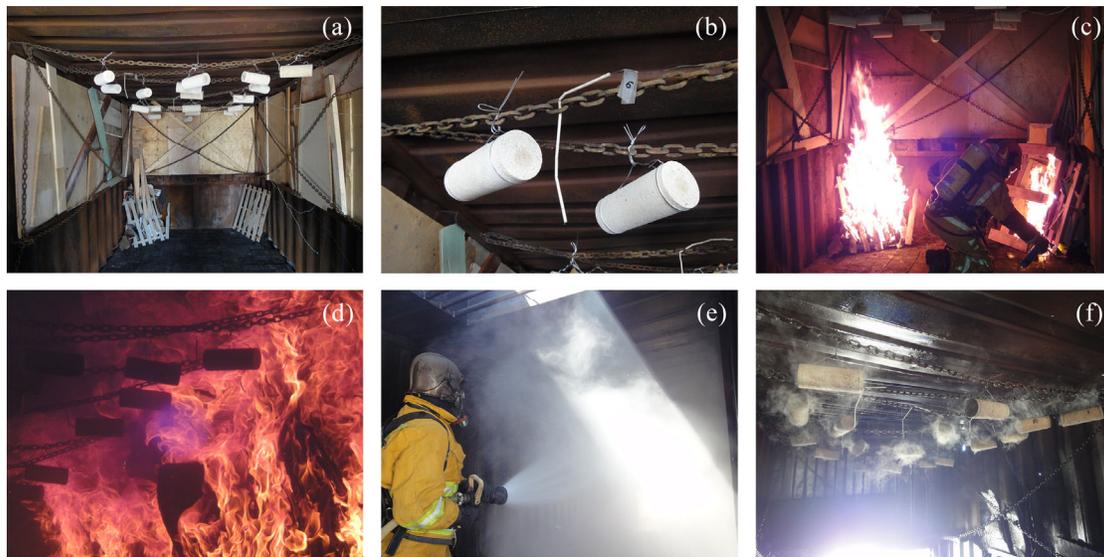
**Figure 3.** Real fire tests: (a) general view of the container; (b) detail of samples and thermocouples attachment; (c) ignition of combustible material; (d) fully developed fire; (e) fire extinction; (f) view of specimens after being cooled.

Figure 3 shows some relevant pictures of the fire exposure. A general view of the container with the stone samples and the combustible material prepared for ignition is included in Figure 3a. A detail of thermocouples relative location can be seen in Figure 3b. All of the process was made with the assistance of firefighters, including the ignition of combustible material (Figure 3c), the development of the fire inside the cabin (Figure 3d), and the fire extinction (Figure 3e). In addition, a view of the specimens at the instant immediately after being cooled is included in Figure 3f.

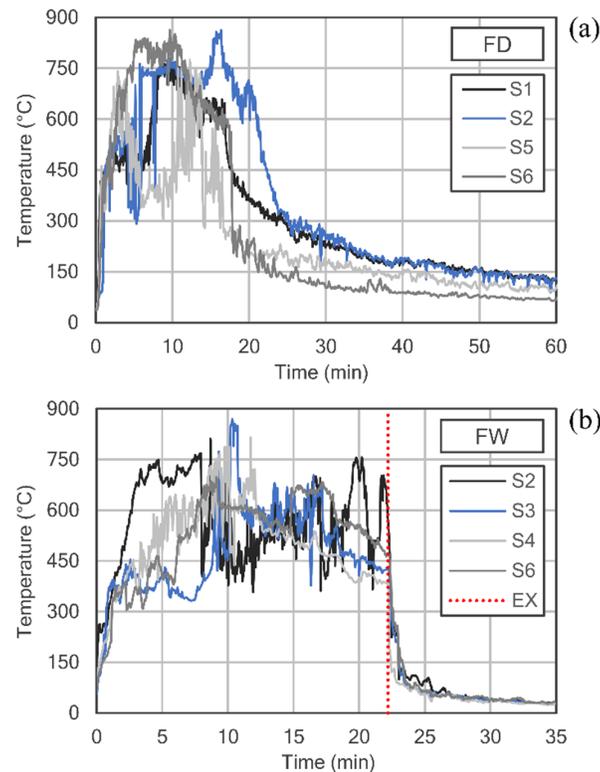
Figure 4. Temperature records inside the cabin for both tests performed: (a) FD and (b) FW.

Temperature recording curves inside the cabin are shown in Figure 4, for the two tests performed: FD and FW. It should be noted that some temperature sensors did not provide reliable data during the course of the tests, so only those considered valid have been represented (sensors S1, S2, S5, S6 in FD test and sensors S2, S3, S4, S6 in FW test). Both graphs have been drawn with different time scales on the abscissa axis, in order to facilitate the display of curves. As can be seen, the maximum temperature inside the container was reached quickly, approximately 5 min after the ignition of the combustible material. The average temperature with a fully developed fire was around 600 °C, although peaks above 800 °C were registered in some sensors. In the FD test (Figure 4a), a generalized drop in temperature can be appreciated from minutes 20 to 25, which corresponds to the gradual extinction of the flames once most of the combustible material had been consumed. For this reason, it was decided to intervene at the 22nd minute for the rapid cooling of the samples in the FW

test, Figure 4b, where EX represents the instant when the spraying with cold water was started with the assistance of the firefighters team.

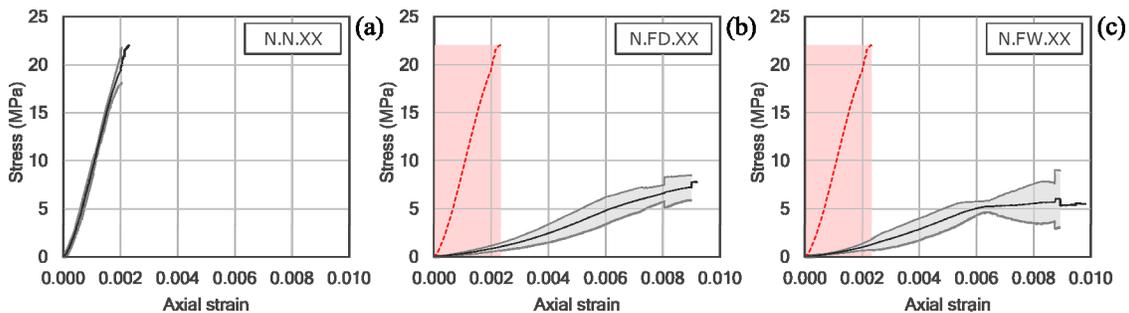
**Figure 5.** Stress-strain curves of unconfined stone samples: (a) undamaged, or after fire exposure with (b) slow air-cooling or (c) quick water-cooling.

The results corresponding to the unconfined samples are summarized in Table 3, and the axial stress-strain curves of the three series tested are shown in Figure 5. As can be seen, the undamaged specimens showed an approximately linear response with brittle failure, a common behavior in this type of stone material. Exposure to real fire produced a notable decrease in the ultimate compressive strength (65% and 70% in the samples with slow and quick cooling, respectively). The ultimate strain increased in both series by more than 4 times with respect to the undamaged stone specimens, which resulted in large reductions of the modulus of elasticity (about 90%), regardless the cooling system used. It is worth noting the great homogeneity of the results obtained, in view of the confidence intervals amplitude, considering that the tests deal with a natural material, such as stone is. As can be seen, the greatest dispersions were obtained in the samples with quick water cooling.

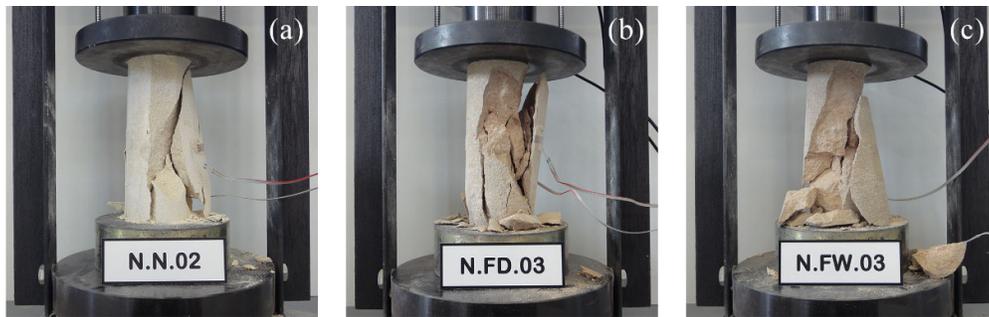
**Figure 6.** Examples of failure of unconfined stone samples: (a) undamaged, or after fire exposure with (b) slow air-cooling or (c) quick water-cooling.

Regarding the type of failure, some examples corresponding to the three series tested are shown in Figure 6. The rock exhibited a brittle fracture, with the specimen cracking in the direction of the load application, regardless of the heat treatment and cooling system used. Exposure to real fire produced a change in the color of the stone material, which darkened and acquired brown and reddish tones.

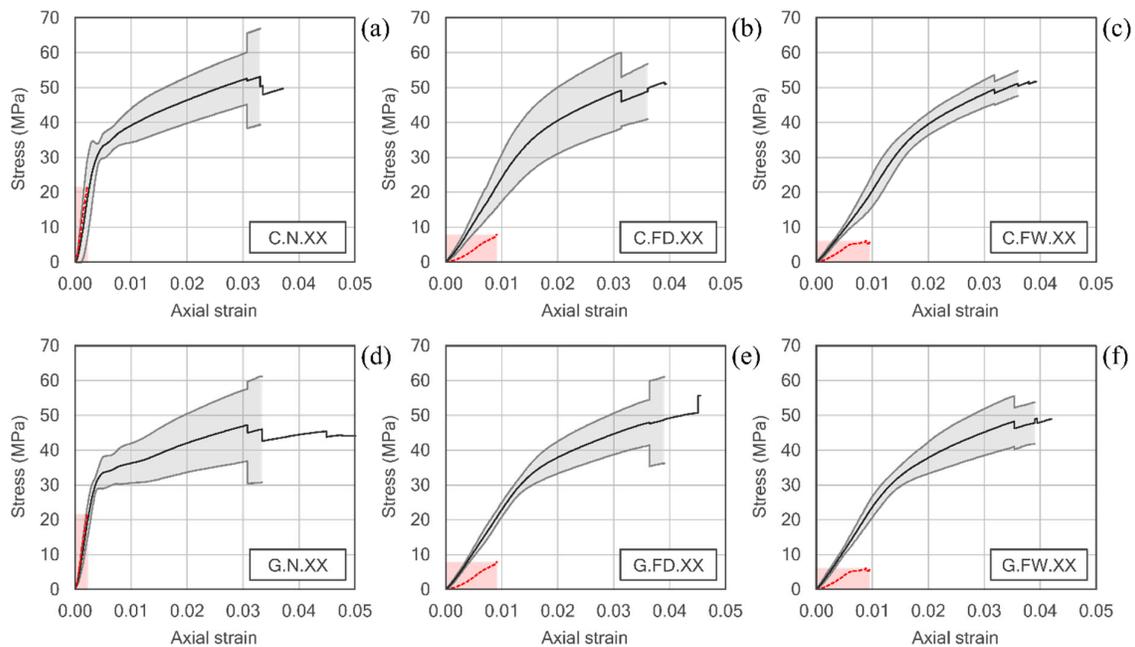
**Figure 7.** Stress-strain curves of FRP confined stone samples: CFRP, (a) undamaged, or after fire exposure with (b) slow air-cooling or (c) quick water-cooling; GFRP, (d) undamaged, or after fire exposure with (e) slow air-cooling or (f) quick water-cooling.

Figure 7 shows the stress-strain curves of the six series of stone samples confined with FRP. The graphs also include in a red dashed line the curves for the equivalent series with unconfined specimens, in order to facilitate the interpretation of the results. In case of undamaged stone specimens, shown in Figure 7a,d, the graphs show the characteristic bilinear response of the FRP

confined stone (or concrete) elements that has been reported in most of the published research. In the first phase of the test, the behavior of the reinforced specimen is similar to that of the unconfined stone, since at reduced stress levels, the lateral expansion of the core is negligible, and the effect of the confinement remains practically inactivated. Actually, the slope of the initial branch approximately coincides with the modulus of elasticity of the undamaged stone. This initial branch extends now beyond the ultimate compressive strength of the unconfined stone (about 30 to 35 MPa), as has been observed in other published research with stone materials [18,21,23]. From this point, core cracking occurs, and transverse expansion of the rock becomes much more pronounced; this deformation is limited by the effect of the jacketing, which is rapidly activated. Finally, the curve is stabilized in a second branch, approximately straight and flatter, until the specimen fails, with notable increases in strength and ultimate strain with respect to the unconfined stone material. As can be seen, a slightly higher ultimate strength is obtained in case of CFRP confinement (54.70 MPa) than in GFRP (49.47 MPa), while the ultimate strain is somewhat greater in the latter case. These very small differences are due to the weight of the fabrics used (300 g/m<sup>2</sup> in case of carbon fiber fabrics and 900 g/m<sup>2</sup> in case of glass fabrics, as specified in Table 1). In this way, the smaller mechanical capacity of the GFRP is compensated by its higher fiber content. In any case, the increases in strength (with  $f_{mc}/f_{mo}$  ratios between 2.47 and 2.74) and, above all, in ultimate strain (which increases almost 20 times with GFRP jackets), are very remarkable.

With respect to the series subjected to the action of fire, Figure 7b,c and Figure 7e,f, it can be seen how the stress-strain curves exhibit the bilinear behavior described above, although the transition between the two branches occurs smoothly and a point as clearly marked as in case of undamaged series is not detected. This behavior has been reported in previous studies with concrete samples [25,26]. In terms of stress and strain at failure, it can be seen that the results are very similar to those of the equivalent series without heat treatment, with differences below 5% in all cases. Therefore, it can be concluded that the behavior of the confined specimen seems to depend basically on the properties of the FRP wrapping and not on the degree of damage that the stone core may have suffered. In relative terms, comparing the failures with those of the equivalent unconfined series, it

can be seen that the ratio  $f_{mc}/f_{mo}$  increases in the quick cooled samples, the most damaged ones, while the ratio  $\varepsilon_{mc}/\varepsilon_{mo}$  results in the same order, regardless of the cooling system.

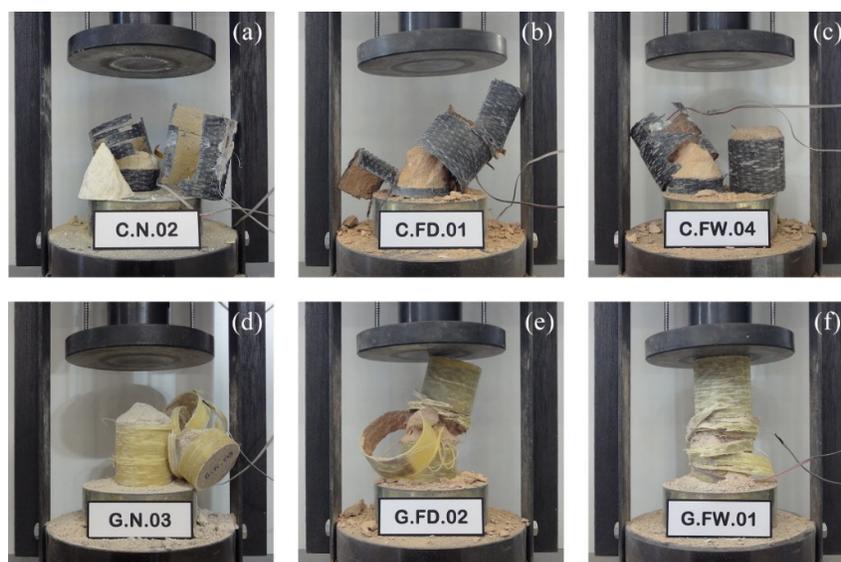
**Figure 8.** Examples of failure of FRP confined stone samples: CFRP, (a) undamaged, or after fire exposure with (b) slow air-cooling or (c) quick water-cooling; GFRP, (d) undamaged, or after fire exposure with (e) slow air-cooling or (f) quick water-cooling.

From the point of view of failure modes, Figure 8 shows some examples of the different series tested. In general, there are no substantial differences between undamaged stone or those subjected to the action of fire. Failure is determined by the tensile rupture of the FRP wrapping, producing a brittle and explosive rupture, more violent in case of CFRP confinement. FRP sheet presents break lines which follow the direction perpendicular to the fibers and, although they are usually concentrated in the midheight of the specimen, in some cases they extend to the ends and the jacket suffers a complete breakage. The stone shows a strong degradation, cracking in approximately conical shape at both ends of the specimen, while the rest of the core appears completely disintegrated. In most cases, further degradation is observed with CFRP confinement, while the samples remain somewhat more intact with the GFRP wrappings. A thin layer of stone material can always be seen adhering perfectly to the inner side of the FRP sheet, which proves the high adhesion capacity of the epoxy resin. On the other hand, it is important to note that in no case did the collapse occur in the area of the fabric overlap, which may prove that the length of the overlap adopted (25% of the perimeter of the specimen, as described previously) was sufficient in all the samples tested. Finally, it should be note that, despite their sudden and explosive nature, breakages are generally predictable. In the final stages of the test, different noises can be heard as a consequence of the cracking of the stone core or the occasional breakage of any of the FRP fibers. Furthermore, in case of GFRP jackets (has not been observed with CFRP wrapping), some white patches appear at about 70–80% of the ultimate load. These patches are attributed to a plastic flow of the resin before the FRP failure and have also been observed in other previous studies with both stone and concrete specimens.

case was lower after fire exposure. If similar confinement is considered, weaker materials will present higher strength gains. However, the effective confinement pressure is limited in the code by the reduced strain value in Equation (5). This limitation is the minimum value of two possible situations: first, the failure of the FRP (considering the efficiency factor) and second, a maximum limit to control the damage in the base material. This limitation intends to avoid an excessive damage in the support, especially under transverse forces, which could compromise the lateral stability of the structure. The experimental results and predictions in Table 5 showed that, as the material was weakened, the expected strength gain prescribed in the Italian code tended to a value of 4 times. This value will correspond to a situation of perfect confinement in which the stiffness of the confinement is much higher than that of the reinforced material. For example, in a triaxial stress state, and considering the Drucker Prager yield criterion, if a confinement pressure is applied in order to totally prevent lateral strains, the longitudinal strength will be four times the unconfined strength of the material. The samples tested in this work presented strength increases up to 8.7 times the unreinforced material's strength. Therefore, despite the FRP gave additional strength, the heated samples were expected to suffer high degradation of the core, as shown in Figure 8, which is actually what the standard intends to avoid.

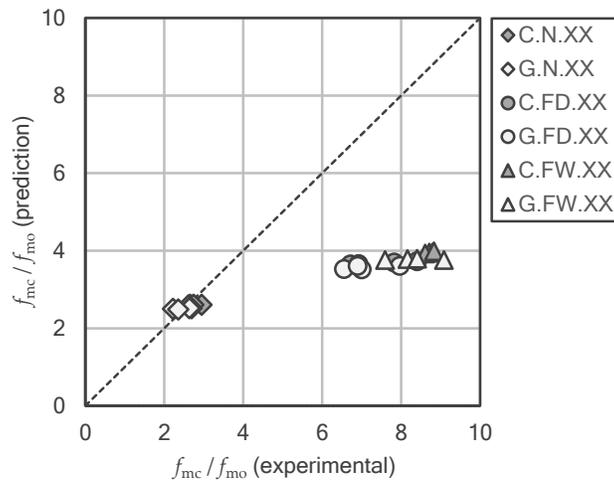
**Figure 9.** Comparison of the strengthening ratios  $f_{mc} / f_{mo}$  obtained experimentally and predicted by the confinement model adopted in the Italian guideline for masonry or stone FRP wrapping.

It is clear that the confinement model of CNR-DT 200 R1/2013 provides a good approximation for undamaged stone series, i.e., the stone samples that were not exposed to fire. The differences from experimental results are less than 5% and with a very low dispersion index, as can be clearly seen in the comparative graph in Figure 9. Nevertheless, in case of the series exposed to high temperature, significant deviations and higher dispersions have been obtained. In these series, the standard provides very conservative results, about half of the experimental results, and it can be seen how the differences increase in the series with quick cooling, which are the most damaged. Therefore, in a first analysis, it can be concluded that for a material so seriously affected by fire, the confinement model of the Italian standard does not match the experimental results, although this discrepancy remains on the safety side.
