# Effect of Cleaning Protocol on Bond Strength between Resin Composite Cement and Three Different CAD/CAM Materials

Nina Lümke1, Lisa Marie Schönhoff1, Ramona Buser1 and Bogna Stawarczyk1 \*

Department of Prosthetic Dentistry, Dental School, University Hospital, LMU Munich, 80336 Munich, Germany; nina.luemke1@med.uni-muenchen.de (N.L.); lisa.schoenhoff1@med.uni-muenchen.de (L.M.S.); ramona.buser1@med.uni-muenchen.de (R.B.)

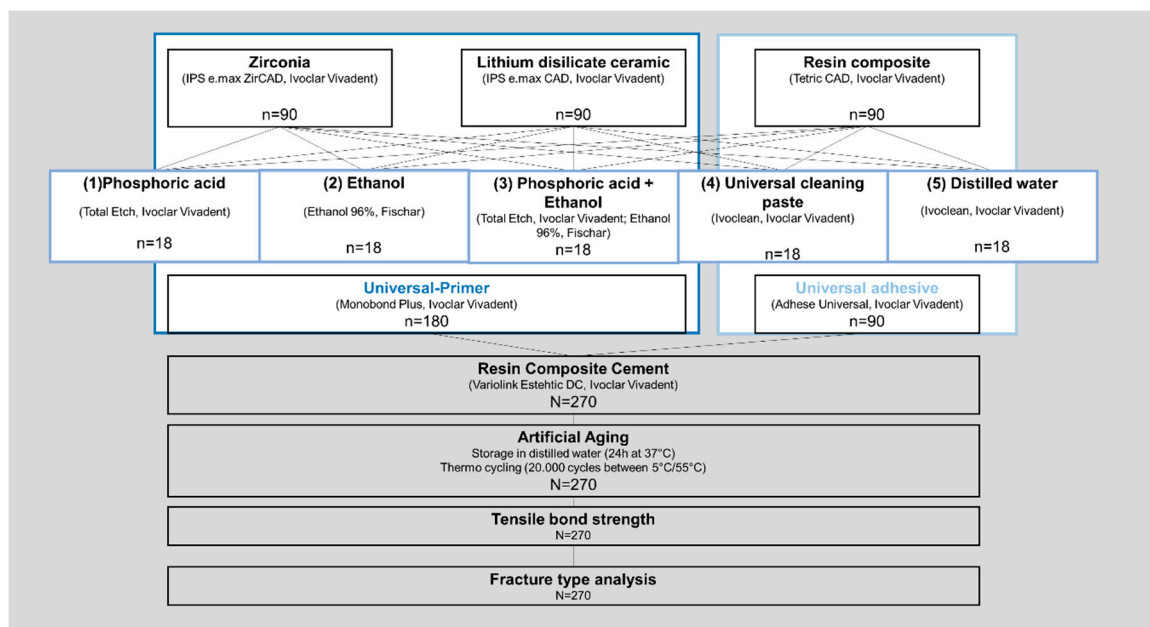
**Figure 1.** Study design: impact of cleaning protocol on the tensile bond strength between a resin composite cement and three different computer aided design/computer aided manufacturing (CAD/CAM) materials.

A total number of 90 specimens was prepared from each material (Figure 1). All materials used are listed in Table 1. For zirconia (IPS e.max ZirCAD LT, Ivoclar Vivadent; Schaan, Liechtenstein), square-shaped blocks with a cross section of  $7 \times 7$  mm and a thickness of at least 5 mm were cut from a pre-sintered CAD/CAM blank using a diamond wheel. Successively, the zirconia specimens were sintered according to the manufacturer's instructions (Table 2; LHT 02/16, Nabertherm; Lilienthal, Germany). For lithium disilicate ceramic (IPS e.max CAD HT, Ivoclar Vivadent; Schaan, Liechtenstein) and resin composite (Tetric CAD, Ivoclar Vivadent; Schaan, Liechtenstein), plate-shaped specimens with a cross section of  $12.4 \times 14.5$  mm (lithium disilicate ceramic, Figure 2A) or  $11.8 \times 13.8$  mm (resin composite) and a thickness of 1.5 mm were cut from CAD/CAM blocks using an automated cutting machine (Secotom-50, Struers; Copenhagen, Denmark) equipped with a diamond-coated saw blade (M1D13, Struers; Copenhagen, Denmark). The cutting parameters were set at a feed speed of 0.05 mm/s and circulation speed of  $2500 \text{ min}^{-1}$ . After cutting, the lithium disilicate specimens were crystallized (Figure 2B) according to the processing instructions provided by the manufacturer (Table 2; Programat EP5000, Ivoclar Vivadent; Schaan, Liechtenstein).

Zirconia ( $n = 90$ ) and resin composite specimens ( $n = 90$ ) were air-particle abraded with alumina powder ( $50 \mu\text{m}$ ) at a pressure of 0.1 MPa for 10 s (basic quattro IS, Renfert; Hilzingen, Germany). The surface of the lithium disilicate specimens ( $n = 90$ ) was etched with 5% hydrofluoric acid (IPS Ceramic Etching Gel, Ivoclar Vivadent; Schaan, Liechtenstein) for 20 s and rinsed with distilled water. All specimens were ultrasonically cleaned with distilled water for 5 min after surface pre-treatment and allocated into the defined groups of cleaning protocols (Figure 1).

After performing the different cleaning protocols, the specimen surfaces were conditioned respectively (Figure 1, Table 1). For zirconia and lithium disilicate ceramic a universal primer

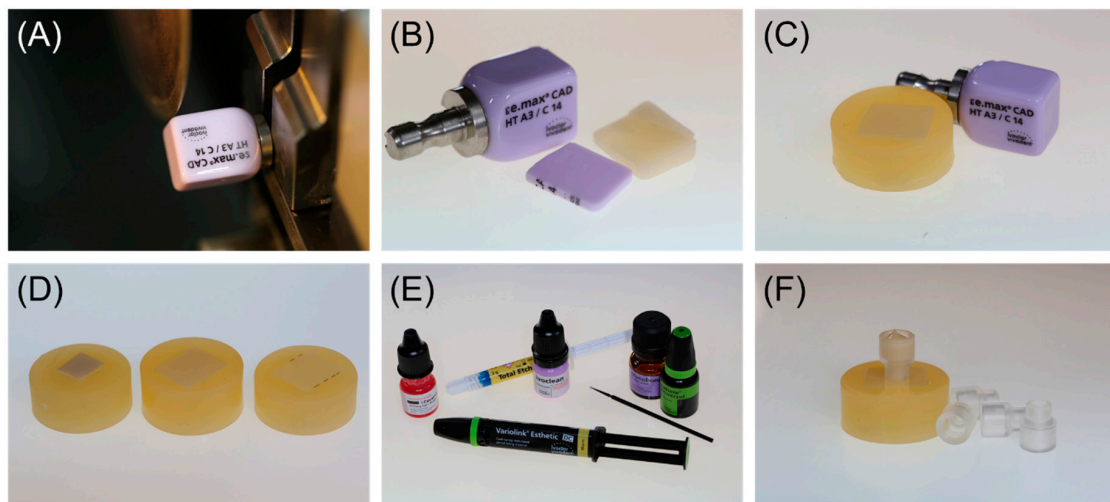
**Figure 2.** Step by step procedure of specimen preparation with (A) cutting of plate-shaped specimens with a cross section of  $12.4 \times 14.5$  mm (lithium disilicate ceramic) and a thickness of 1.5 mm from CAD/CAM blocks using an automated cutting machine; (B) plate-shaped lithium disilicate specimens before and after crystallization; (C) embedded lithium disilicate ceramic specimen after polishing; (D) overview of all tested CAD/CAM specimens after application of cleaning protocols; (E) materials used for surface pretreatment and bonding with resin composite cement; and (F) acrylic cylinder bonded to specimen surface using resin composite cement.

All specimens were singly embedded in acrylic resin (Figure 2D, ScanDiQuick A/B, ScanDia; Hagen, Germany) and polished according to a standardized polishing protocol using a series of silicone carbide papers up to P4000 under permanent water cooling (Tegramin-20, Struers; Copenhagen, Denmark). Afterwards, the specimens were ultrasonically cleaned with distilled water for 5 min (Transitor/Ultrasonic T-14, L&R; Kearny, NJ, USA).

(Monobond Plus, Ivoclar Vivadent; Schaan, Liechtenstein) was applied onto the specimen surface with a brush (Figure 2E), allowed to react for 60 s and gently dispersed with oil-free air. The resin composite specimens were conditioned with a universal adhesive (Adhese Universal, Ivoclar Vivadent; Schaan, Liechtenstein) that was evenly applied, allowed to react for 20 s, gently dispersed and light-cured for 10 s (Elipar S10, 3M; Saint Paul, MN, USA).

A transparent acrylic cylinder with an inner diameter of 2.9 mm was positioned in the center of the conditioned specimen surface, filled with resin composite cement (Variolink Esthetic DC, Ivoclar Vivadent; Schaan, Liechtenstein) and light-cured for 20 s (Elipar S10, 3M; Saint Paul, MN, USA) (Figure 2F). Excess resin composite cement was gently removed with a scalpel.

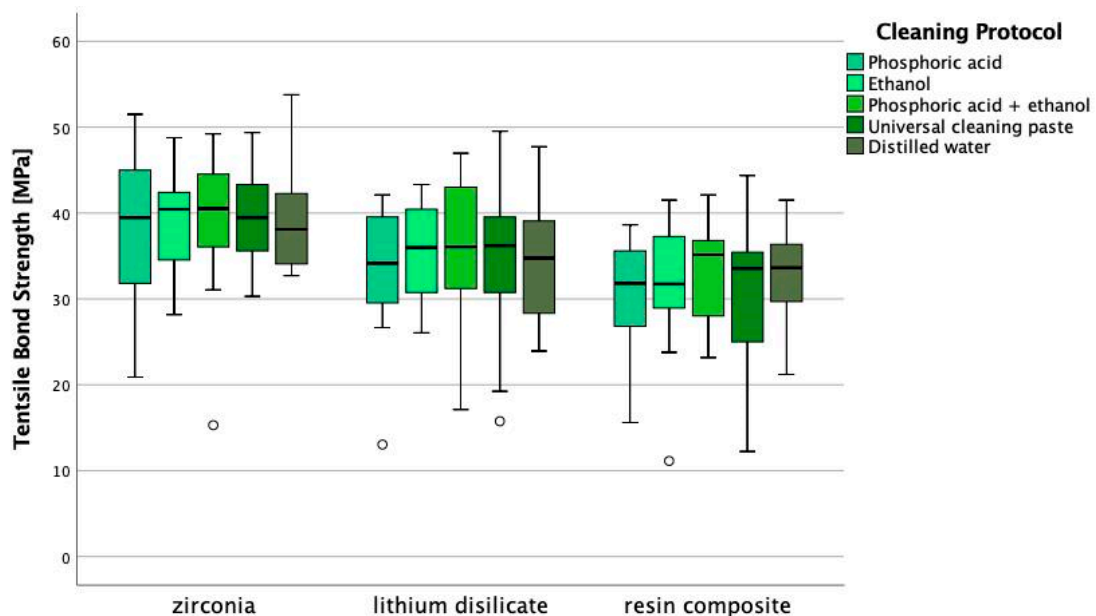
**Figure 3.** Tensile bond strength in MPa depending on the material and the cleaning protocol.

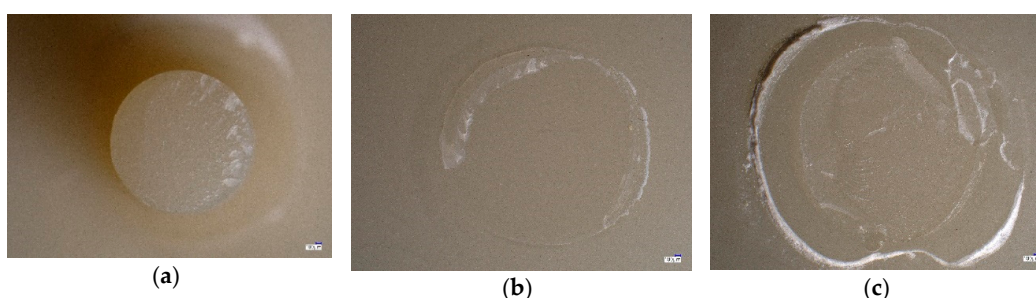
**Figure 4.** Overview of occurred fracture types according to the definition of (a) adhesive, (b) cohesive and (c) mixed.

- (A) *adhesive*: no residuals of resin composite cement on specimen surface
- (B) *cohesive*: adhering residuals of resin composite cement on specimen surface
- (C) *mixed*: adhering residuals of resin composite cement on specimen surface combined with fractures in specimen substrate

disilicate and composite groups, mixed fracture types only occurred in two resin composite groups (Figure 4).
