# Conflict on the Northern Front: Archaeological Perspectives on the Spanish Civil War at Monte Bernorio, Palencia, Spain

Published online: 11 August 2020  
© The Author(s) 2020

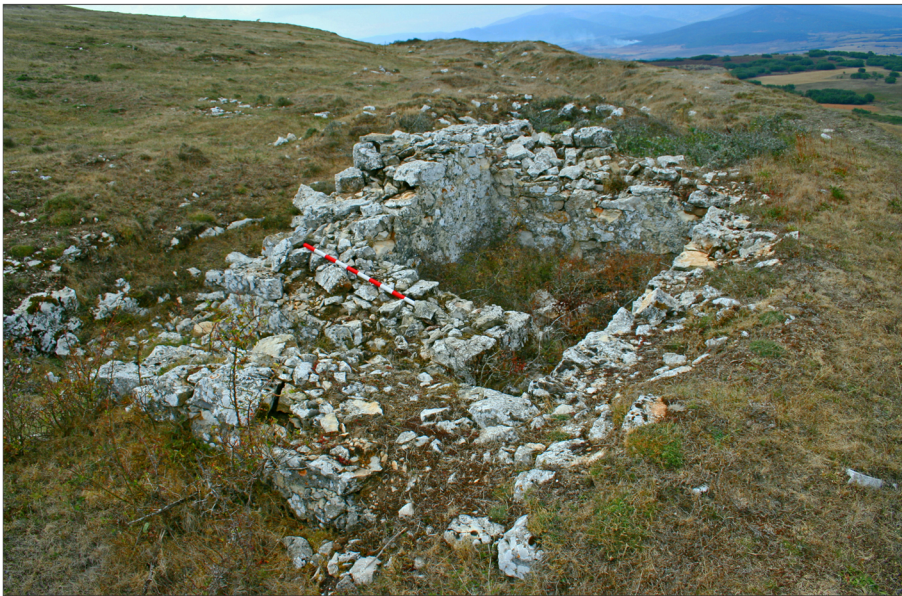
**Fig. 3.** Above general view of the remains of the “Parapet of Death” bunker and below a sketch of that fortification (IMBEAC. Drawing: A. Martínez-Velasco).

On the eastern side of Monte Bernorio there is a rectangular bunker with an unusual spiral-shaped ground plan that was known as “the parapet of death” (*parapeto de la muerte*) (Fig. 3). It is on the edge of the summit in an area where the slope is precipitous and has a long drop. This did not make it immune to enemy fire and it was very exposed to the Republican snipers. Its construction claimed many casualties, as it is attested that Republican bullets killed and wounded many soldiers in that spot (García Guinea 2005: 42–46; Román Ibáñez 2013: 111–113, 2015: 307–309). The bunker did not have a masonry roof but was covered with a structure of planking and perhaps a corrugated iron or fiber cement roof covered with sandbags, stone, and earth. Its peculiar shape was designed to protect the interior of the structure from explosive shockwaves, but that also meant it was very small inside. The exit connected to its own system of trenches to defend the position, which in turn was connected to the frontline trenches and the auxiliary trenches that led to the second line. This bunker was also built opposite one of the strong points on the Republican defensive lines.

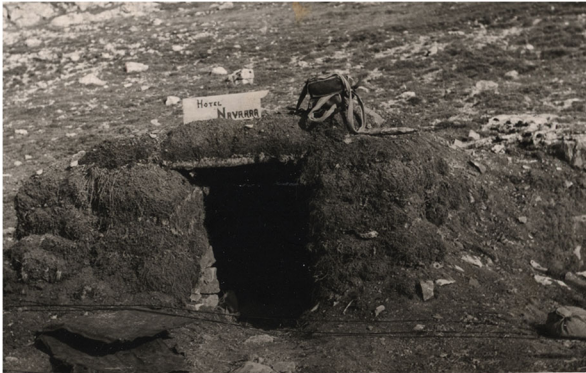
**Fig. 4.** Photograph from 1937 showing a small shelter built of stone and wood and covered with turf, probably on the western side of Monte Bernorio, in the second defensive lines. Both the type of shelter and the poster with a humorous tone recall similar structures built by soldiers in the First World War. At the bottom there is a line of cables, probably telephone lines (photo ceded by W. Román).

Running from each end of the first line of trenches were the “service trench” lines. These connected to a “second line of trenches” for the rear defense of the position. On the western side it is still possible to make out the remains of this intricate line of trenches with a large number of shelters and small refuges (the so-called “chabolos” or “chamizos”) (Fig. 4).

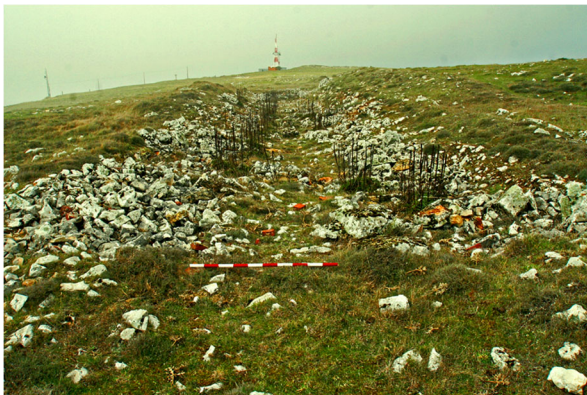
Fig. 5. Photograph of the large troop shelter located on the eastern side of Monte Bernorio (IMBEAC).

On the eastern side of Monte Bernorio there was another large troop shelter with latrines, as well as a series of rifle pits to defend the position in case the enemy managed to break through the first and the second trench lines (Fig. 5). The shelter was built in a similar way to that of the western side, but the slope still preserves a ditch used to drain the waters and the lowering of the ground into which the roof was inserted and supported. It had three entrances and it preserves the remains of at least one fireplace as well as various supports for the vertical beams that held up the roof.

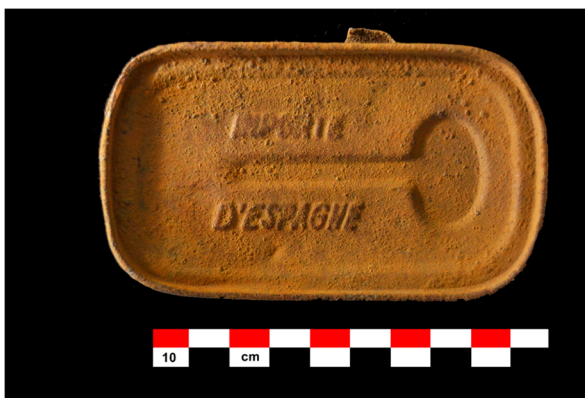
Fig. 7. Sardine tin with the inscription "*Importe d'Espagne*" (imported from Spain written in French) (IMBEAC).

Finally, we cannot forget the small finds that tell us about aspects of daily life, such as the food and drink consumed by the Civil War occupants of the site. Most of the evidence comes in the form of tins that mainly contained sardines and peppers, as well as some of meat, condensed milk, and other processed foods (Fig. 7). According to the testimonies collected from ex-combatants, this made up their basic diet. The foodstuffs were handed out with bread when combat conditions meant that only cold rations could be distributed, along with a drink (water and occasionally wine or another alcoholic
