Assessment of fractures in endodontically treated teeth restored with and without root canal posts using high-resolution cone beam computed tomography

Background: Root fractures are a diagnostic challenge for dentists in endodontic treatment. This study aimed to determine the relationship between the characteristics of tooth fractures and the presence of root canal posts in endodontically treated teeth using high-resolution cone beam computed tomography (CBCT).

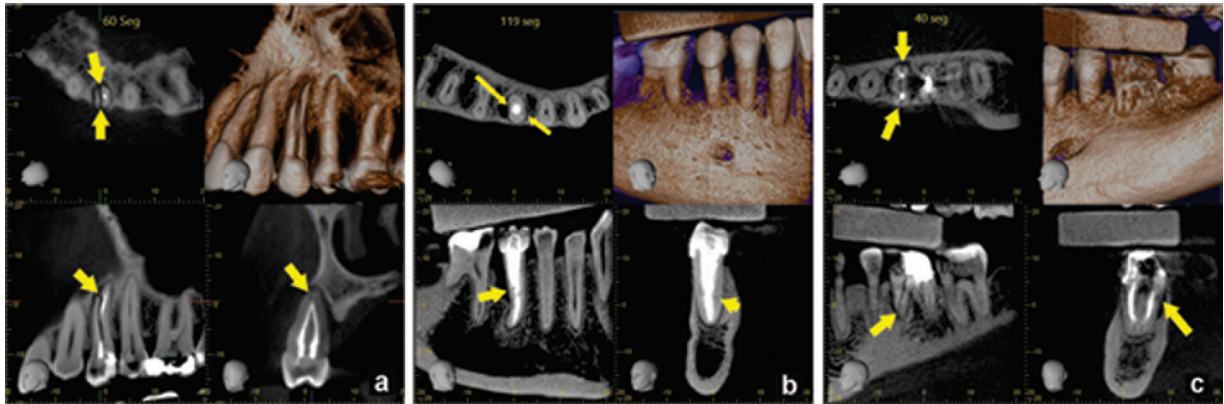
Fig. 1: Type of retention: Without post (a), Non-metal post (b), Metal post (c).

Horizontal fracture was the least common, with 6 cases, followed by vertical fracture with 18 cases. Oblique fracture was the most common, with 26 cases. According to the type of retention, 40% of the sample had no post, 56% had a metal post, and 4% had a non-metal post. Regarding the extent of the fracture, 4% reached the crown, 24% reached the first third of the root ca-

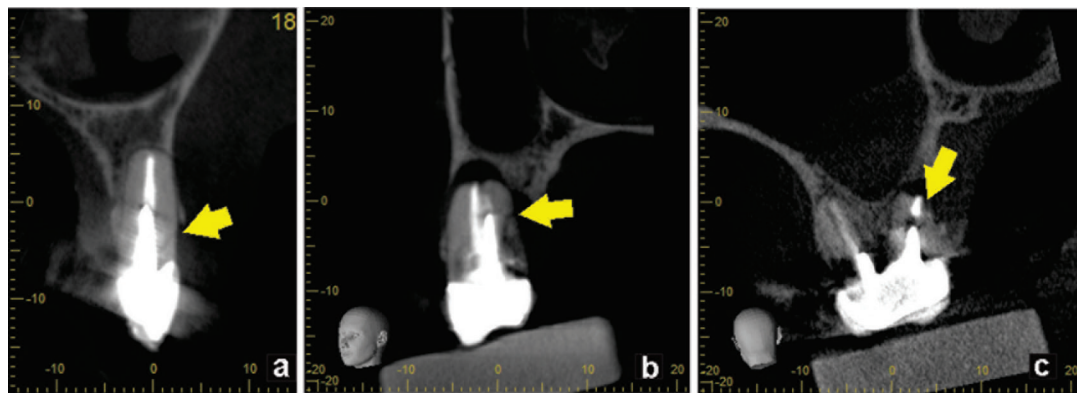
Fig. 2: Extent of the fracture: First third (a), middle third (b), apical third (c).

apical third of the root canal (Fig. 2); 4. Cause of endodontic failure: without failure, unfilled root canal, partially filled canal, or false canal (Fig. 3); and 5. Location of the lesions: no lesion, apical lesion, periradicular lesion, paradicular lesion, or interradicular lesion. All data were recorded in an Excel table (Microsoft Corp., USA).

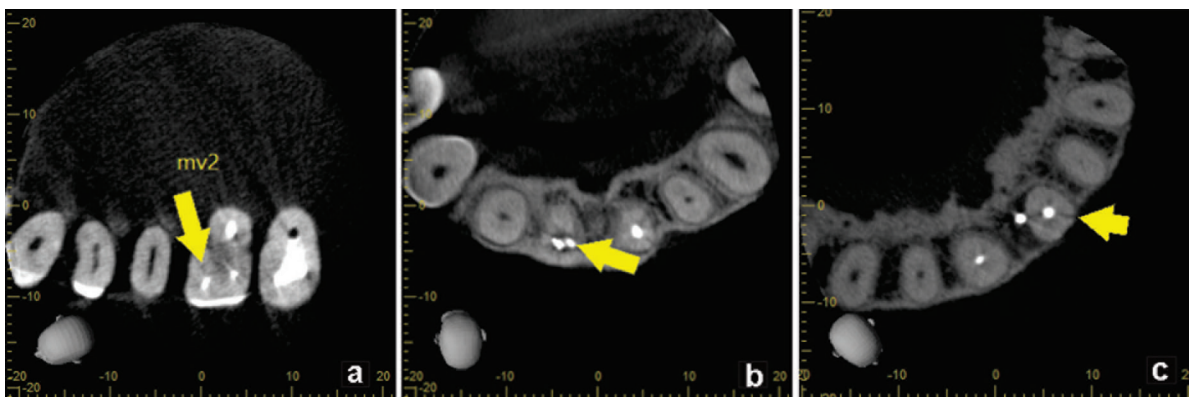
Fig. 3: Cause of endodontic failure: Unfilled root canal (a), incompletely filled canal (b), false canal (c).

nal, 54% reached the middle third, and 18% reached the apical third. In relation to endodontic failures, different causes were found in 38% of the cases, such as unfilled root canals (10), incompletely filled canals (8), and a false canal (1). Regarding the location of the lesion, apical fracture was the most common and was found in 40% of the cases.
