IABSE Symposium 2019 Guimarães
Towards a Resilient Built Environment - Risk and Asset Management
March 27-29, 2019, Guimarães, Portugal

Assessment of roadway bridges damaged by human errors using risk indicators and robustness index

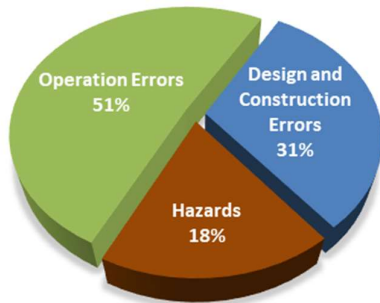
Figure 1. Leading causes of failure for reinforced concrete bridges [2]

To improve the safety of bridges is first required, the screening of the main sources of the uncertainties that have been leading them to fail. Relying on a bridge failure database, that to the author's knowledge, is one of the most completed available database, developed by [2] with more than 450 worldwide bridge failure incidents since 1966 to 2017, covering the leading causes of failure (Figure 1), is inevitable the conclusion that the human errors are the primary source of uncertainties leading to bridge failure and collapse.

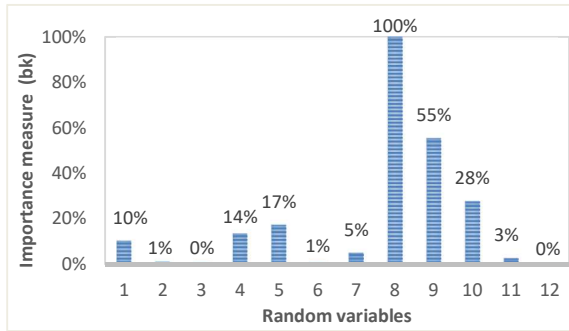
Figure 5. Random variables sensitivity analysis

probabilistic analysis. According to this importance factor (b_k) given by the chosen approach, the random variables with the highest influence on the load-bearing capacity of the structure are identified. A threshold value of 10%, for the importance factor, is considered to identify the random variables with high influence on the structural performance of the case study. Thus, they are, the compressive strength of the concrete, the thickness of the deck slab, the area of the longitudinal reinforcement and the ultimate yielding stress of the ordinary and prestressing reinforcement. However, the yielding stress of the ordinary reinforcement is the most influential of all random variables (Figure 5). In order to determine

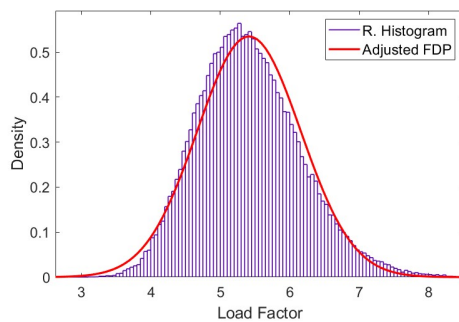
Figure 6. Probabilistic distribution of the case study load bearing capacity

Through the normal probabilistic distribution function that characterizes the resistance and the load uncertainties, the formulation presented in [18] is used to compute the structural reliability index (β), where μ_R and μ_S respectively represent the mean value of the resistance and the load, and σ_R e σ_S respectively represent the standard deviation of the resistance and the load. Therefore:

$$\beta = \frac{\mu_R - \mu_S}{\sqrt{\sigma_R^2 + \sigma_S^2}} = \frac{5.41 - 1}{\sqrt{0.746^2 + 0.15^2}} = 5.80 \quad (1)$$

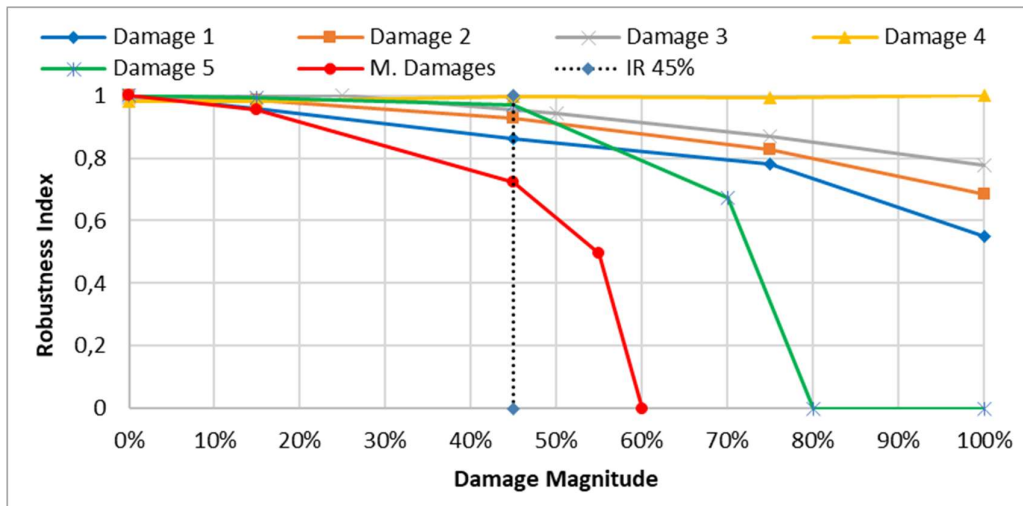
Figure 7. Robustness index reduction caused by the damage magnitude increase

As expected, there is a more or less marked drop of the reliability index with increasing error severity (Figure 7). Exceptionally for Damage 4, there is an increase in the reliability index. This damage outcome on the mean maximum load-bearing capacity of the structure is minimum, representing a total loss of 3.5% throughout the entire damage

magnitude. However, there is a marked decrease of the standard deviation, i.e. an increase in the certainty of structure behaviour, which eventually pay off the minimum loss of load bearing capacity, thereby, increasing the reliability index. The loss of prestressing stress, despite being shown has favourable to the structure safety condition, taking into account the bending moment ultimate limit state it's not for the structure serviceability. This calls into question its decompression limit state, thus leading to larger cracks since the structure will be under higher tensile stresses. The computation of the robustness index comes from the normalization of the reliability indexes, relatively to the highest reliability index associated with each damage, in order to obtain the robustness index presented by [20]. The formulation presented by
