An Intensive Cultural Resources Investigation for the Redbud Pump Station Transmission Water Line Project Collin County, Texas

**AN INTENSIVE CULTURAL RESOURCES INVESTIGATION FOR THE
REDBUD PUMP STATION TRANSMISSION WATER LINE PROJECT
COLLIN COUNTY, TEXAS**

City Project No.: WA-4340

Project: Redbud Pump Station Transmission Water Line Project

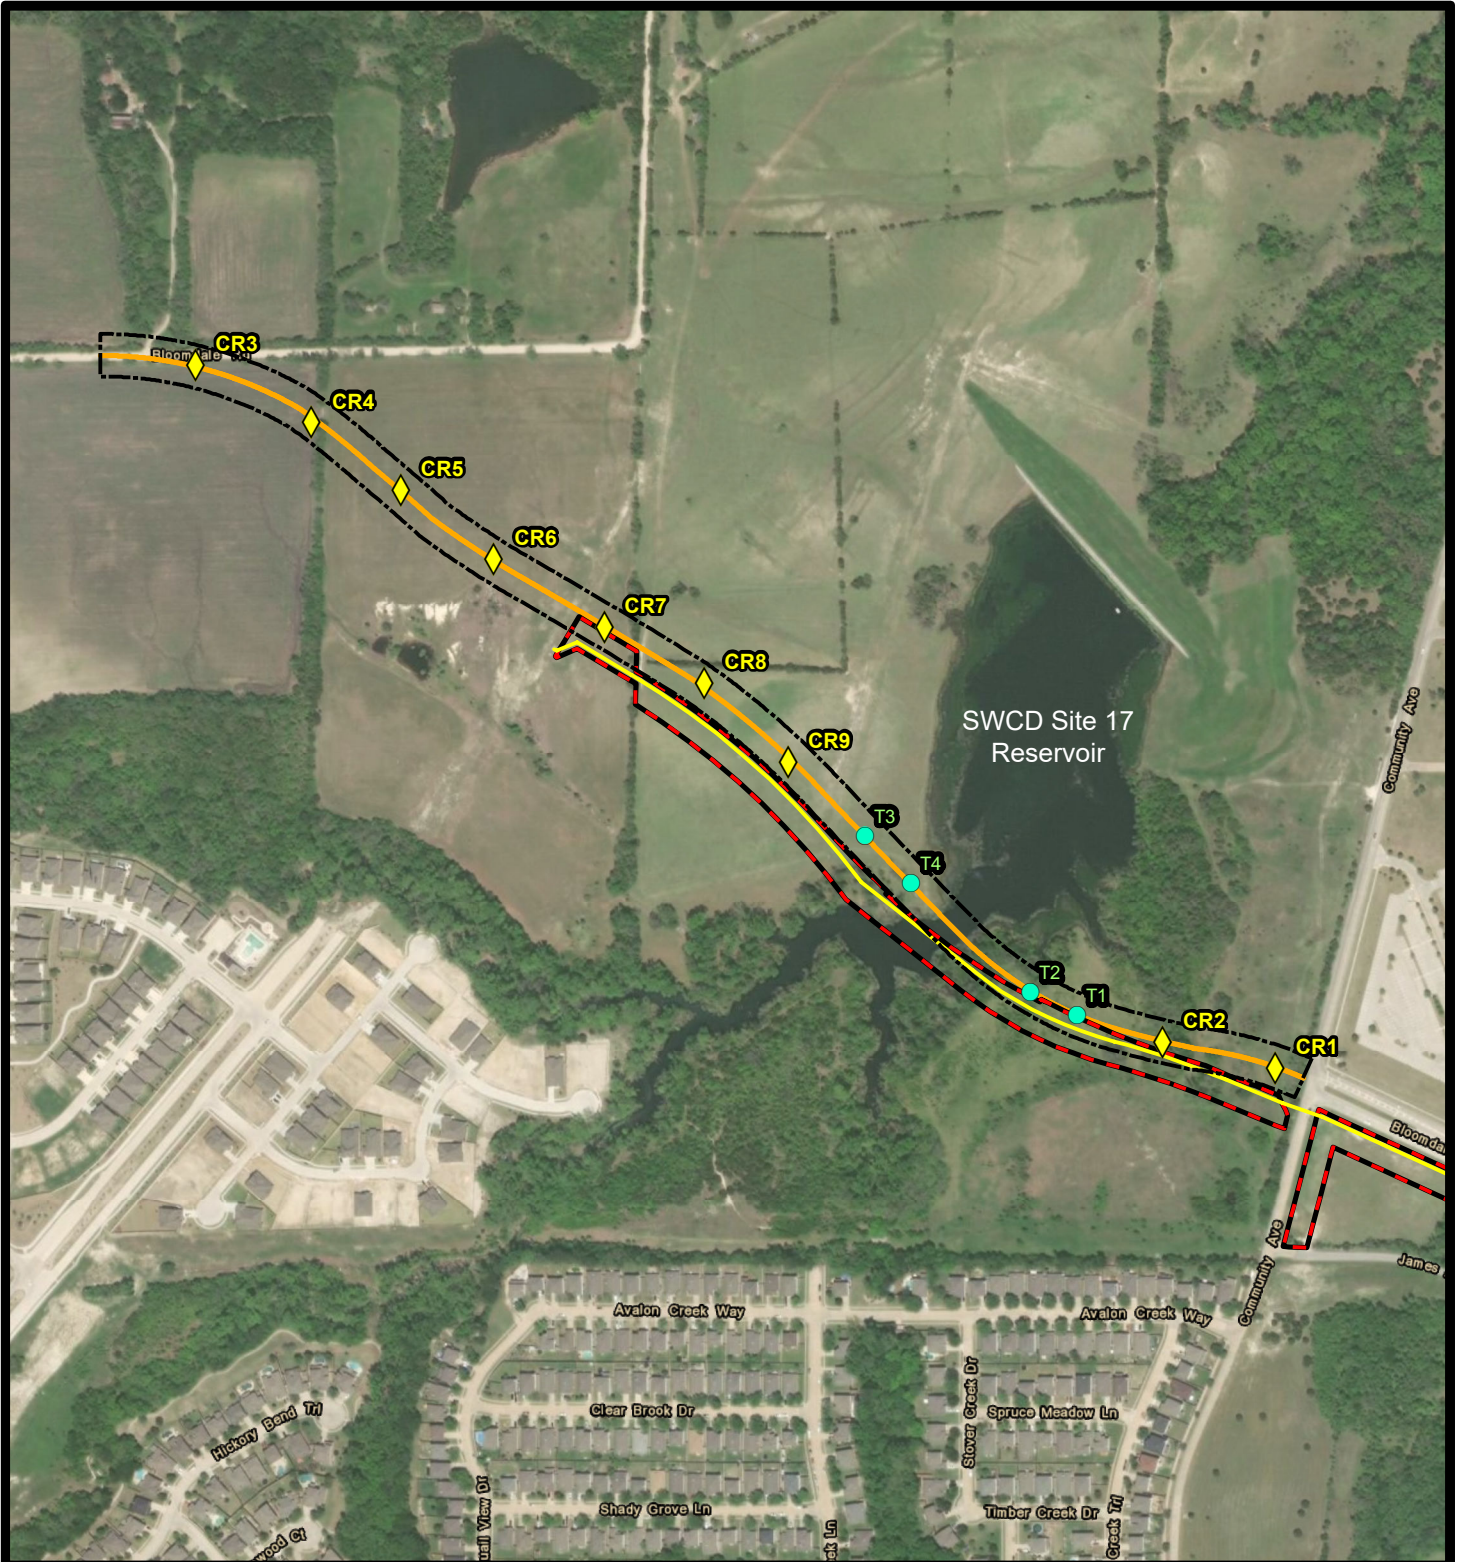
From Community Avenue to the Project's northwestern terminus, the APE is located immediately adjacent to an area that has been subjected to a previous archaeological investigation (**Appendix A, Figure 3**). This area was previously surveyed during May 2017 by archaeologists from Burns & McDonnell Engineering Company, as part of a cultural resources survey for the Bloomdale Road Extension project (Antiquities Permit No. 7946) (Fischbeck et al. 2017). The report documenting the results and recommendations from this survey has been submitted to and accepted by the THC. During that previous archaeological investigation, nine negative shovel tests (ST) were excavated. In addition, four backhoe trenches were excavated during exploratory ge archaeological trenching. Two trenches were investigated on each side of the SWCD Site 17

The backhoe trenches from the previous investigation were excavated along a centerline that roughly parallels the current Project centerline at a distance of 25 m (82 ft) on the northwest side of the Reservoir and at 12 m (39 ft) on the southeast side of the Reservoir. The bore pits that the current project will be excavating at each side of the Reservoir will be between 11 and 12 m (35 and 38 ft) deep, to accommodate for the straight grade auger bore or tunneling construction method.

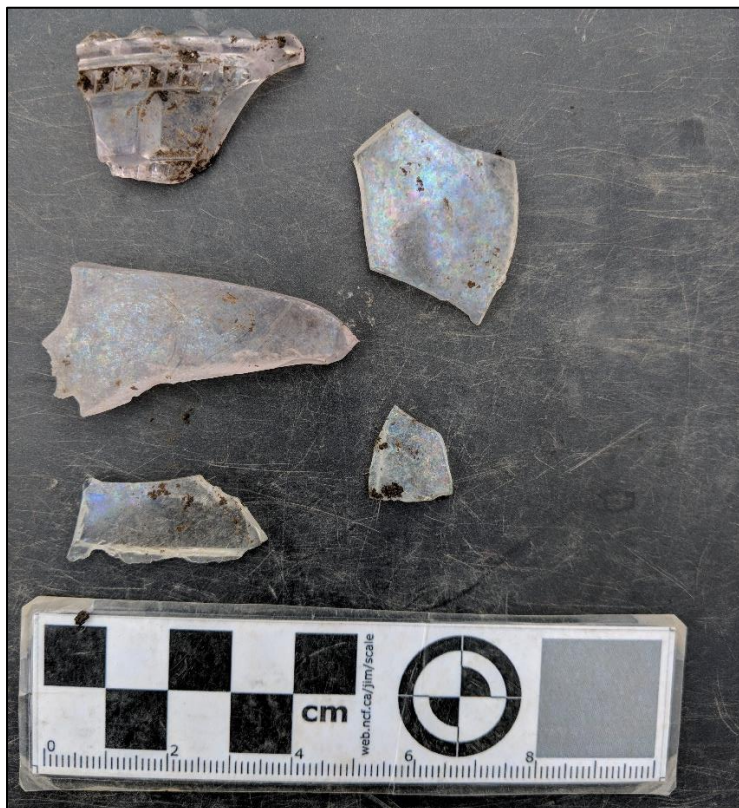
Figure 18. Historic artifacts from site 41COL324.

Site 41COL324 is located [REDACTED] therefore all artifacts were documented in the field and not collected. Prior to photo documentation and recordation, artifacts were rinsed, sorted and preliminarily analyzed. Artifacts consist of clear glass fragments (n=5), three of which exhibited significant patination (weathering/decay) (Munsey 1970), while two reflected a violet/amethyst solarized hue (known also as sun-colored). Amethyst tinted glass is the result of the use of manganese as a decolorization agent; when exposed to sunlight, the manganese causes the glass to turn a distinctive shade of violet (Lockhart 2006). The next most frequent artifact type represented decorated, pale blue-green glazed whiteware (n=4), two shards of which fit together (Miller 2015; Stelle 2011). All ceramic shards were absent a makers-mark. Of the two remaining materials, there was a single ceramic grate rim fragment, possibly from a gas operated, cast iron Radiantfire fireplace burner (n=1) (Humphrey 2015) and a pearled, pale yellow colored cast resin fragment, possibly Bakelite (n=1) (Davidov and Redington 1988) (**Appendix B, Figures 18 – 23**). Although limited in number, the range of material suggests the site was a residential locus from the late 19th to the mid-20th century (**Table 3**).

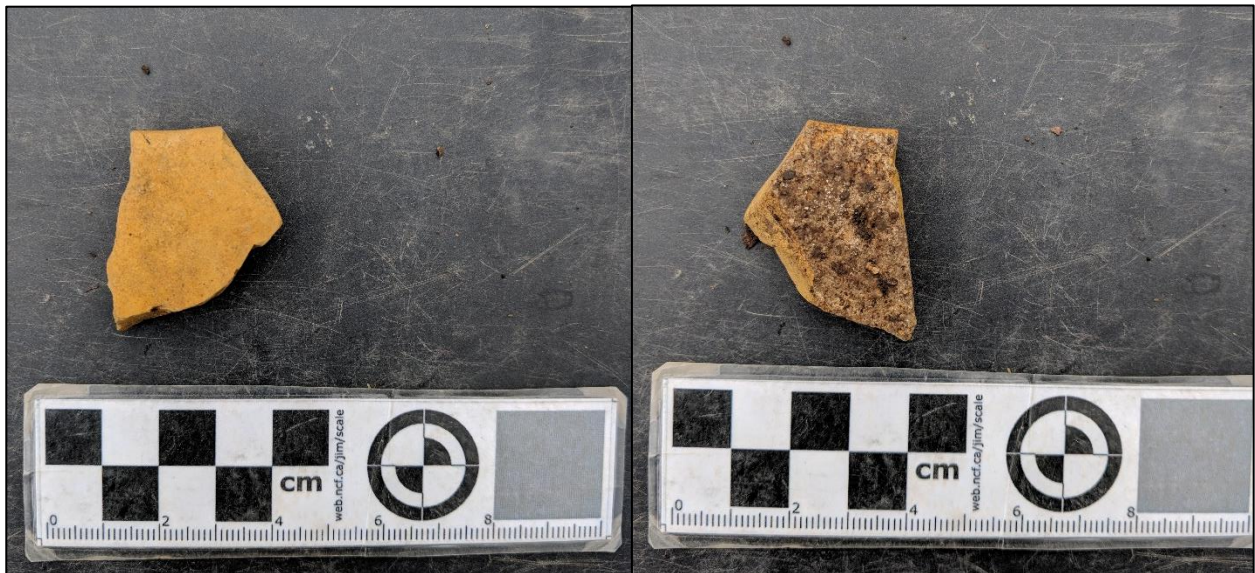
Figure 21 and 22. Site 41COL324 ceramic, amber colored, possibly a heater grate/panel rim fragment from a gas fireplace burner (heater).

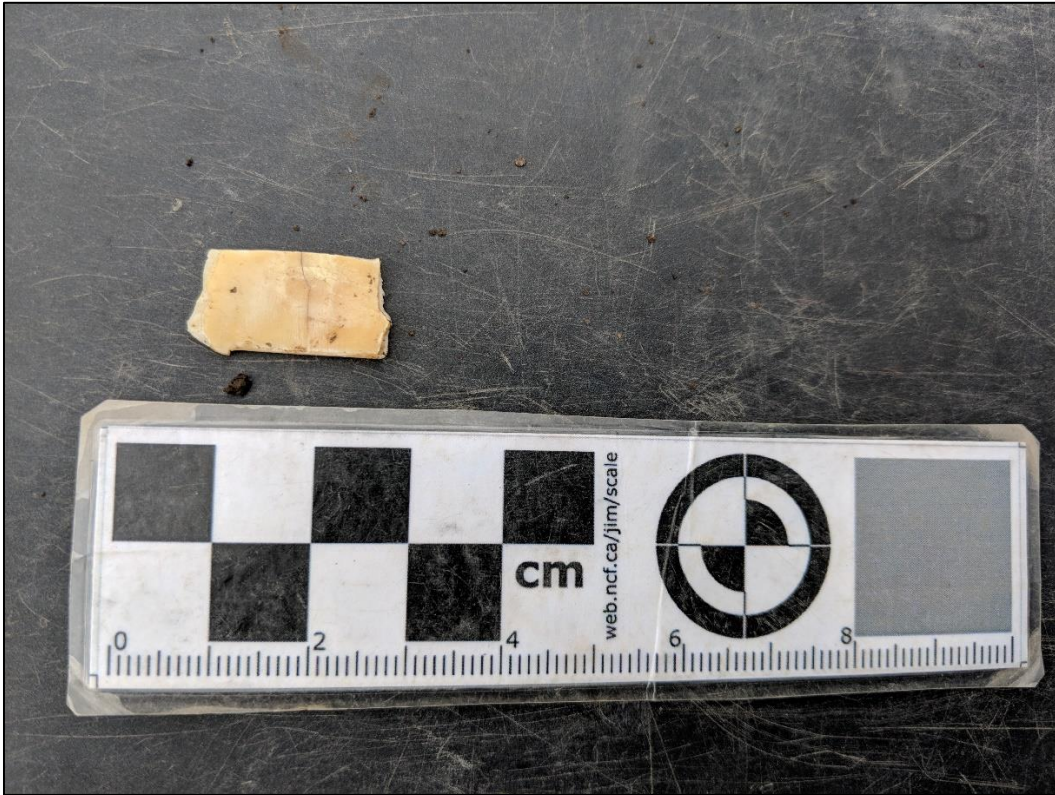
Figure 23. Site 41COL324 resin fragment. Possibly Bakelite. Pearled surface, pale yellow in color.
