## Cultural Resources Survey For The Fort Worth-Haslet-Trinity River Authority (FW-Haslet-Tra) Sewer Project

**CULTURAL RESOURCES SURVEY FOR THE  
FORT WORTH-HASLET-TRINITY RIVER AUTHORITY  
(FW-HASLET-TRA) SEWER PROJECT**

Tarrant County, Texas

Final Report  
February 2019

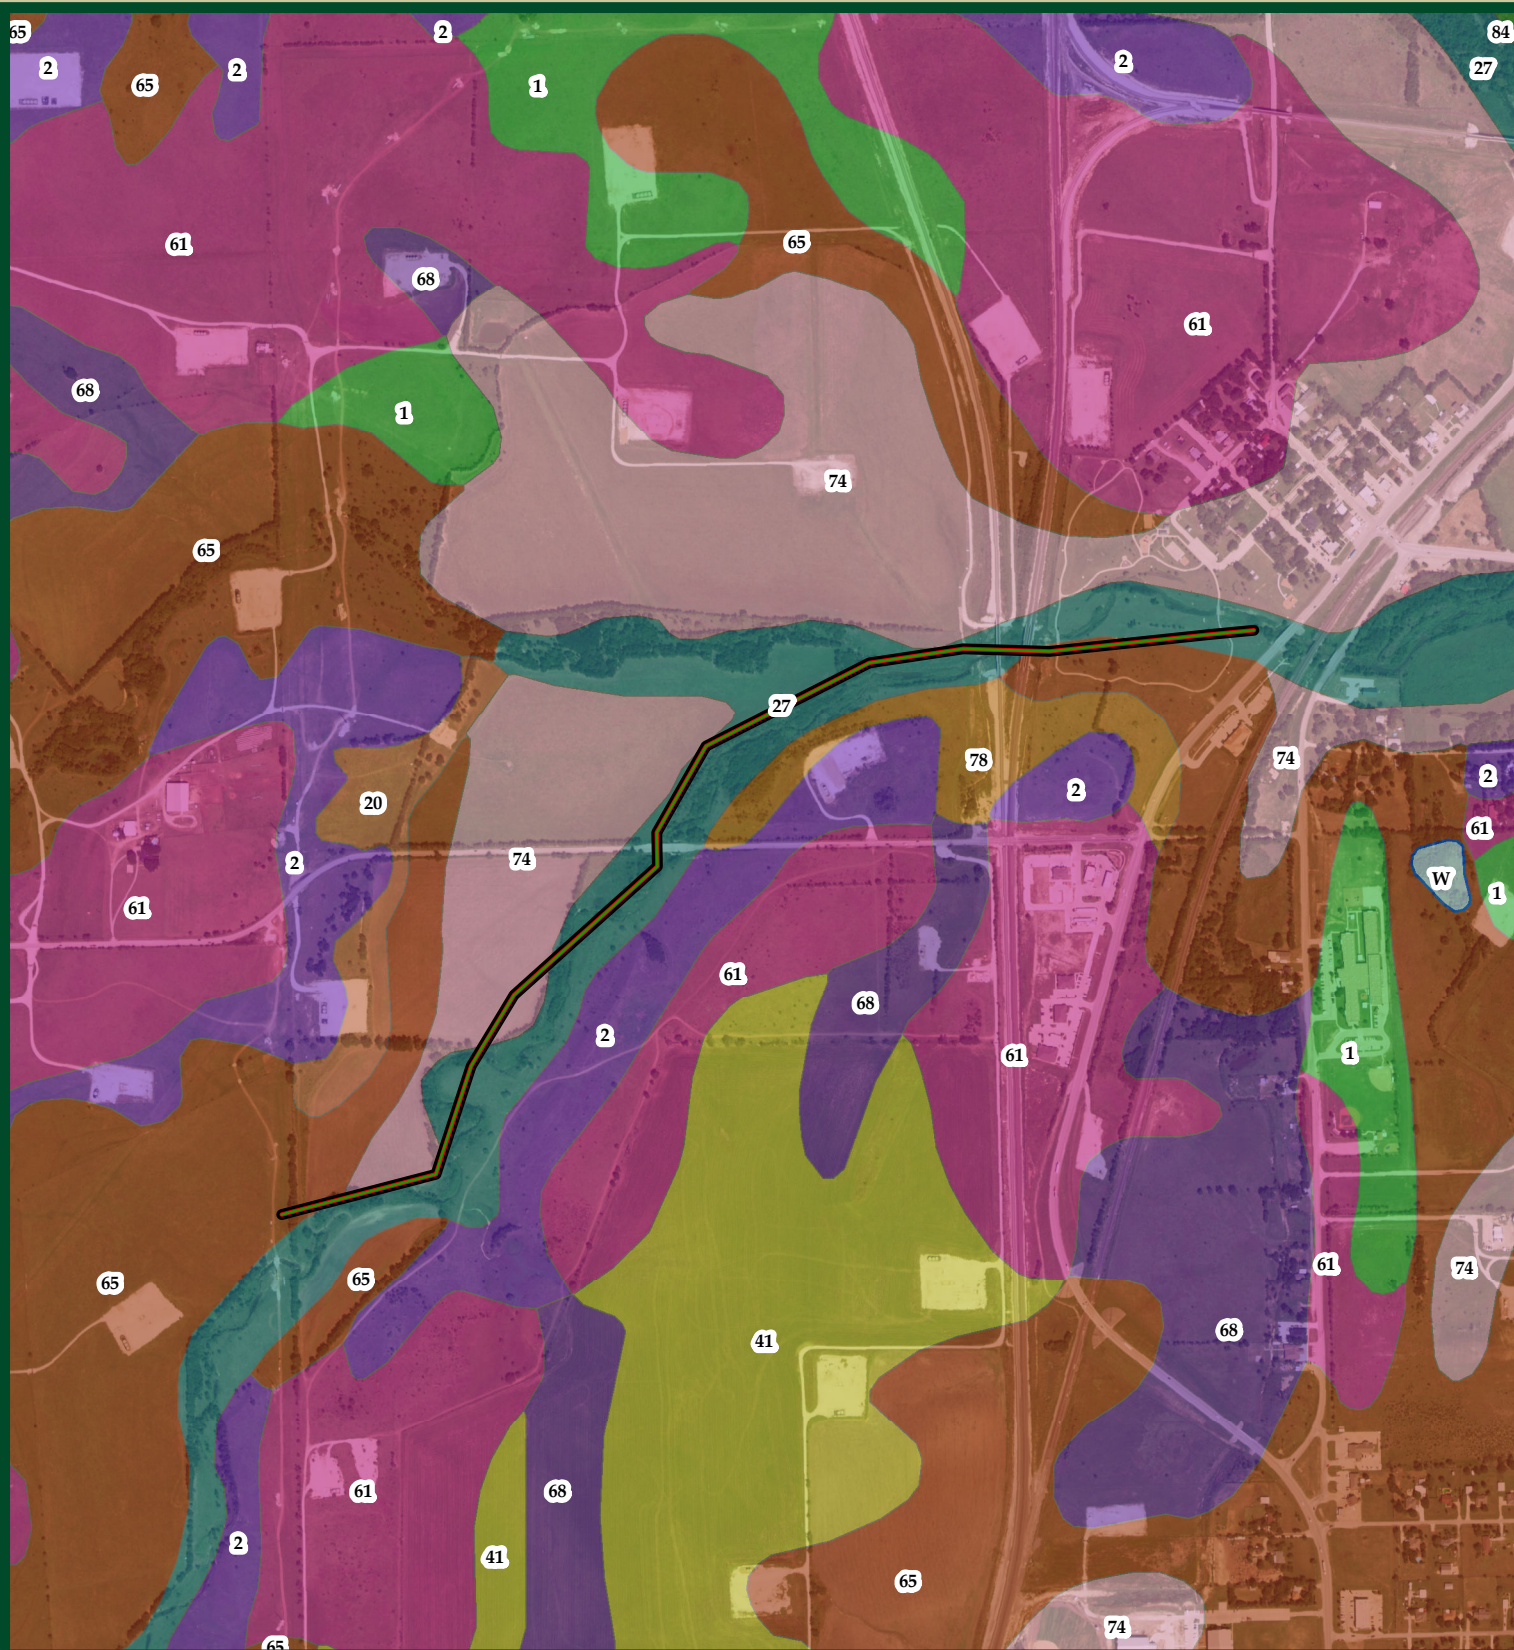
Three soil series are mapped along the APE (Figure 3). The soils are mapped as Frio silty clay, Sanger clay, and Slidell clay (NRCS 2018). While Sanger and Slidell have been previously determined to have a low probability to contain archeological sites according to the Potential Archeological Liability Maps

- *Frio silty clay, frequently flooded (27)* - The Frio series consists of very deep, well drained, moderately slowly permeable soils that formed in calcareous loamy and clayey alluvium. These nearly level to very gently sloping soils occur on flood plains.
- *Sanger clay, 1 to 3 percent slopes (65)* - The Sanger series consists of very deep, well drained, very slowly permeable soils that formed in clayey marine sediments. These gently sloping to strongly sloping soils are on broad uplands.
- *Slidell clay, 1 to 3 percent slopes (74)* - The Sanger series consists of very deep, well drained, very slowly permeable soils that formed in clayey marine sediments. These gently sloping to strongly sloping soils are on broad uplands.

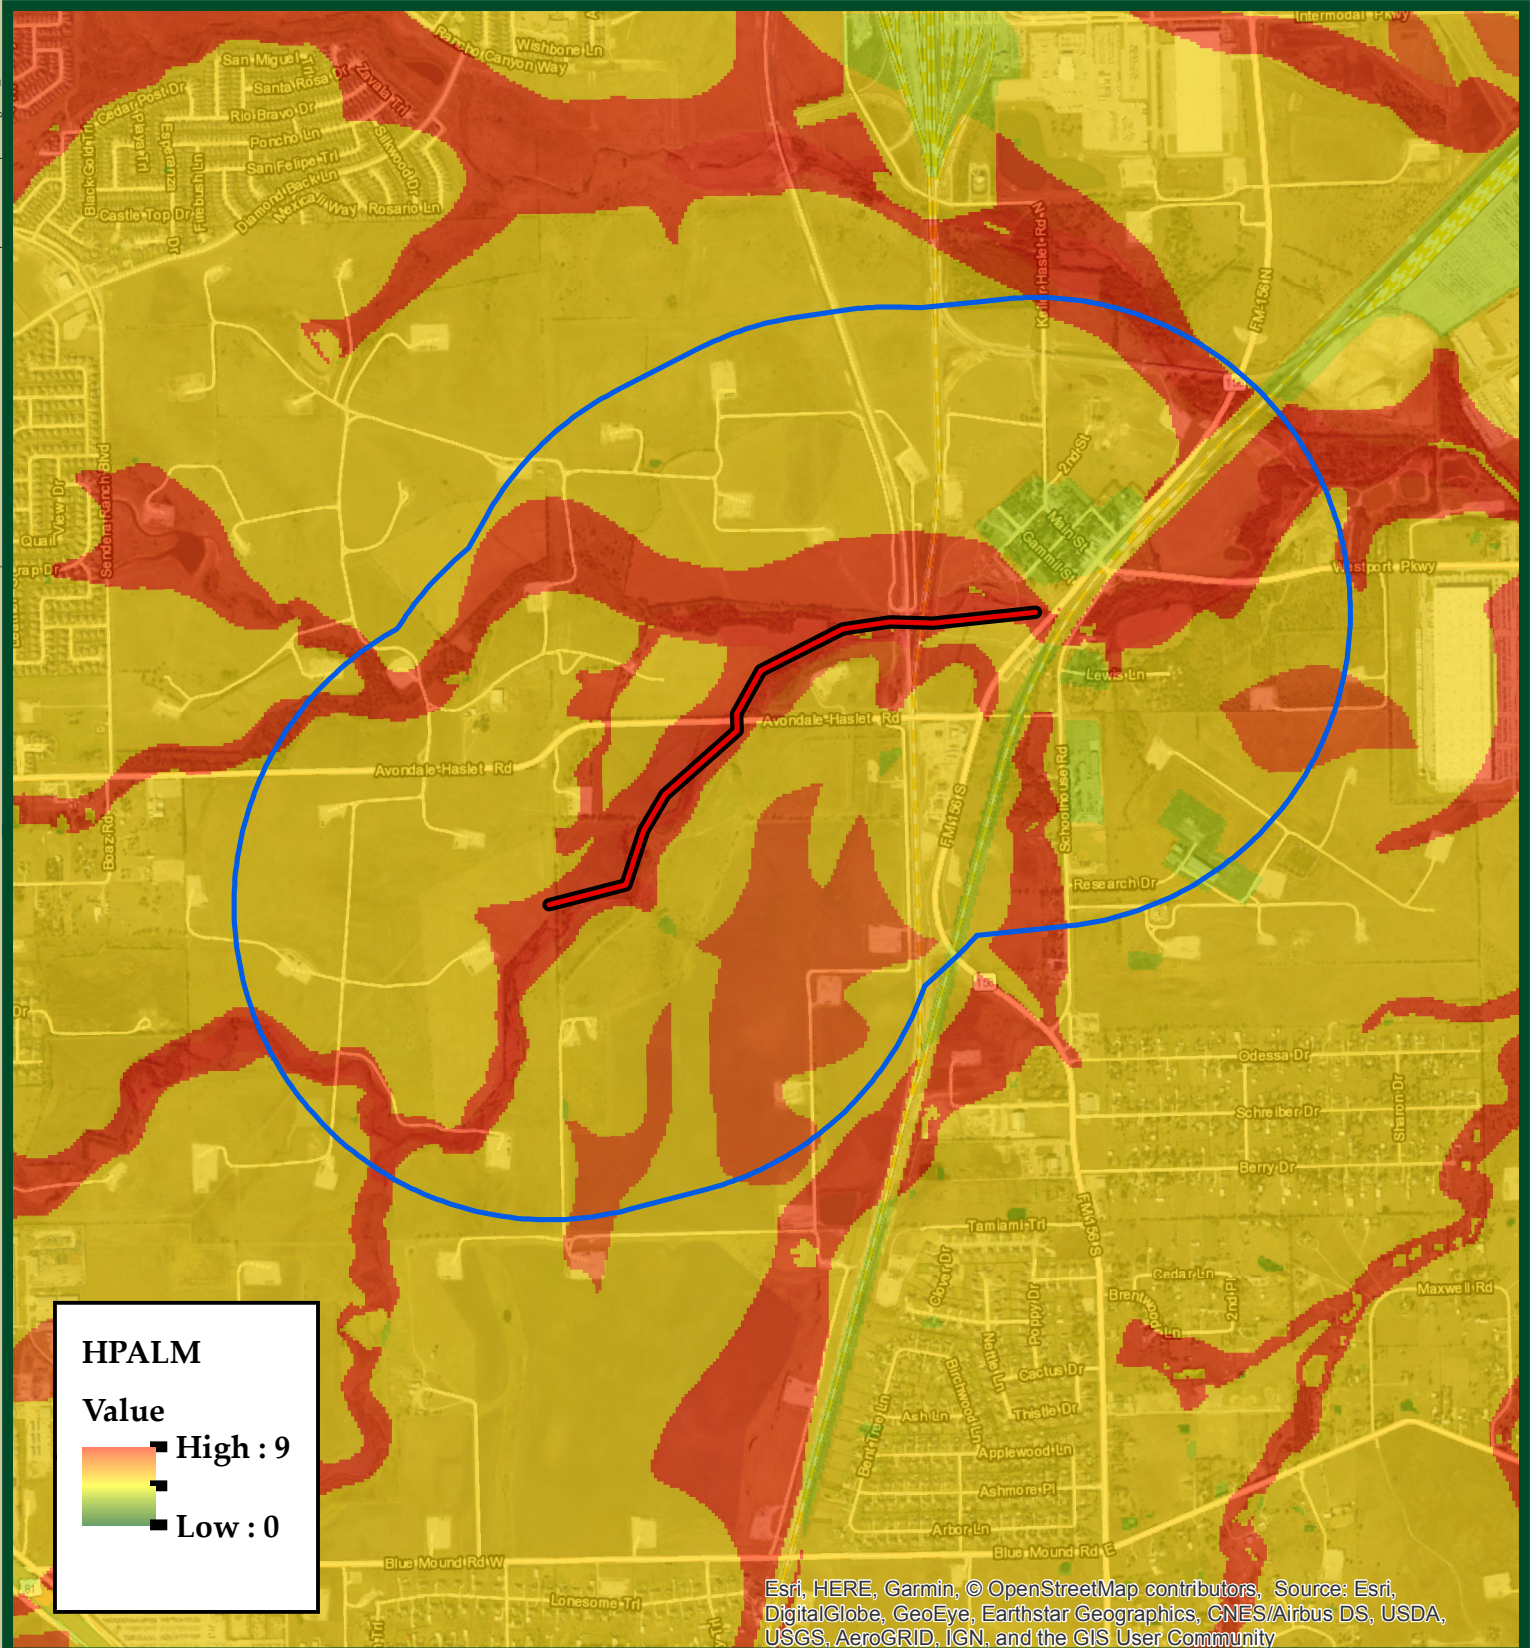
**HPALM**

According to the Fort Worth Hybrid District Potential Archeological Liability Map (HPALM), the majority of the APE has very high potential for cultural resources (Figure 4) (Abbott 2011).

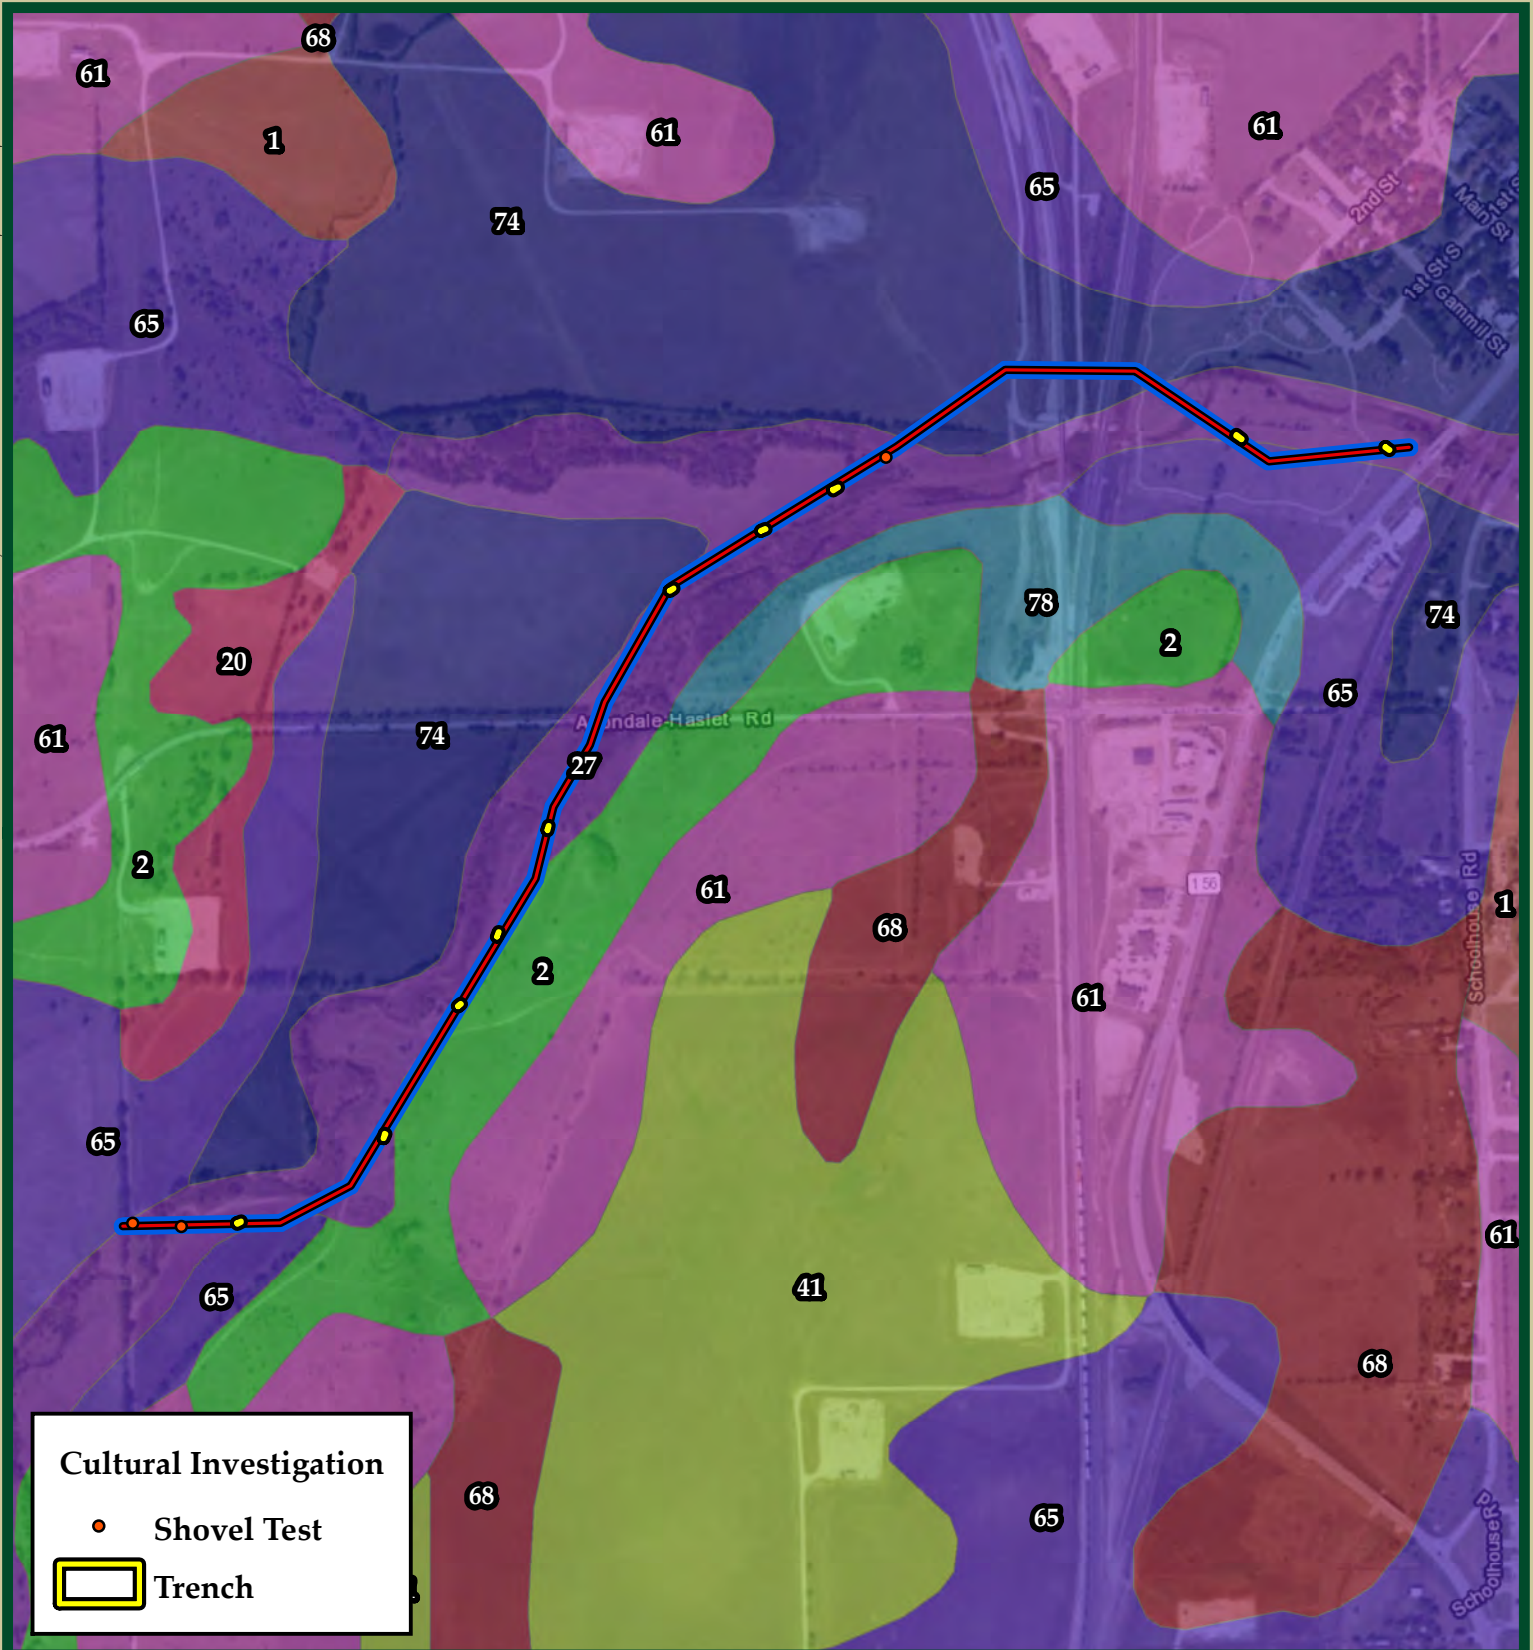
An intensive pedestrian survey of the APE was conducted along the entire 1.24-mile (2-kilometer) alignment to locate any archeological sites or other historical properties that may be within the APE (see Figures 1 and 2). The majority of the proposed project lies within high probability area in Frio soils, which are likely to contain deeply buried archeological sites. Therefore, backhoe trenches were excavated along the stream in approximately 100 meter-intervals, in accessible areas with Frio soil. Ten backhoe trenches (BHT) were excavated along the unnamed tributaries to Henrietta Creek, supplemented by three shovel tests (Figure 6).

As seen on Figure 6, five trenches were placed north of Avondale Haslet Road (two within the park and three within ranchland) and five trenches were placed south of Avondale Haslet Road (all within ranch land). One shovel test was placed north of Avondale Haslet Road north of the tributary where a backhoe could not access (see Photo 5). Two more shovel tests were placed near the southern terminus (see Photo 6). All shovel tests were negative for cultural materials. The area around the BNSF railroad tracks were not surveyed subsurface as the land was highly disturbed due to railroad construction and maintenance and due to the negative previous survey of 2009. Ground visibility for the APE was generally low due to overgrown grass.

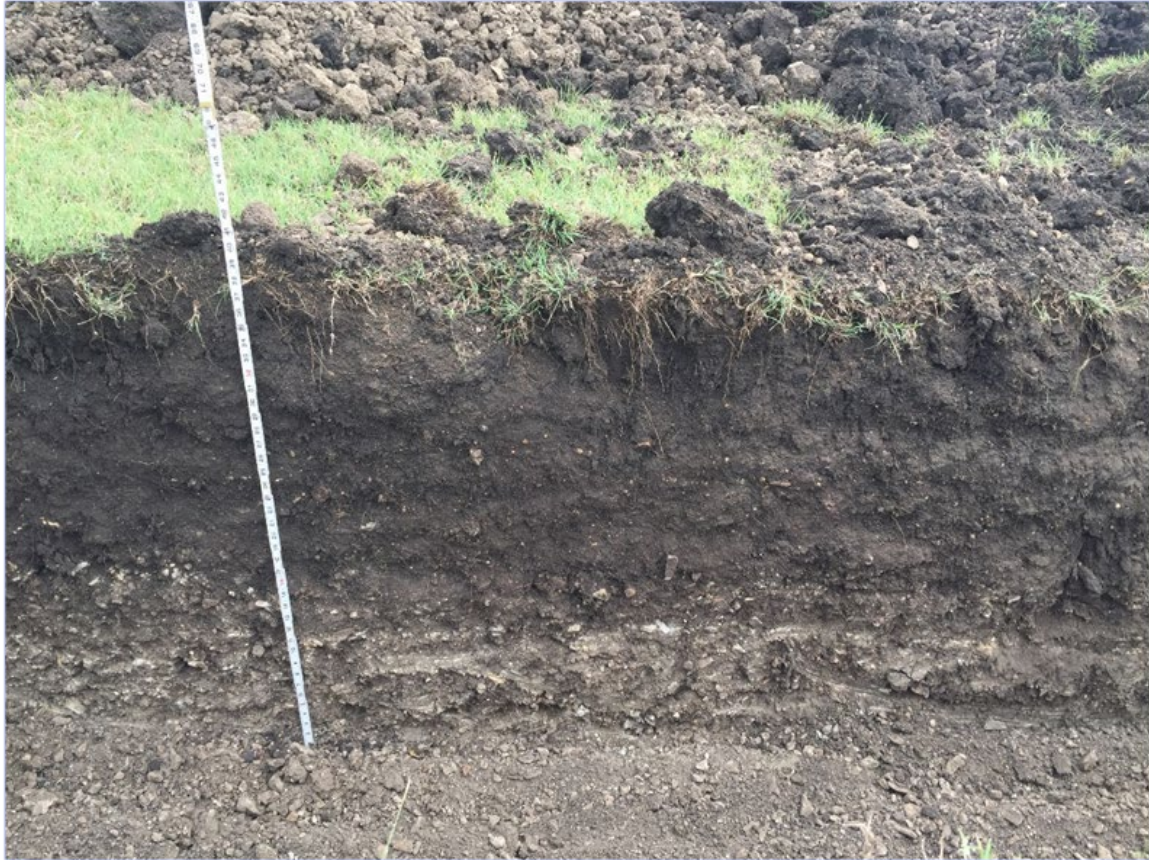
## BHT 1

Zone	Depth (cmbs)	Description – Northeast Wall
I	0-70	10YR3/1 very dark gray clay loam; clear, smooth boundary; moderate fine structure; hard, firm; moderately sticky, moderately plastic; many fine, medium, few coarse roots; A horizon.
II	70-110	10YR 6/2 light brownish gray clay; boundary unknown; moderate medium and coarse prismatic structure; hard, firm; moderately sticky, moderately plastic; few fine, medium, and coarse roots; many fine films and threads and a few soft masses of calcium carbonate; Bk horizon.

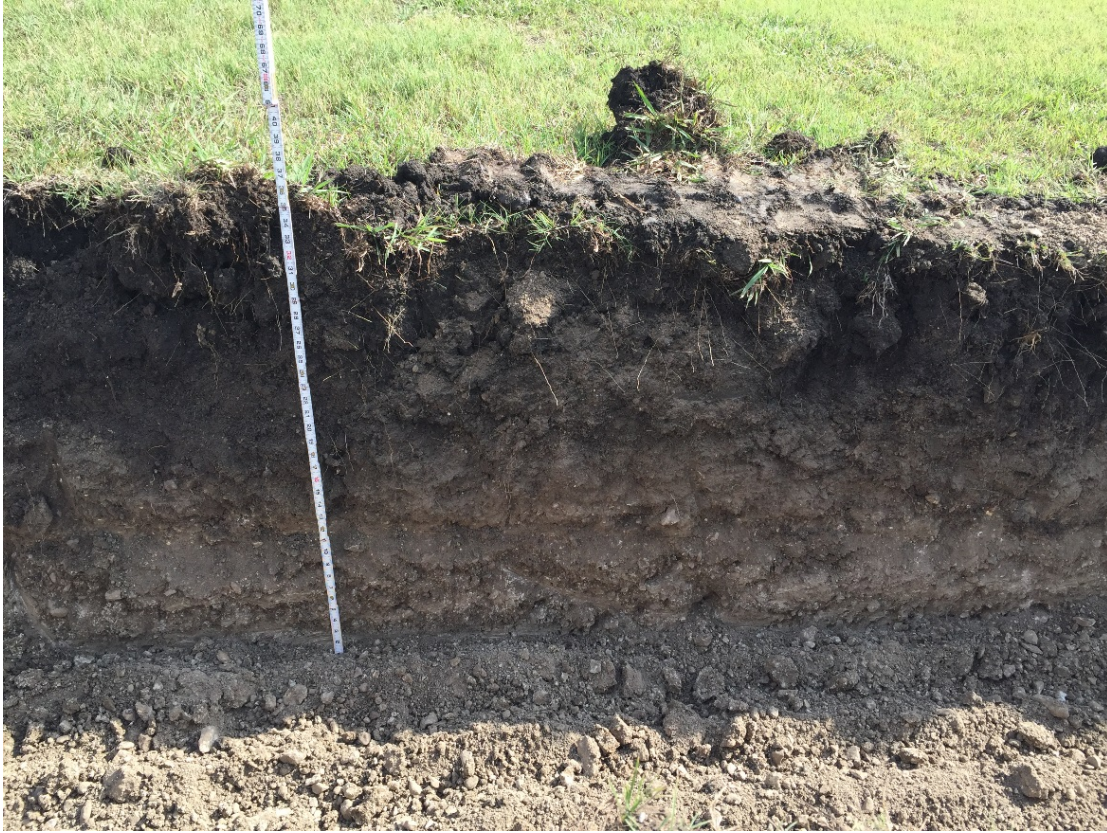
## BHT 2

Zone	Depth (cmbs)	Description – North Wall
I	0-30	10YR3/1 very dark gray clay loam; wavy boundary; moderate fine structure; hard, firm; moderately sticky, moderately plastic; many fine, medium, few coarse roots; A horizon.
II	30-100	10YR 6/2 light brownish gray clay; boundary unknown; coarse prismatic structure; hard, firm; moderately sticky, moderately plastic; few fine, medium, and coarse roots; many fine films and threads and a few soft masses of calcium carbonate; Bk horizon.

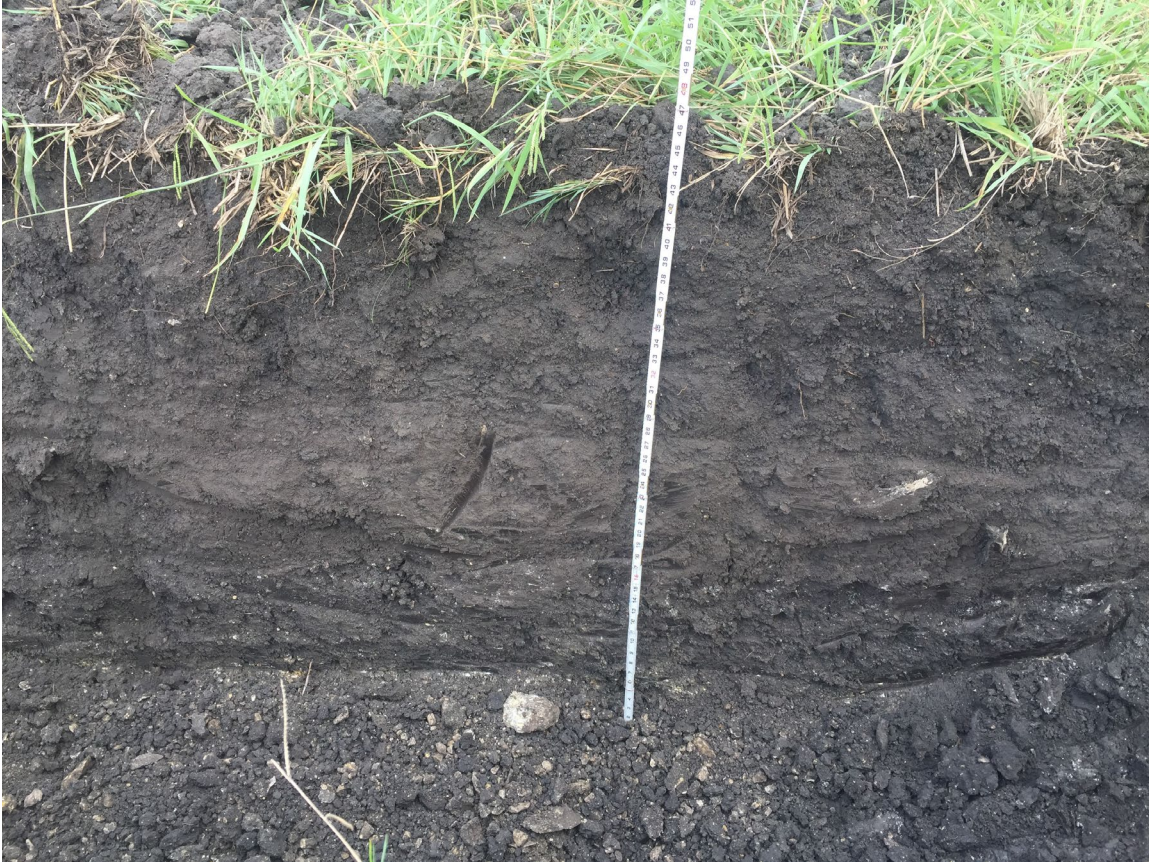
### BHT 3

Zone	Depth (cmbs)	Description – North Wall
I	0-40	10YR2/1 very dark gray clay loam; wavy boundary; moderate fine structure; hard, firm; moderately sticky, moderately plastic; many fine, medium, few coarse roots; A1 horizon.
II	40-80	10YR 3/1 very dark gray clay; wavy boundary; moderate fine structure; hard, firm; moderately sticky, moderately plastic; many fine, medium, few coarse roots; A2 horizon.
III	80-120	10YR 6/2 light brownish gray clay; boundary unknown; coarse prismatic structure; hard, firm; moderately sticky, moderately plastic; few fine, medium, and coarse roots; many fine films and threads and a few soft masses of calcium carbonate; Bk horizon.

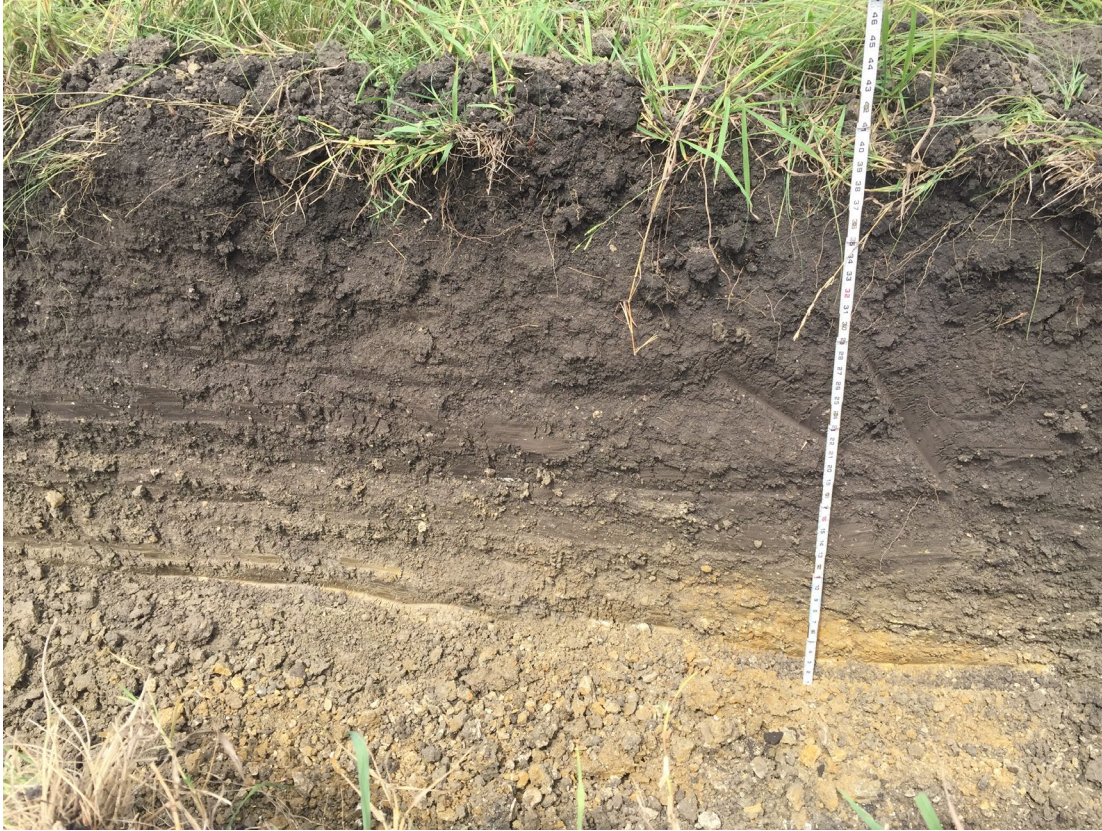
## BHT 4

Zone	Depth (cmbs)	Description – North Wall
I	0-40	10YR3/1 very dark gray clay loam; wavy boundary; moderate fine structure; hard, firm; moderately sticky, moderately plastic; many fine, medium, few coarse roots; A1 horizon.
II	40-80	10YR 6/2 light brownish gray clay; wavy boundary; moderate fine structure; hard, firm; moderately sticky, moderately plastic; many fine, medium, few coarse roots; Bk1 horizon.
III	80-120	10YR 6/2 light brownish gray clay; 10YR3/3 common distinct mottles; boundary unknown; coarse prismatic structure; hard, firm; moderately sticky, moderately plastic; few fine, medium, and coarse roots; many fine films and threads and a few soft masses of calcium carbonate; Bk2 horizon.

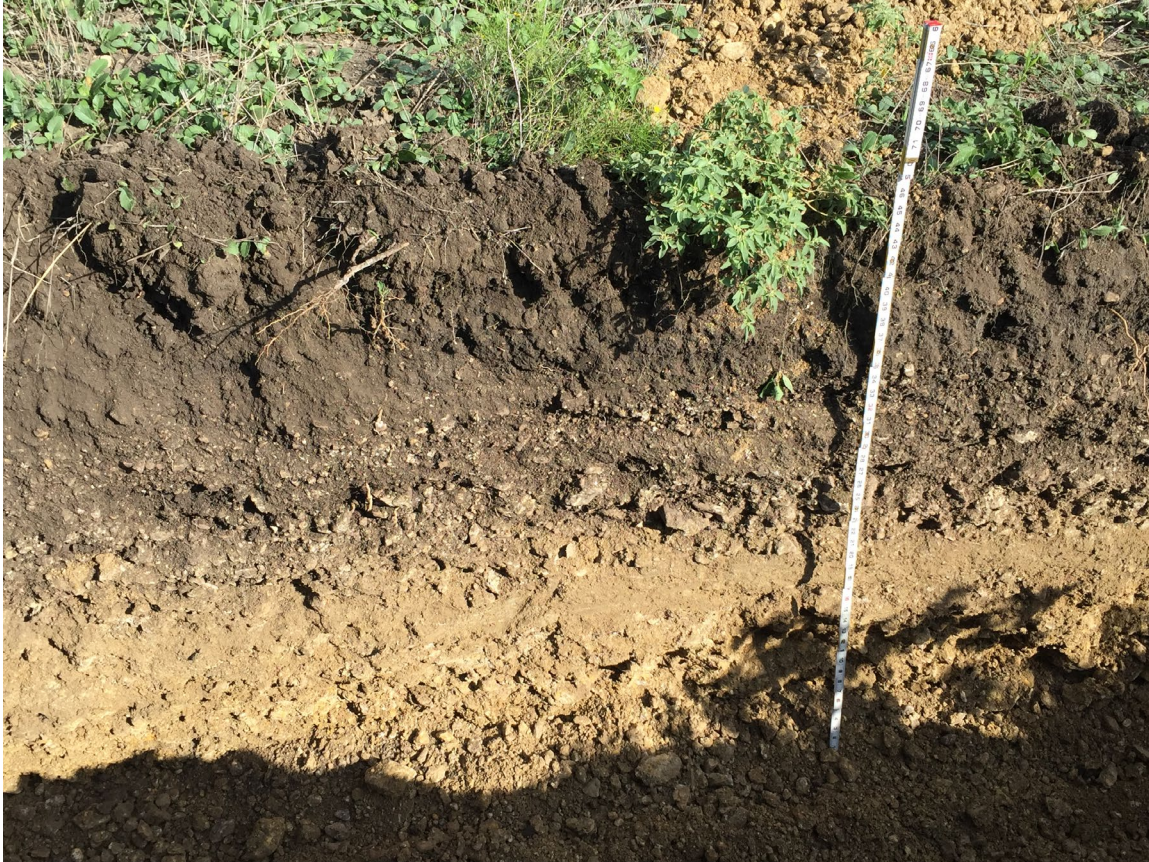
**BHT 5**

Zone	Depth (cmbs)	Description – North Wall
I	0-60	10YR2/1 very dark gray clay loam; wavy boundary; moderate fine structure; hard, firm; moderately sticky, moderately plastic; many fine, medium, few coarse roots; A1 horizon.
II	60-90	10YR 3/1 very dark gray clay; wavy boundary; moderate fine structure; hard, firm; moderately sticky, moderately plastic; many fine, medium, few coarse roots; A2 horizon.
III	90-110	10YR 5/2 grayish brown silty clay; boundary unknown; moderate medium and coarse prismatic structure parting to weak coarse blocky; hard, firm; moderately sticky, moderately plastic; few fine, medium, and coarse roots; many fine films and threads and a few soft masses of calcium carbonate; Bk horizon.

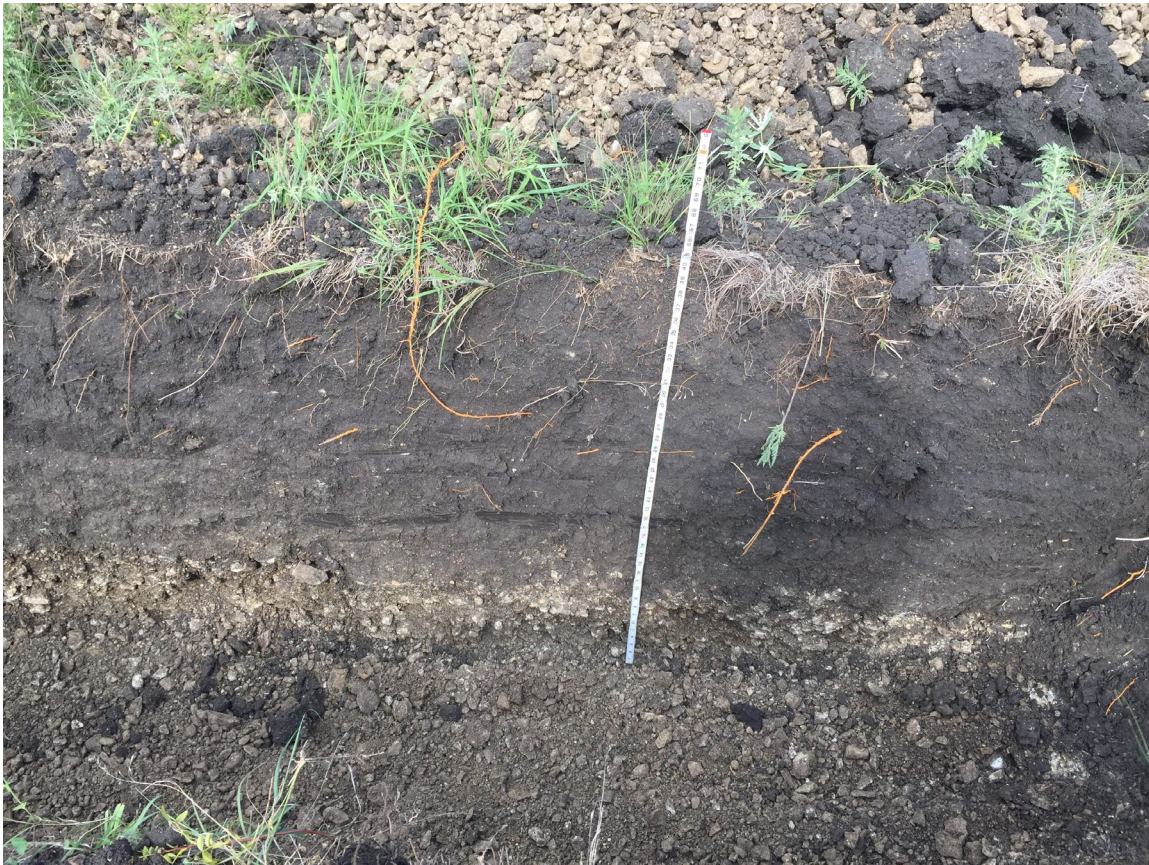
**BHT 6**

Zone	Depth (cmbs)	Description – West Wall
I	0-80	10YR2/1 very dark gray clay loam; wavy boundary; moderate fine structure; hard, firm; moderately sticky, moderately plastic; many fine, medium, few coarse roots; A horizon.
II	80-100	10YR 5/2 grayish brown silty clay; boundary unknown; moderate medium and coarse prismatic structure parting to weak coarse blocky; hard, firm; moderately sticky, moderately plastic; few fine, medium, and coarse roots; many fine films and threads and a few soft masses of calcium carbonate; Bk horizon.

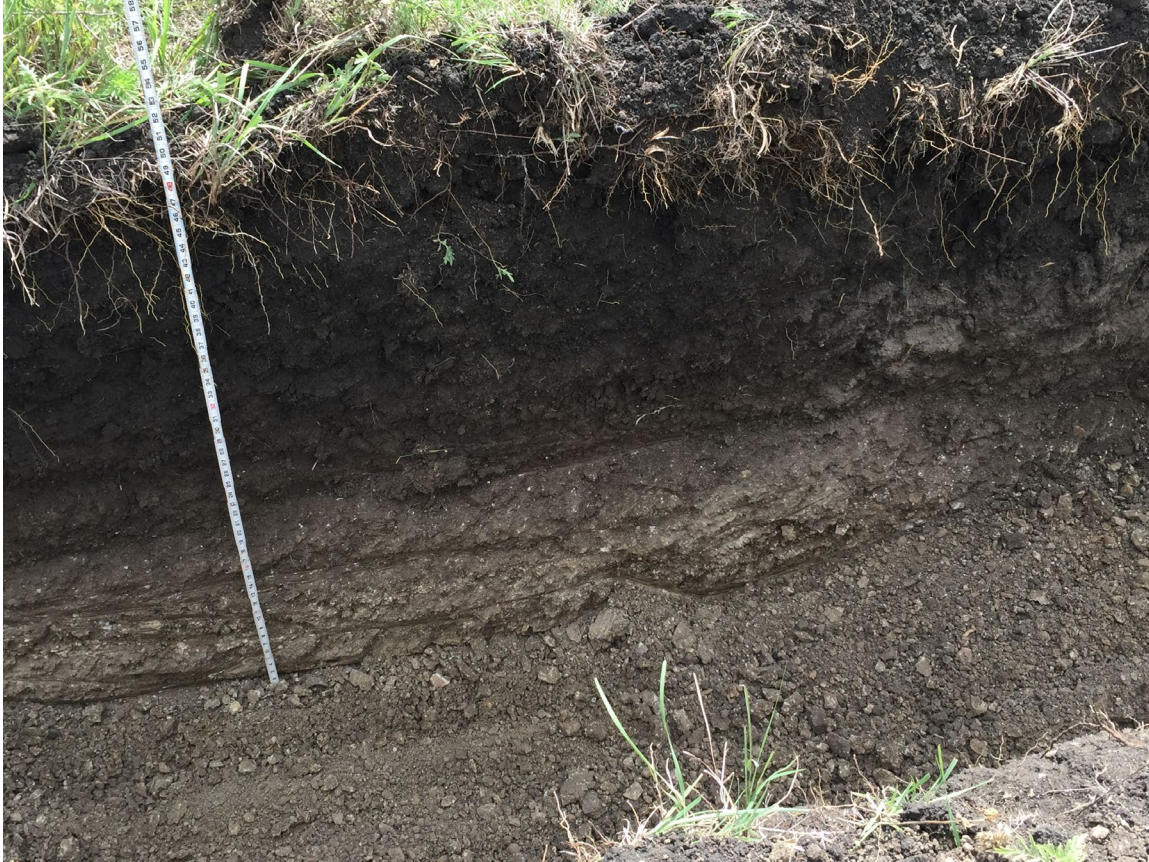
**BHT 7**

Zone	Depth (cmbs)	Description – East Wall
I	0-40	10YR2/1 very dark gray clay loam; wavy boundary; moderate fine structure; hard, firm; moderately sticky, moderately plastic; many fine, medium, few coarse roots; A1 horizon.
II	40-70	10YR 4/2 dark grayish brown clay loam; moderate medium and coarse subangular blocky structure parting to moderate fine subangular blocky; hard, firm; moderately sticky, moderately plastic; many fine, medium, and few coarse roots; moderately alkaline; clear smooth boundary; A2 horizon.
III	70-120	10YR 6/2 light brownish gray clay; boundary unknown; coarse prismatic structure; hard, firm; moderately sticky, moderately plastic; few fine, medium, and coarse roots; many fine films and threads and a few soft masses of calcium carbonate; Bk horizon.

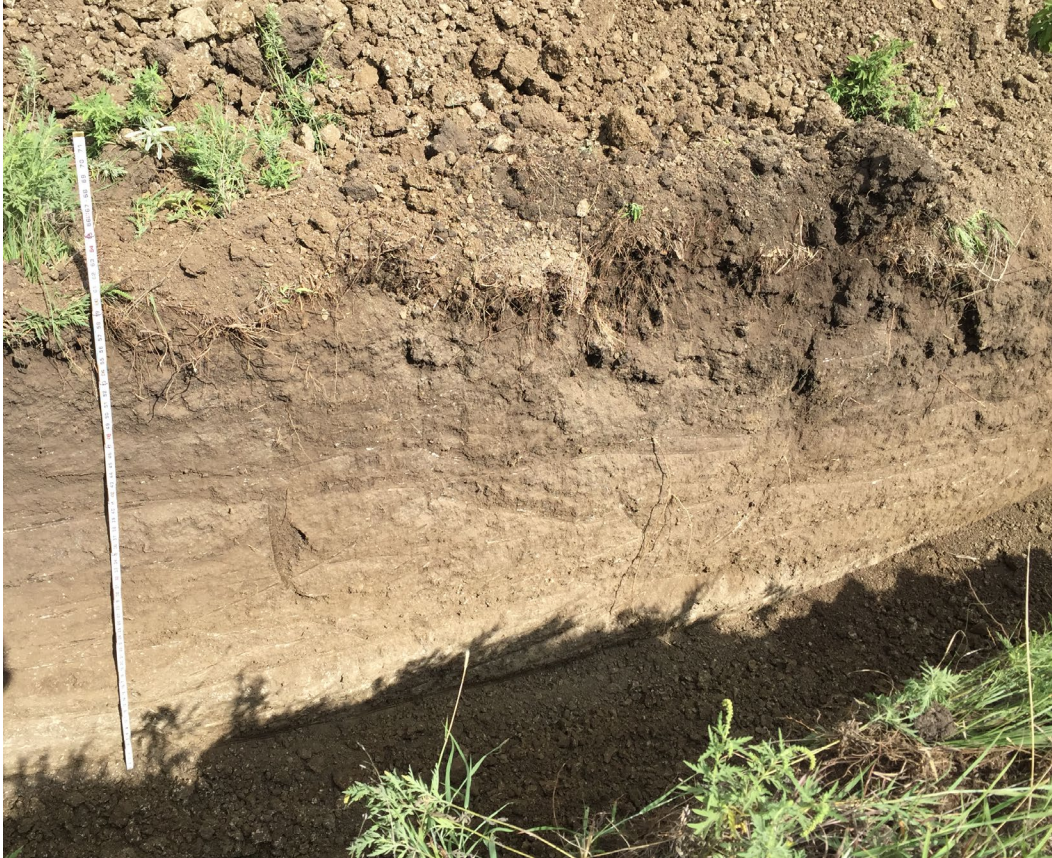
**BHT 8**

Zone	Depth (cmbs)	Description – West Wall
I	0-80	10YR2/1 very dark gray clay loam; wavy boundary; moderate fine structure; hard, firm; moderately sticky, moderately plastic; many fine, medium, few coarse roots; A1 horizon.
II	80-150	10YR 6/2 light brownish gray clay; boundary unknown; moderate medium and coarse prismatic structure; hard, firm; moderately sticky, moderately plastic; few fine, medium, and coarse roots; many fine films and threads and a few soft masses of calcium carbonate; Bk horizon.

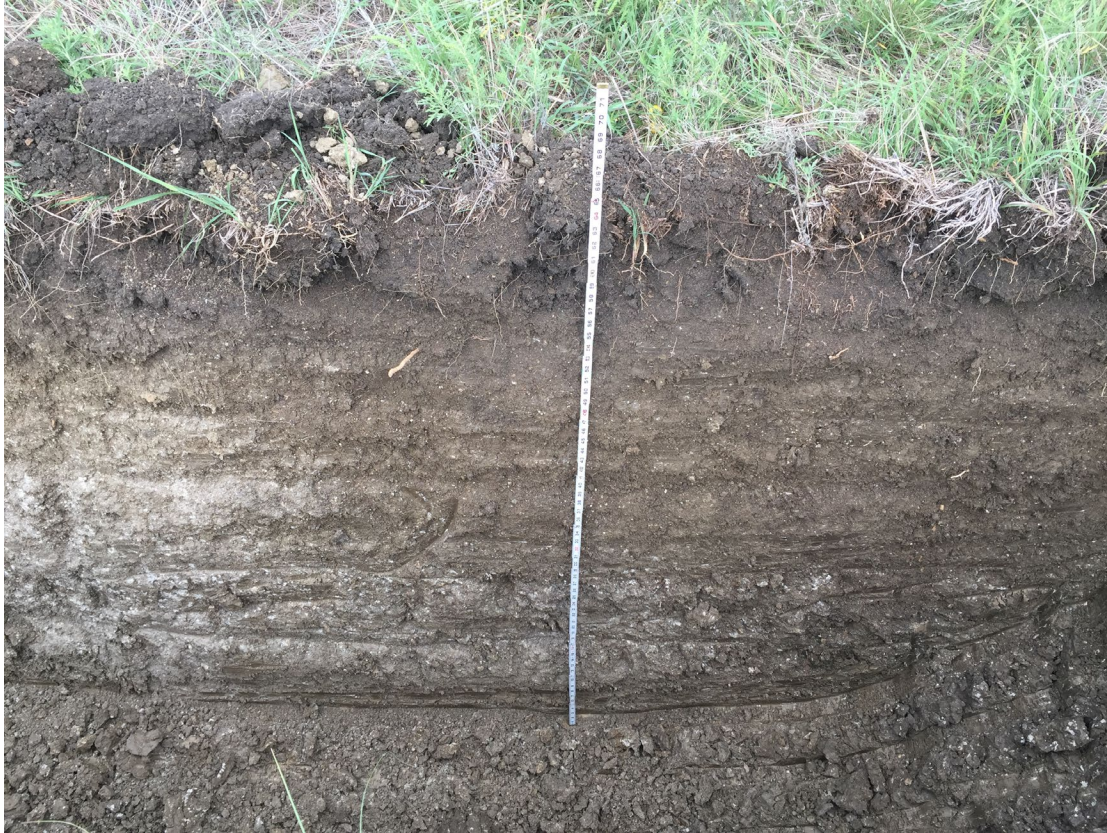
**BHT 9**

Zone	Depth (cmbs)	Description – Northwest Wall
I	0-40	10YR3/1 very dark gray clay loam; wavy boundary; moderate fine structure; hard, firm; moderately sticky, moderately plastic; many fine, medium, few coarse roots; A1 horizon.
II	40-70	10YR 4/2 dark grayish brown clay loam; moderate medium and coarse subangular blocky structure parting to moderate fine subangular blocky; hard, firm; moderately sticky, moderately plastic; many fine, medium, and few coarse roots; moderately alkaline; clear smooth boundary; A2 horizon.
III	70-120	10YR 6/2 light brownish gray clay; 10YR3/3 common distinct mottles; boundary unknown; coarse prismatic structure; hard, firm; moderately sticky, moderately plastic; few fine, medium, and coarse roots; many fine films and threads and a few soft masses of calcium carbonate; Bk2 horizon.

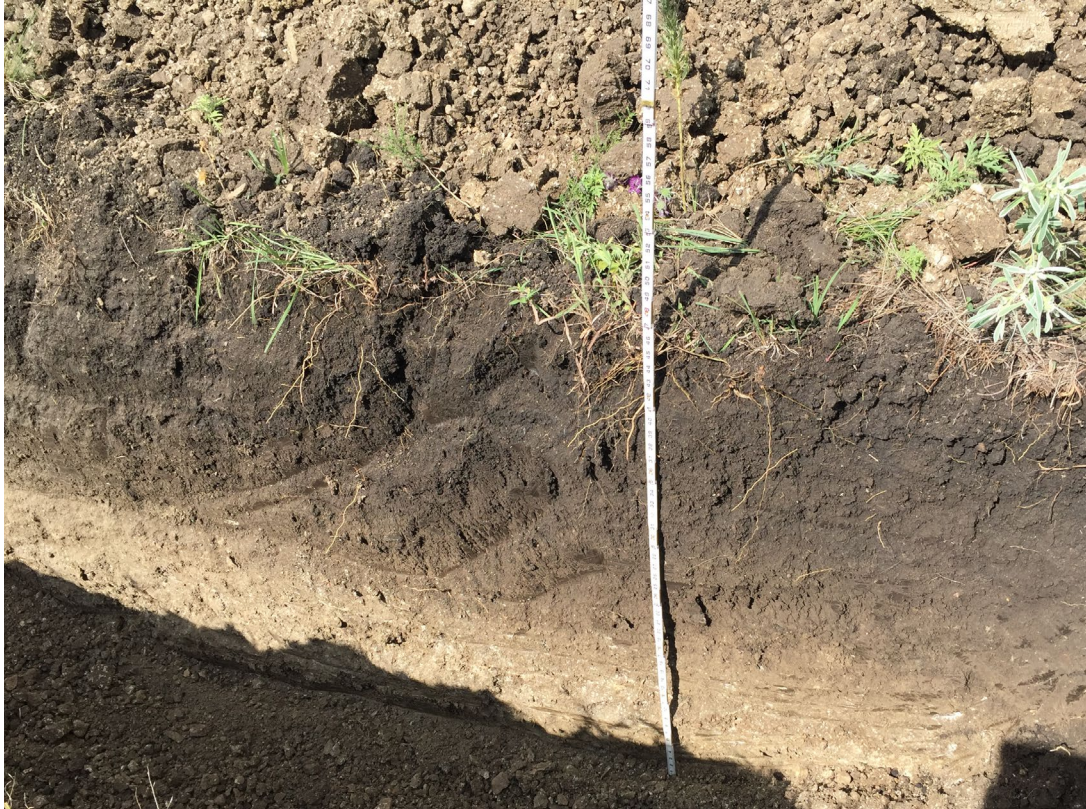
**BHT 10**

Zone	Depth (cmbs)	Description
I	0-80	10YR3/1 very dark gray clay loam; clear, smooth boundary; moderate fine structure; hard, firm; moderately sticky, moderately plastic; many fine, medium, few coarse roots; A horizon.
II	80-120	10YR 6/2 light brownish gray clay; boundary unknown; moderate medium and coarse prismatic structure; hard, firm; moderately sticky, moderately plastic; few fine, medium, and coarse roots; many fine films and threads and a few soft masses of calcium carbonate; Bk horizon.
