**AN ARCHAEOLOGICAL SURVEY AND ASSESSMENT OF THE
PROPOSED NORTH MECKLENBURG WATER TREATMENT PLANT
SITE NEAR HUNTERVILLE, MECKLENBURG COUNTY,
NORTH CAROLINA**

Technical Report No. 21

**Research Laboratories of Anthropology
University of North Carolina
Chapel Hill**

May, 1993

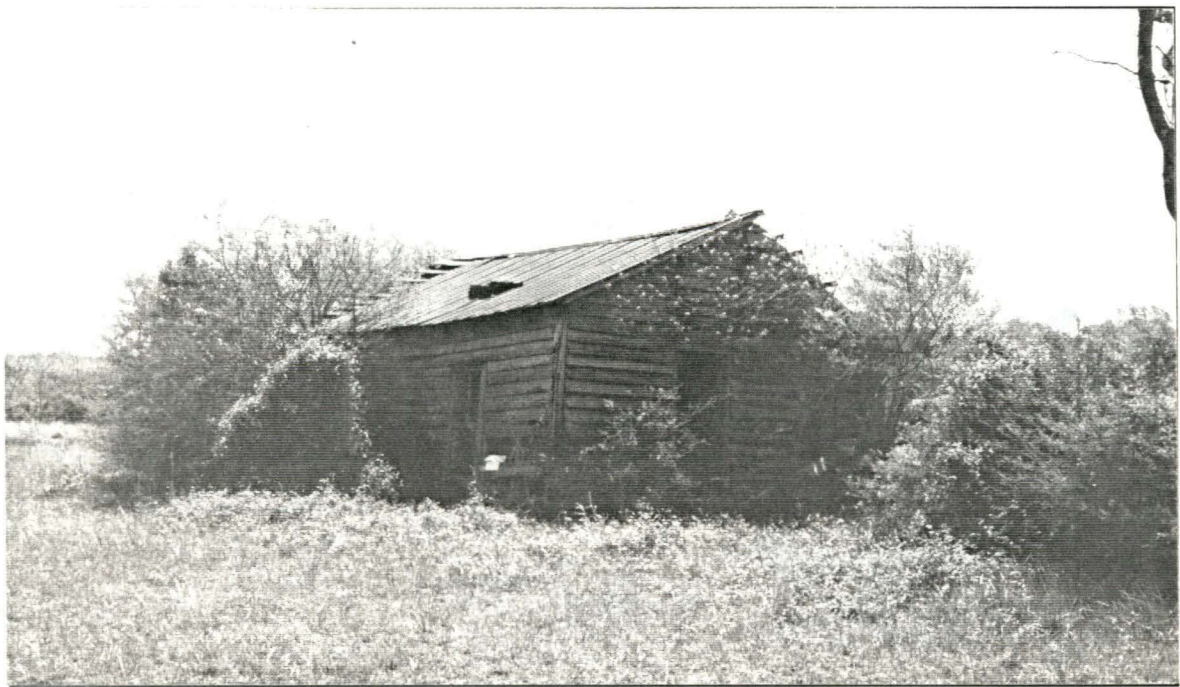
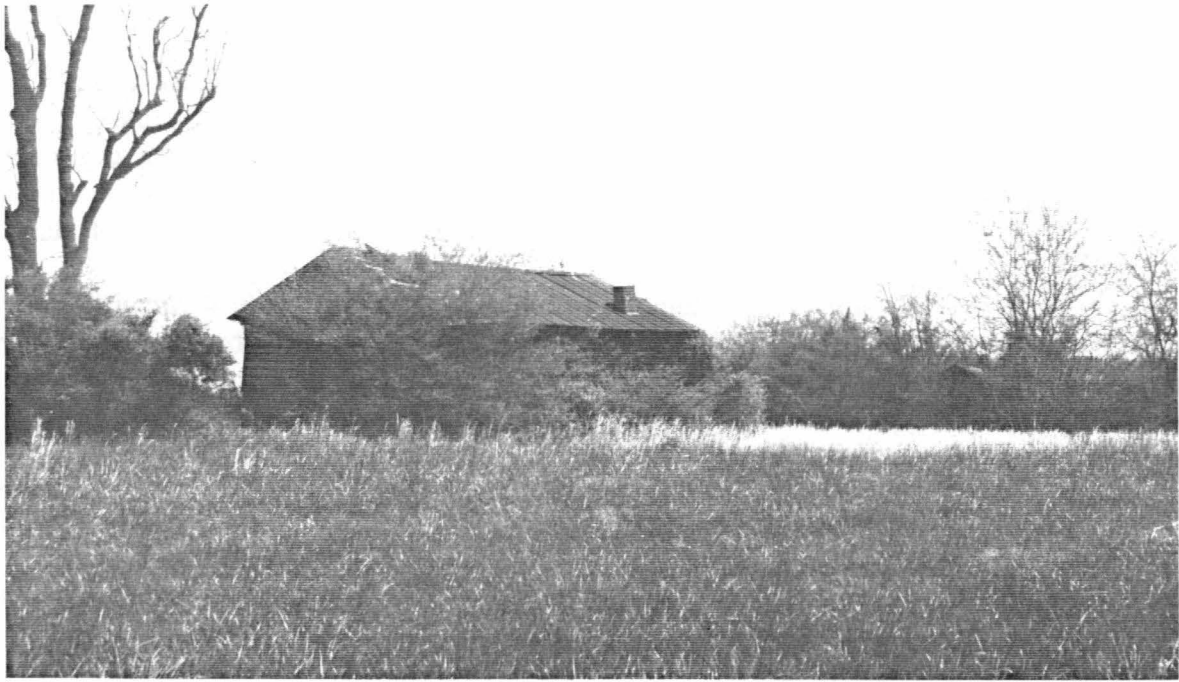
The small, frame house, designated Structure 1, measures 24 ft by 20 ft and is divided into four equal-sized (10 ft by 12 ft) rooms (Figures 6-8). Sills are circular-sawn, 4" by 6" pine timbers resting on stone piers at the corners. Studs are rough-cut, circular-sawn, 2" by 4" pine, set on 2 ft centers. Two inch by four inch diagonal braces were toe-nailed between the studs at each corner. Pine rafters measured 2" by 6" and were set on 2 ft centers. Its simple, gabled roof was decked with 1" by 4" pine and roofed with ridged tin, fastened with lead-headed roofing nails. Wire nails were used throughout.

Its exterior walls were sided with mixed pine and poplar 1" by 8" horizontal, ship-lapped planking. Windows in each room were 24" by 52" double-hung sashes with four-over-four

lights. Exterior and interior doors were 30" solid, raised-panel pine. Flooring consisted of 1" by 6" tongue-and-groove pine. Interior walls were horizontally planked with dressed, 1" by 8" pine and poplar. In some rooms, ceilings were planked with 1" by 6" tongue-and groove pine while others were planked with 1/2" by 8" poplar. Two brick chimney stacks, fitted with 6" ceramic flues, rested on the rafters and angle-iron braces. These apparently accommodated woodburning stoves or heaters.

Figure 7. Close-up view of Structure 1 at site 31Mk632 (view to south).

Figure 8. Close-up view of Structure 1 at site 31Mk632 (view to east).

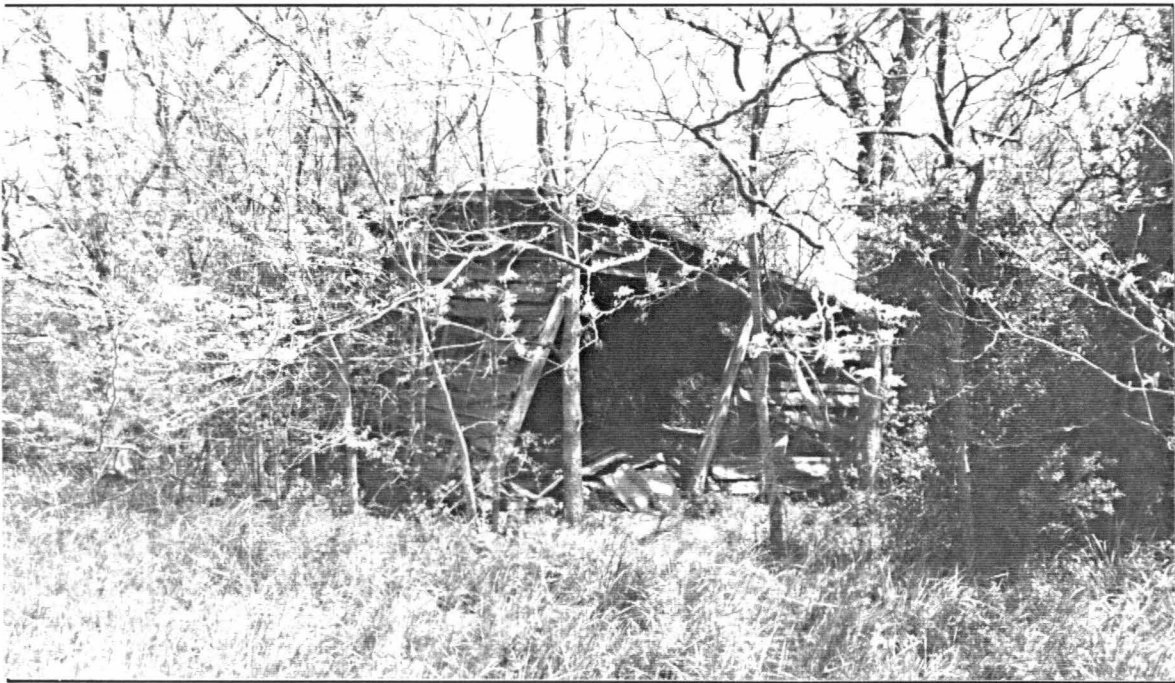
Figure 9. Close-up side view of Structure 2 at site 31Mk632 (view to east).

Structure 2 appeared to have been used as a chicken coop (Figure 9). It measured 16 ft by 14 ft and may have predated the dwelling. Its sills were hand-hewn white oak of varying dimensions and the joists were hand-hewn pine. Corner posts were 4" by 6" rough-cut pine and studs were 2" by 4" pine on 2 ft centers. The simple shed roof was decked with 1" by 4" pine and roofed with ridged tin. Salvaged, single sash (6 light) windows were set along the front wall. Wire nails were used for framing and cut nails were used for the flooring.

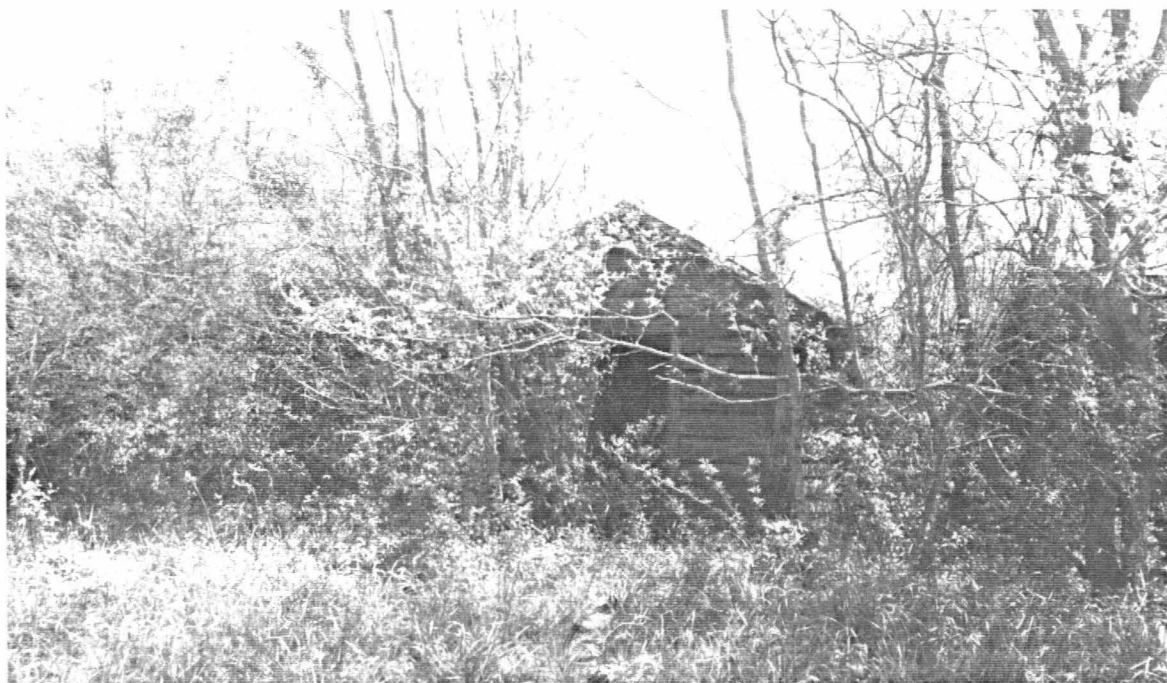
Figure 10. Close-up front view of Structure 3 at site 31Mk632 (view to southeast).

Structure 3 measured 12 ft by 12 ft and had a simple gabled roof, no windows, and no ceiling (Figure 10). It was framed like the other structures with rough-cut pine of standard dimensions and fastened with wire nails. Exterior siding was 1" by 12" pine while interior paneling of 1" by 6" pine extended from the floor up to a height of only 3 ft. This structure appears to have been use for storage.

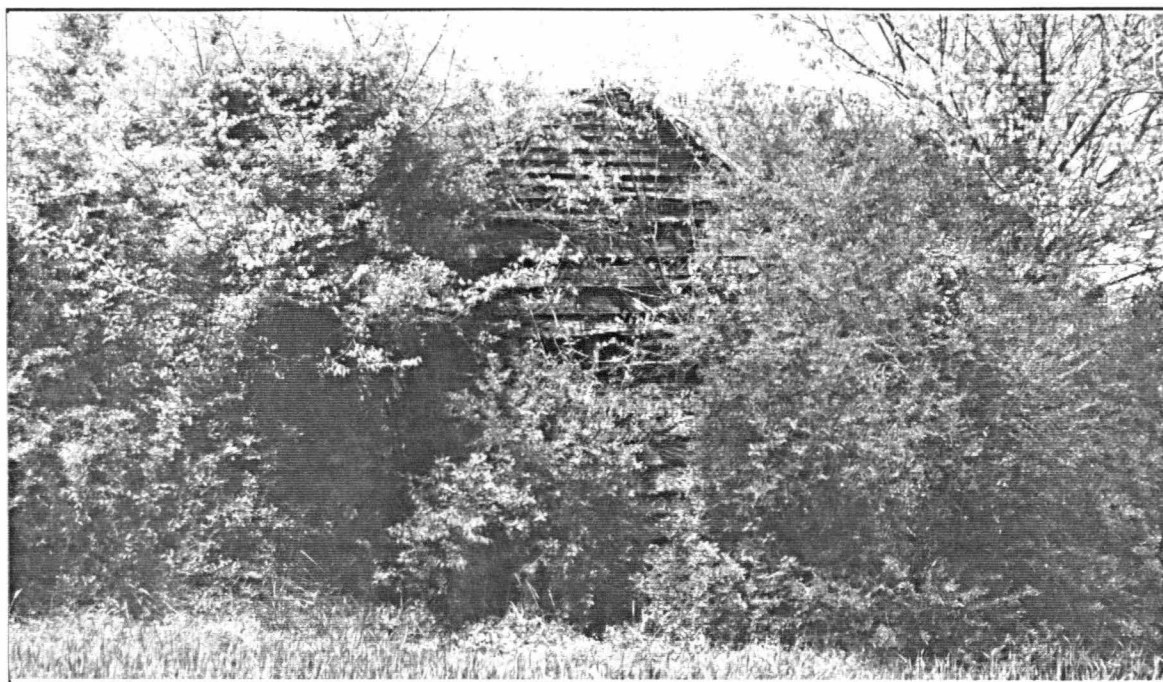
Figure 11. Close-up rear view of Structure 4 at site 31Mk632 (view to northwest).

Structure 4 was a two-story building which measured 11 ft by 20 ft (Figure 11). Its sills were 4" by 8" rough-cut pine and other framing members were also pine of standard dimensions. Interior walls were paneled up to 4 ft. There were no windows in this structure and there was no passage through the ceiling from the lower to the upper story. Doors opened to the first and second floors on the front of the building. The function of this structure is not known.
