THE JOURNAL OF  
**DIGITAL FORENSICS,  
SECURITY AND LAW**

## A FORENSIC FIRST LOOK AT A POS DEVICE: SEARCHING FOR PCI DSS DATA STORAGE VIOLATIONS

# A FORENSIC FIRST LOOK AT A POS DEVICE: SEARCHING FOR PCI DSS DATA STORAGE VIOLATIONS

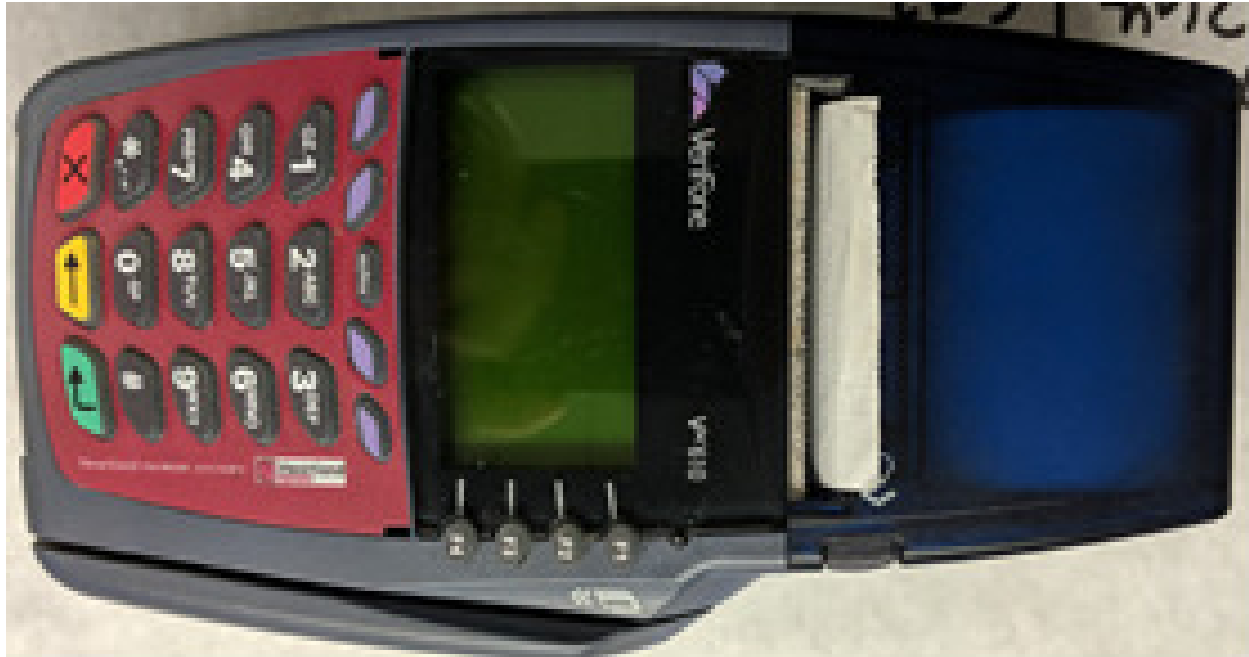
Figure 1. Verifone Vx610 POS device.

One of the authors bought three used POS devices via craigslist. All were of the Verizon brand and were Verifone models; one was an Omni Vx570 model, and two were Omni Vx610 models. These devices are the same type that the author had observed in his restaurant incident. The two Vx610 devices were owned by a catering company (food truck) whose owner said they only connected to process transactions in the evening. The Vx570 model was owned by a bakery. One of the Verifone Vx610 models used for this examination is shown in Figure 1.

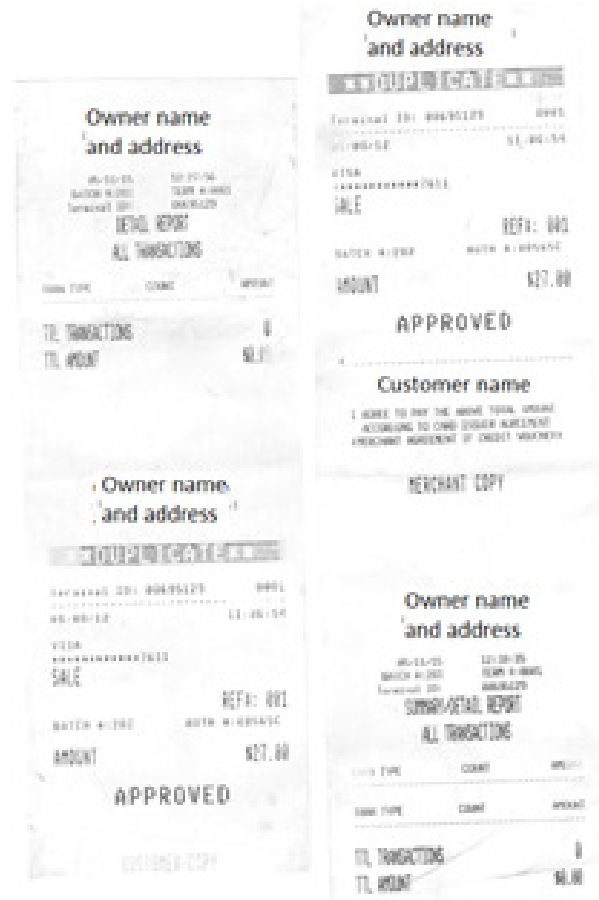
Figure 2. Last Transaction Report.

It was decided to power up one device and see if any data could be extracted from it. The data extraction began with powering on the Vx570 device and printing the last transaction. The printout began with a summary/detail report of transactions, which included the device owner's name, address, and phone number, followed by the information on the last batch processed (date, time, batch#, terminal ID, list of transactions, their dollar amount, and total). This was followed by two printouts of the last transaction (customer copy and merchant copy), which included:

- Device owner, address, and phone number
- Terminal ID #
- Transaction date & time
- Credit card type & last 4 digits of the credit card number
- Transaction amount
- Credit card owner name
- Transaction approved/not approved
- Batch #
- Authorization number

These transaction copies were followed again by a summary and detailed report of transactions as shown in Figure 2.

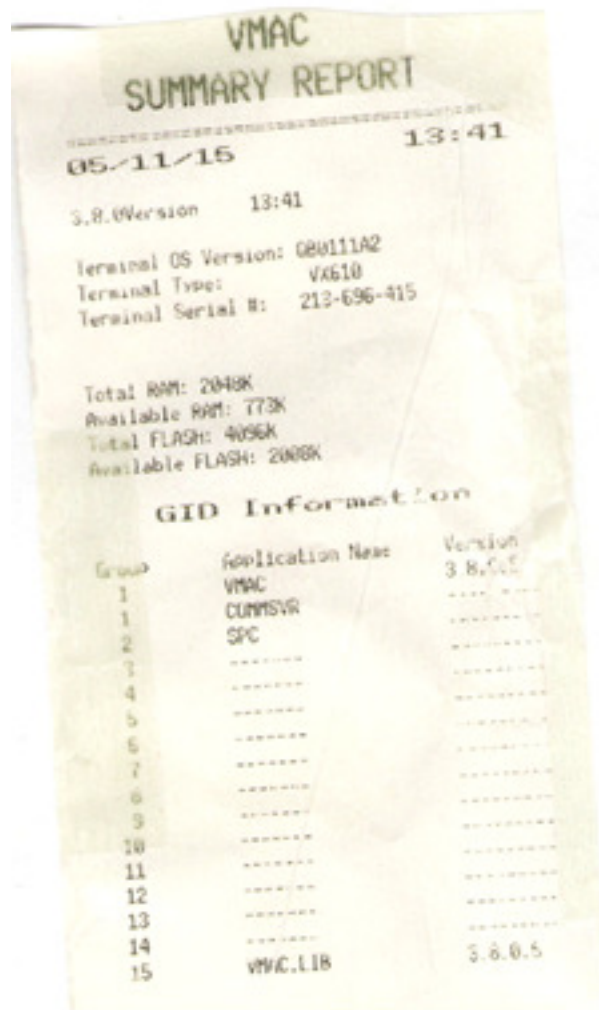
Figure 3. VMAC Summary Report.

Additionally, on one of the Vx610 devices, a Verix Multi-Application Conductor (VMAC) Summary Report was printed, which contained information about the terminal: the OS version, the terminal type, the terminal serial number, RAM, FLASH memory, and GID information (see VMAC Summary Report in Figure 3).

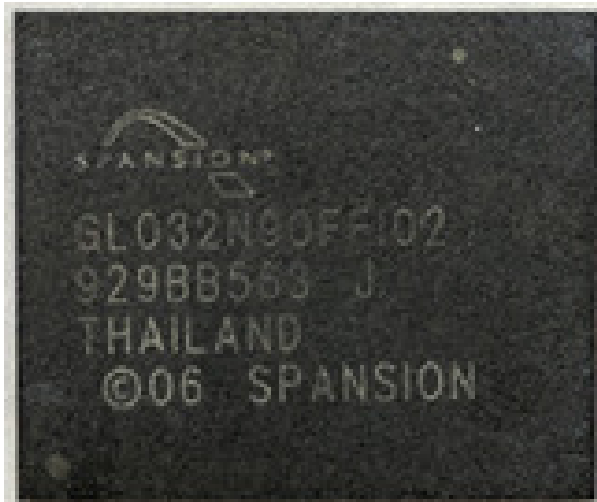
Figure 5. Flash Memory Chip.

The devices each had a 4MB flash memory chip (Figure 5), and the extraction effort supplied both raw chip-off images as well as a copy where the byte order was reversed (RBO2). Data were extracted from both Vx610 devices.
