Tractor Accessorized Zerriest Series II (TAZ II)

Capabilities Demonstration

September 10-11 and October 2-3, 2001

Night Vision & Electronic Sensors Directorate (NVESD)
DoD Humanitarian Demining Research & Development Program

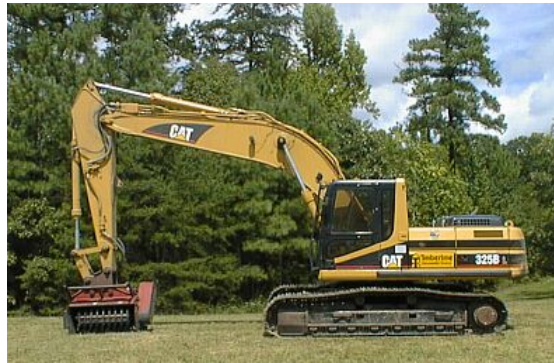
Graphic 1 – TAZ II

The TAZ II is a large tracked Caterpillar Corporation vehicle (325B L Excavator) with a specialized vegetation cutting attachment developed by Timberline Environmental Services. See graphic 1. Timberline Environmental Services has been involved in vegetation clearance for nearly 23 years, supporting both civilian and military organizations. Military support missions have dealt primarily with unexploded ordnance (UXO). By utilizing the Caterpillar base carrier, the TAZ II System has the worldwide product support of the Caterpillar Corporation. The system is capable of masticating all vegetation ranging from light grasses to large trees, as well as excavating the ground. For demining purposes, this tool could be used in conjunction with other tools (rakes, magnets, rollers, etc.) to clear large areas of vegetation, allowing deminers and dogs to completely clear the area and perform quality assurance. The TAZ II is not currently armored or remote controlled to provide safety to operators, but could conceivably be modified to have these capabilities.

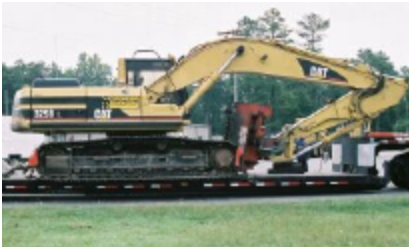
Graphic 6 – TAZII on trailer

The TAZ II was transported to the test site on a “low-boy” trailer in one piece as seen in graphic 6, below, therefore, assembly of the system prior to operations was not required. TAZ II was driven off of the trailer and with a quick pre-operations check the system was ready for operations. The TAZ II is transportable by truck, rail or vessel. However, due to its weight and width, many restrictions are imposed on its truck transport in the U.S. This is an issue that must be considered in relation to demining efforts in third world countries that have poor road and bridge infrastructure. A support package could easily be moved in a standard 20 or 40-foot ISO container, depending on the contents of the package. The system is a rugged tracked system and is mobile in most conditions, but very steep hills, slopes or rocky conditions would affect its maneuverability.

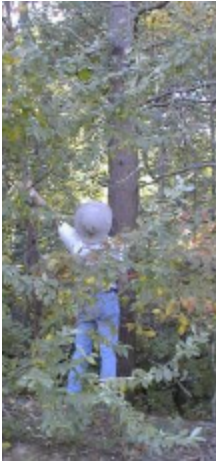
Graphic 22 – Pine Tree
.31m in diameter

Tree Cutting: TAZ II masticated four trees of varying hardness and height. Graphics 21-28 on the next page are pictures of the trees before and after they were cut. All of the trees' tops were cut off as high up as possible and then the remaining trunks were mulched down to the ground. The treetops were not mulched up. The amount of time that TAZ II took to cut off the top and mulched up the trunk was recorded for each tree. Table 2, below, displayed the tree type and dimensions, and the time the TAZ II took to cut down the trees.

Tree/hardness	Height (~)	Diameter	Time (min:sec)	Comments
Pine/soft wood	18.5m	.31m	4:50	The wood was splintered into chards.
Poplar/medium hard wood	33.8m	.31m	8:00	TAZ II shredded the tree to chips/dust. TAZ II cut the tree with the cutting head perpendicular to the tree and had to stop cutting a dozen times to build up rpm's.
Oak/ hard wood	30.8m	.38m	6:00	The cutter head was at a 45° angle and did not require stopping to build up the rpm. The tree was shredded to chips/dust.
Pine/ soft wood	7.7m	.21m	0:59	TAZ II quickly reduced the tree to splintered mulch almost in one motion.

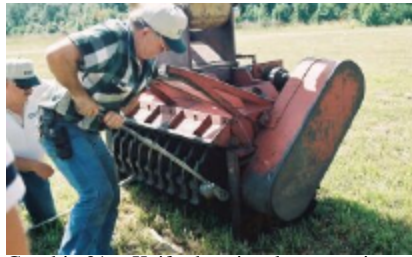
Graphic 31 – Knife changing demonstration

The special cutting head does not have a technical manual or parts manual to determine level of effort to support it, however, most of the parts for the cutting head are repairable or are considered consumable. It is assumed that simple servicing of cutting knife (blade), cutting disc and bearing repair/replacement would be required, as a minimum. Because of the proprietary hydraulic and electrical configuration used to run the cutter head, Timberline would require one of their mechanics to install the cutter head system onto the Caterpillar vehicle. Most general maintenance can be done on the cutter head with one or two people. Timberline demonstrated that two people could change a cutting knife in 6 minutes as shown below in graphic 31. The following tools were used during the knife changing demonstration: a sledge hammer, a large socket wrench, a pry bar, a solid round stock, and a small mallet. The tools are shown in graphic 32 below.
