## Stream Bank and Bar Erosion Contributions and Land Use Influence on Suspended Sediment Loads in Two Ozark Watersheds, Southeast Missouri

A Master's Thesis

Master of Science, Geospatial Sciences in Geography

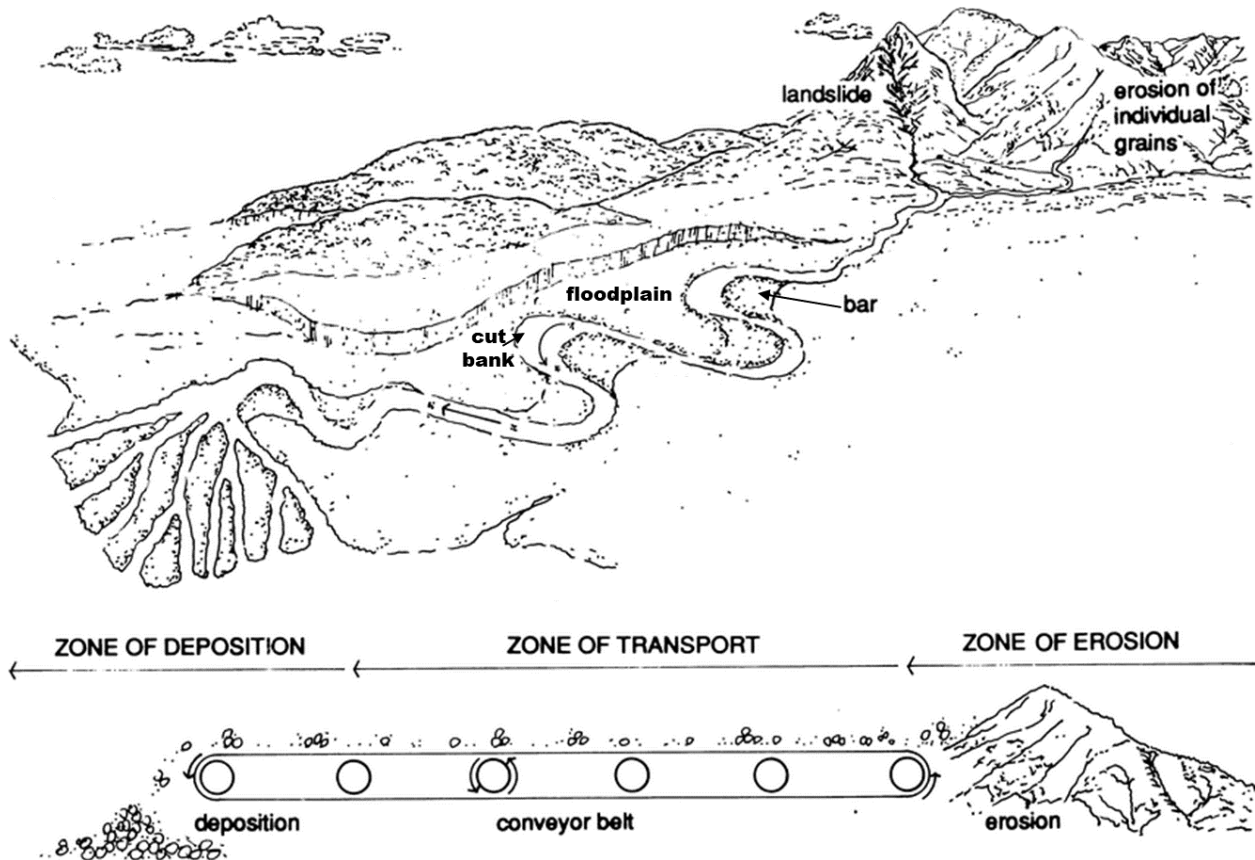
Figure 1. Model of sediment storage and remobilization within the channel (Kondolf, 1997).

The total gravel bar area was digitized in the 1995 and 2015 aerial photographs, while the active channel was used to determine if the active channel was widening or laterally moving in a cut-bank point to bar formation (Kondolf, 1997). Examples of the spatial distribution of erosion and deposition using polygons are shown in Figures 16 and 17. Typically, both erosion and deposition for banks and bars were observed in spatially similar locations (Joyce et al., 2018).

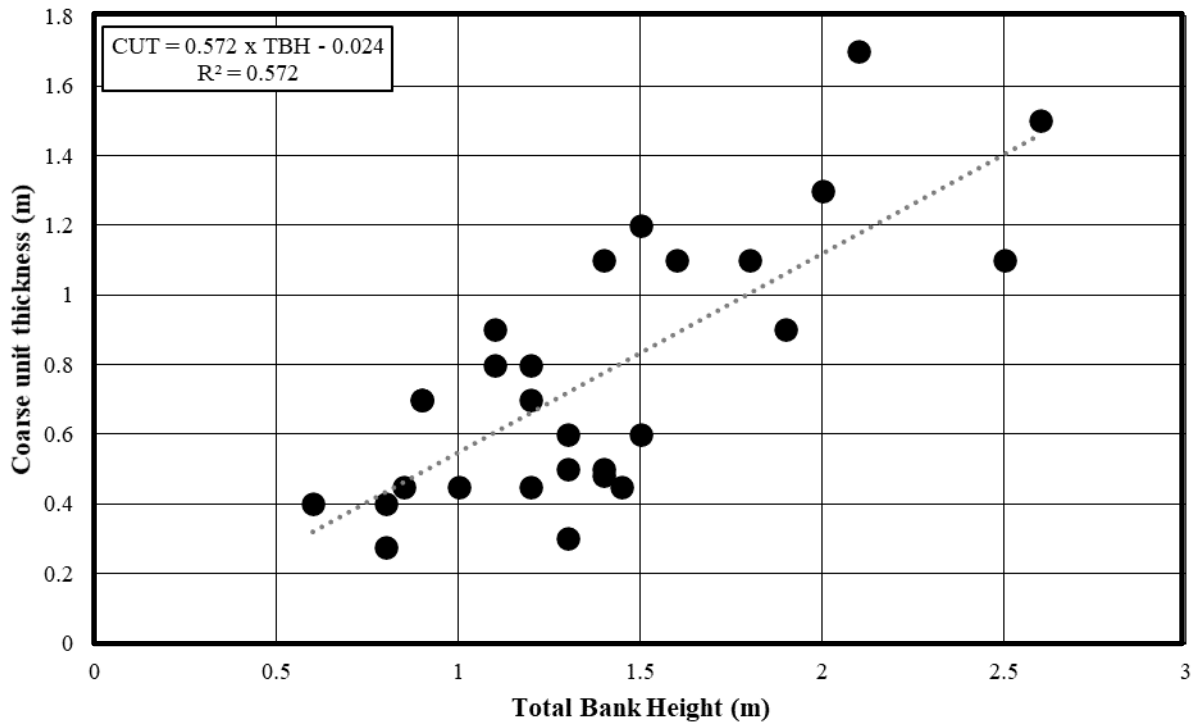
Figure 7. Coarse unit thickness in bank deposits.

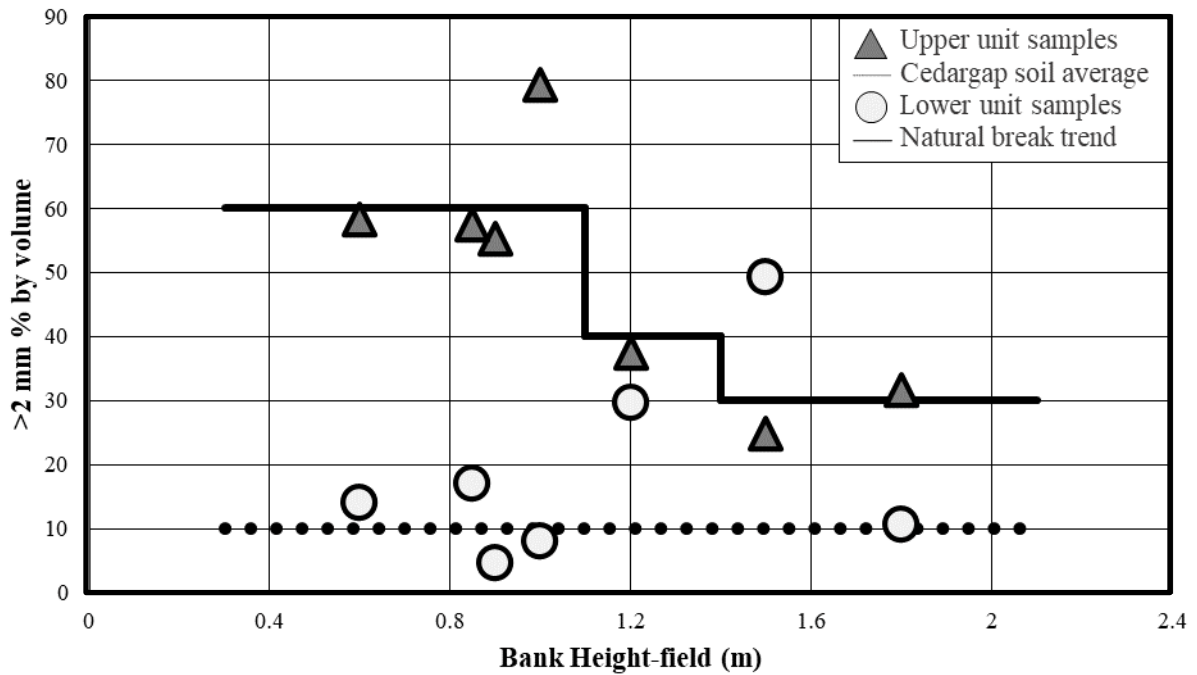
Figure 8. Texture of bank deposits.

In contrast to the upper unit, the lower bank unit tends to become finer with increasing bank height (Figure 8). Again, no trend was found with stream order, however, the sample size was small. In the study area, banks with lower heights tend to be formed in geomorphic settings associated with coarser sediment: (i) gravelly bench deposits where fine sediment is beginning to bury coarse bar deposits to form young floodplains as shown by the Relfe soil series; and (ii) gravelly floodplain deposits located along smaller and steeper channels where coarse sediment transport and deposition is more frequent as shown by the Cedargap and Bloomsdale soils series (Skaer and Cook, 2005). In contrast, higher banks tend occur in geomorphic settings associated with finer-grained deposits: (i) floodplains along larger streams with lower slopes and wider valley floors that deposit more silt and sand as shown by the Kaintuck and Haymond soil series; and (ii) higher terraces along smaller streams as shown by the Higdon soil series (Skaer and Cook, 2005). A linear regression equation was not appropriate for predicting textural characteristics of lower bank units since deposits with similar textures were clustered according to geomorphic features with discrete characteristics, not those grading into one another. Thus, a step-function was used to classify lower unit texture according natural breaks with bank height as

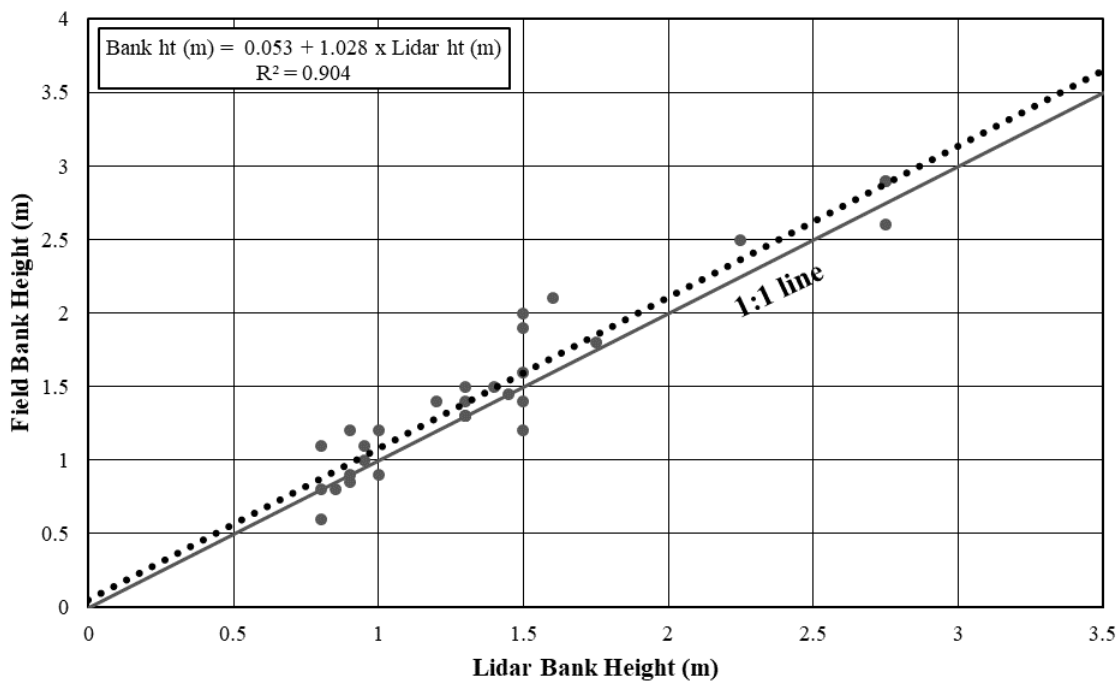
Figure 11. Comparison of LiDAR bank height to field bank height.

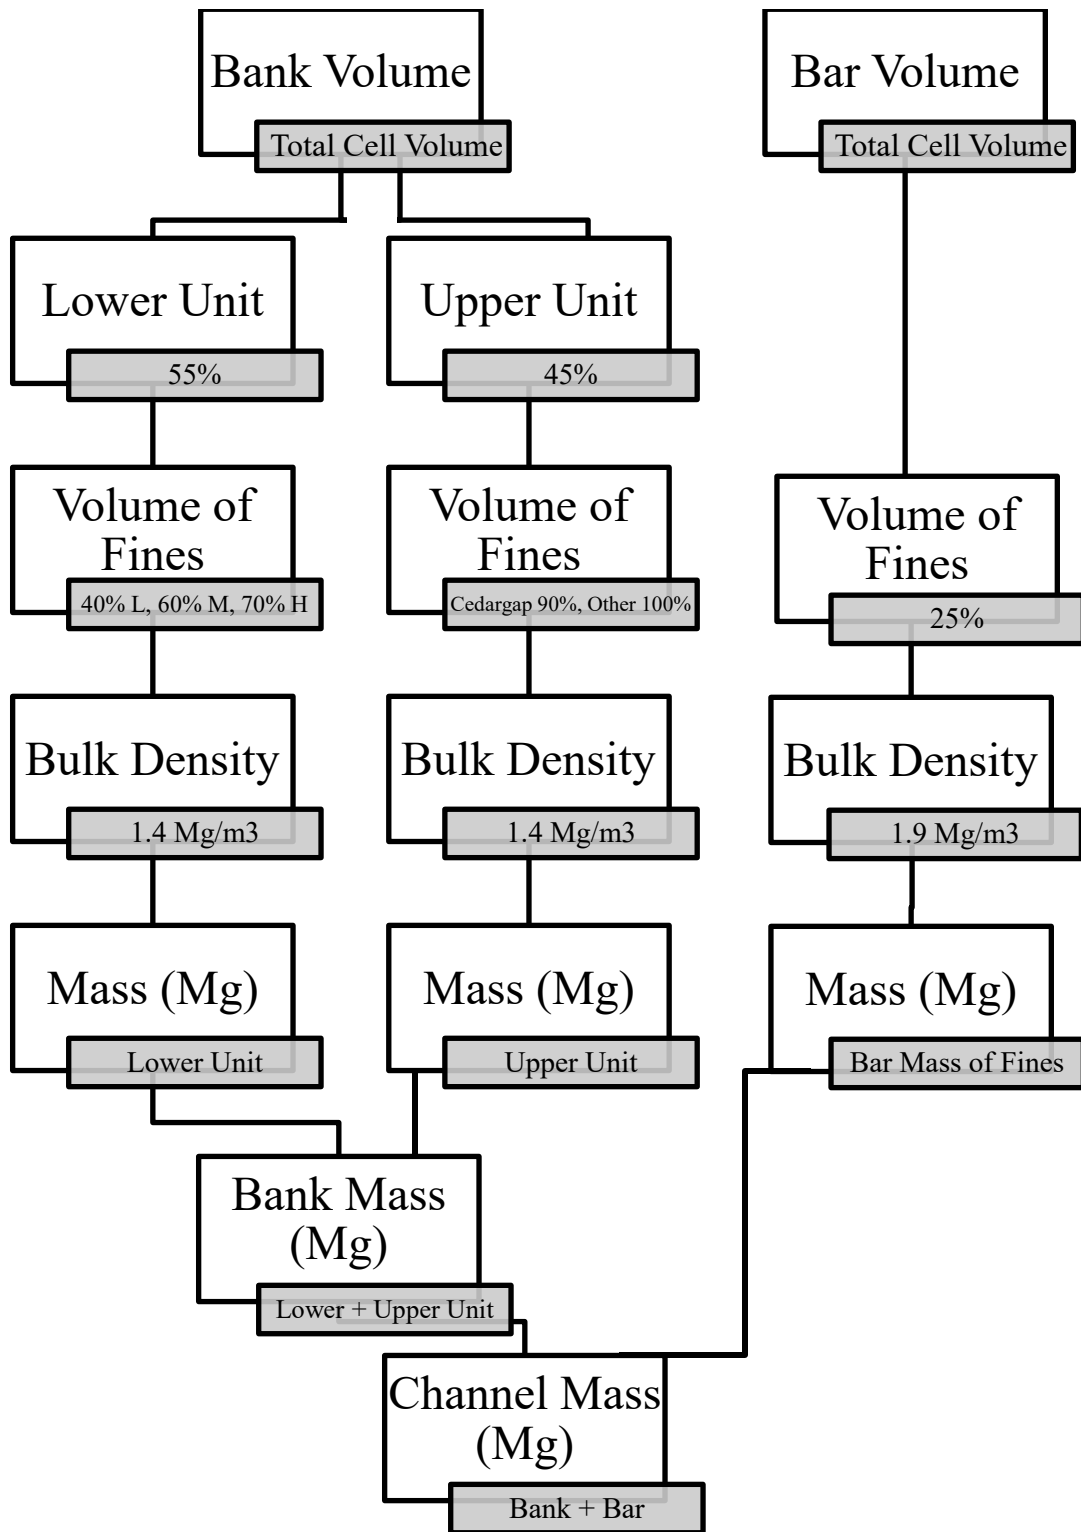
Figure 13. Deposit volume to fine sediment mass conversion by cell.

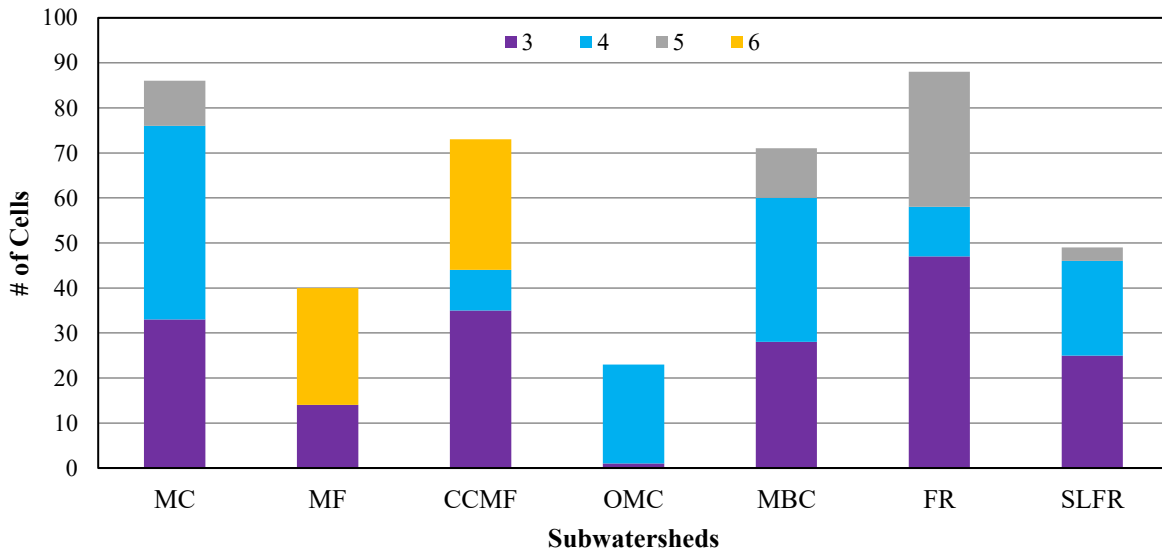
Figure 15. Number of cells in each subwatershed by stream order below dams.

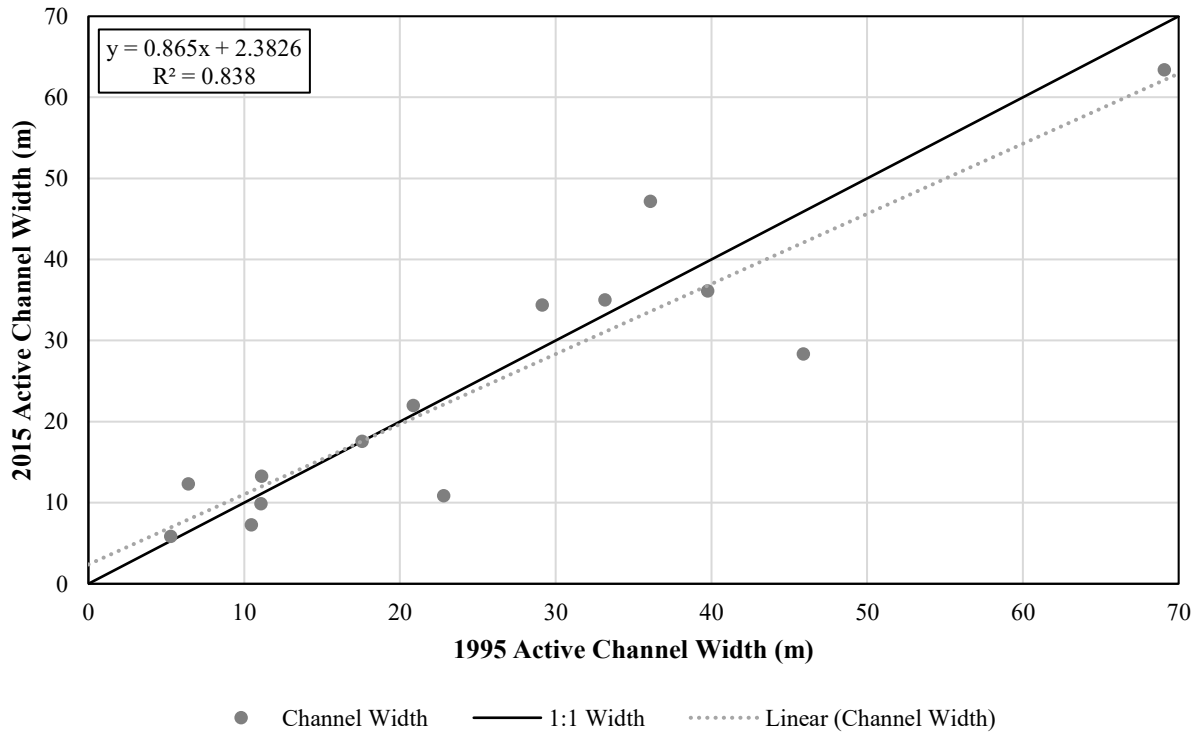
Figure 19. Active channel width reach assessment.

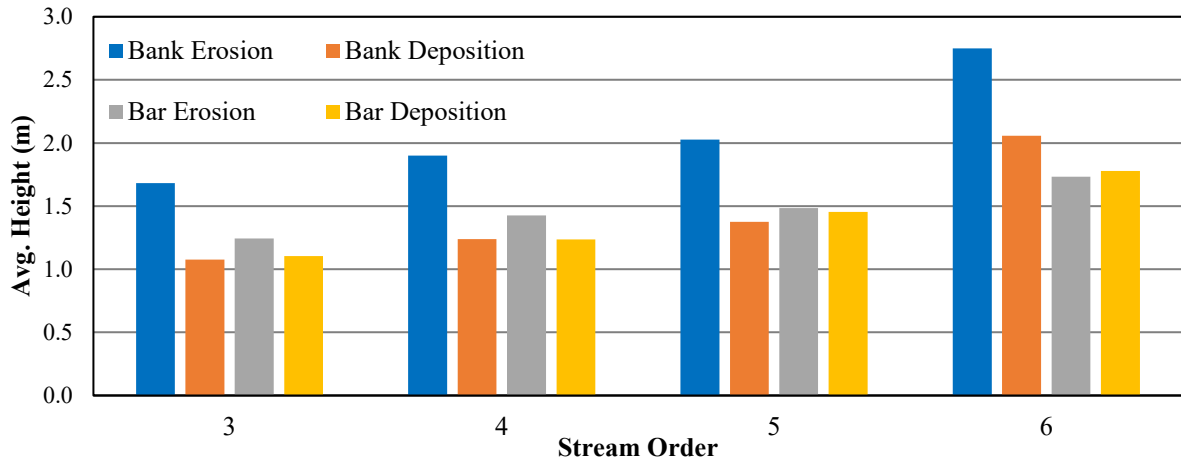
Figure 20. Average bank and bar heights.

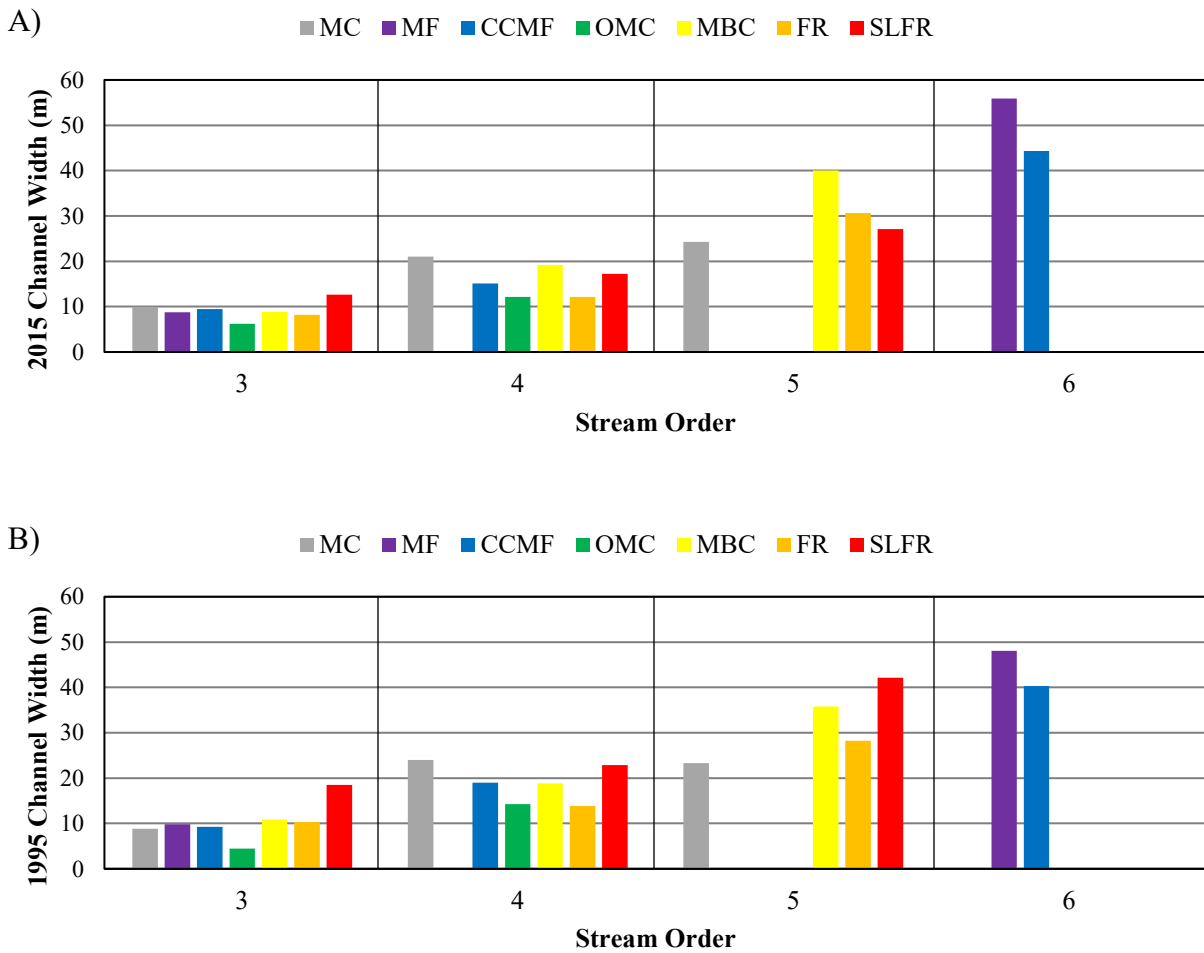
Figure 21. Average active channel width in 2015 (A) and 1995 (B).

As expected, active channel width (including the wetted channel bed and gravel bars) increased downstream from about 8 to 10 m in third order streams to 40 to 55 m in sixth order streams (Figure 21). Average channel widths both increased and decreased among stream orders and subwatersheds over the 20-year study period (Figure 21). The largest increase by almost 40% occurred in third order streams in OMC subwatershed. This geomorphic response may have been caused by recent land disturbances that increase runoff rates into relatively unstable channels due to the presence of mobile gravel deposits possibly linked to the effects of settlement pressure and lead and barite mining since the mid-1700s (Adamski et al., 1995; Jacobson and Primm, 1997; Jacobson and Gran, 1999; Olson, 2017).

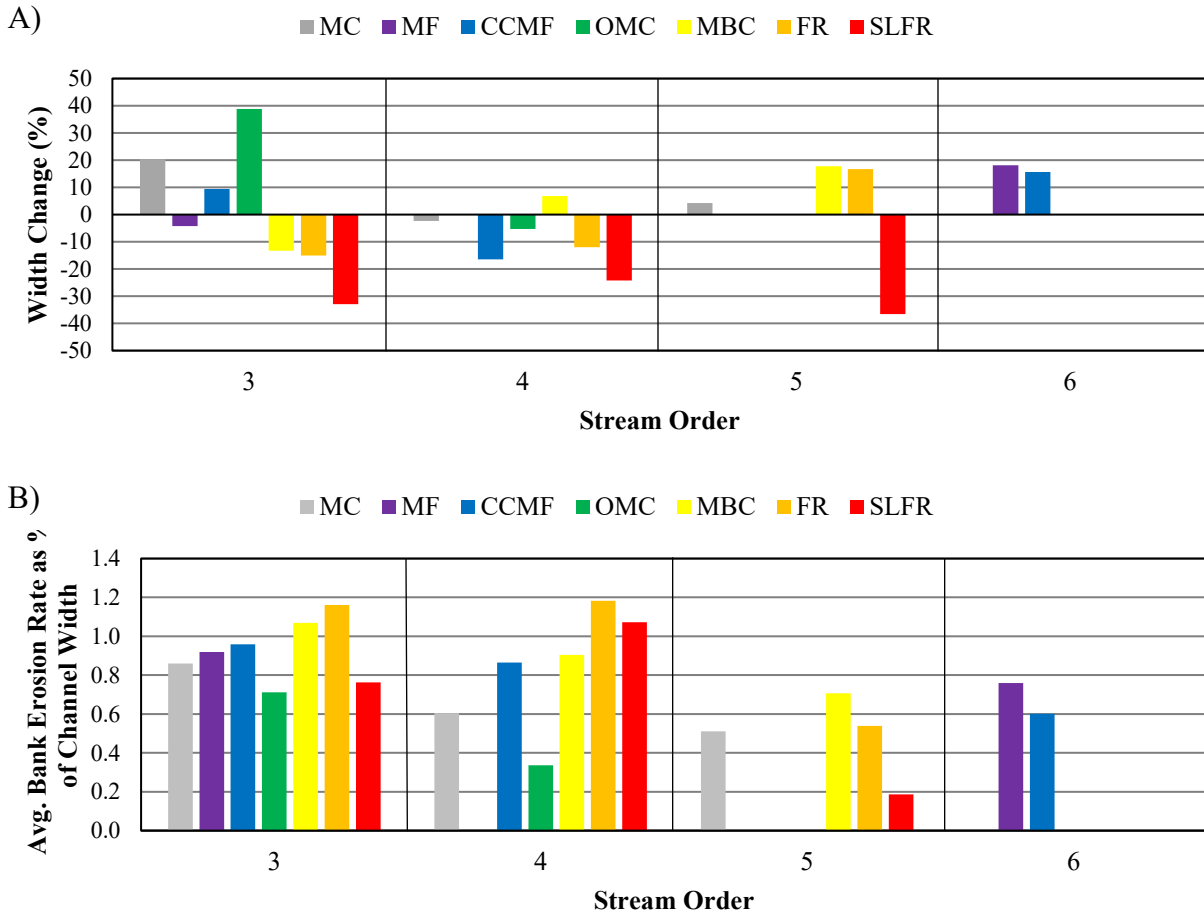
Figure 22. Active channel width change from 1995 to 2015. A) percent change in active width; and B) annual bank erosion rate as a percent of active channel width.

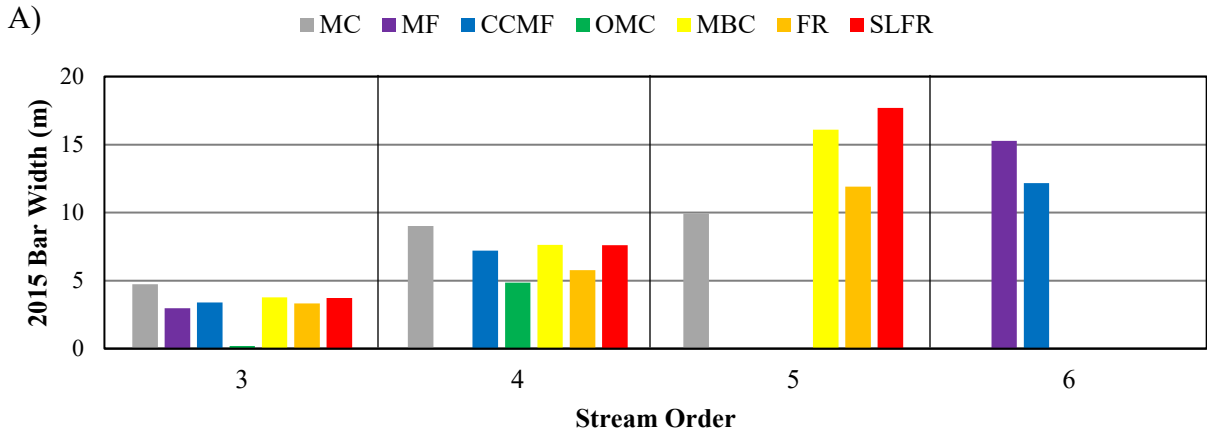
Figure 23. Average bar width in 2015 (A) and 1995 (B).

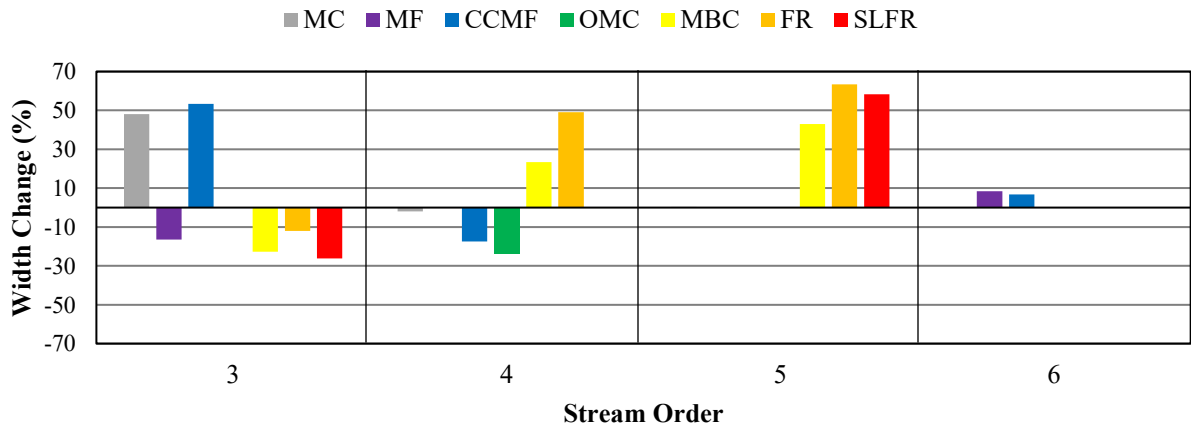
Figure 24. Percent bar width change from 1995 to 2015.

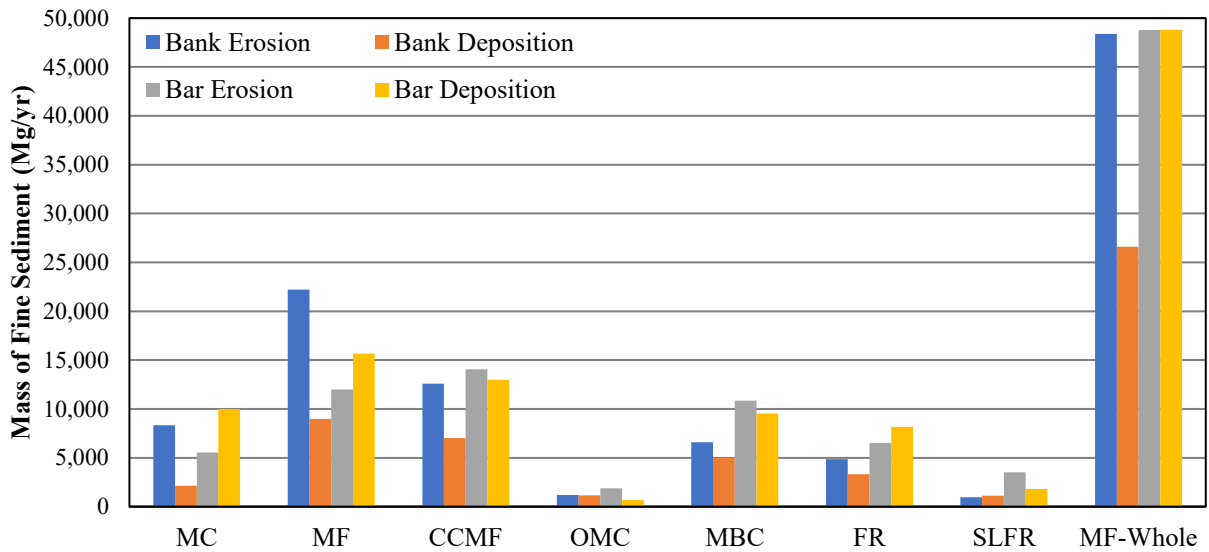
Figure 25. Mass of fine sediment from in-channel contributions.

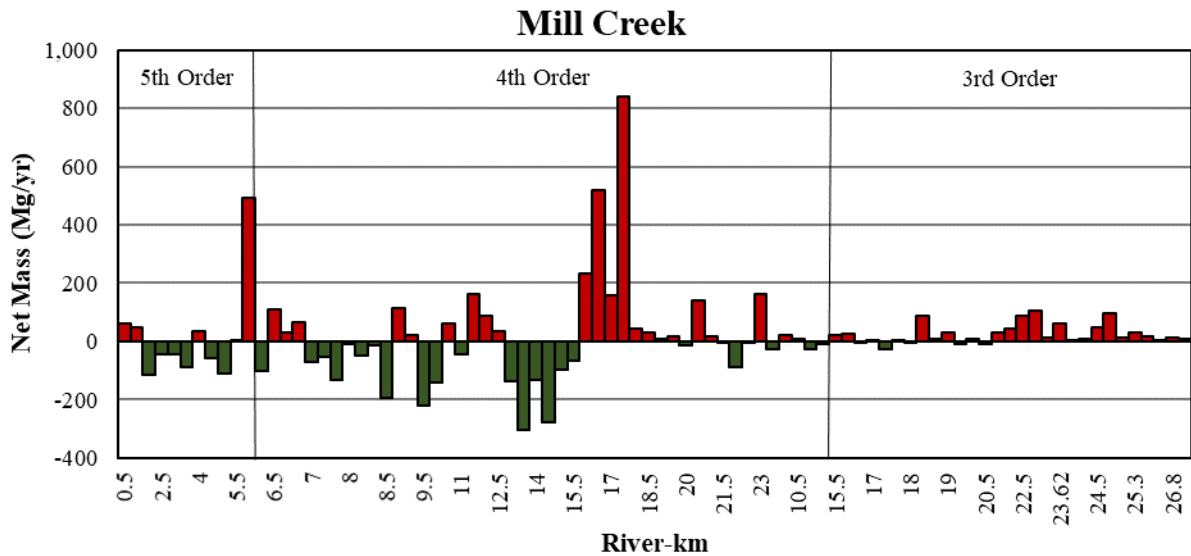
Figure 29. Alternating pattern of erosion and deposition upstream (27 km) to downstream (0 km) in the Mill Creek watershed.

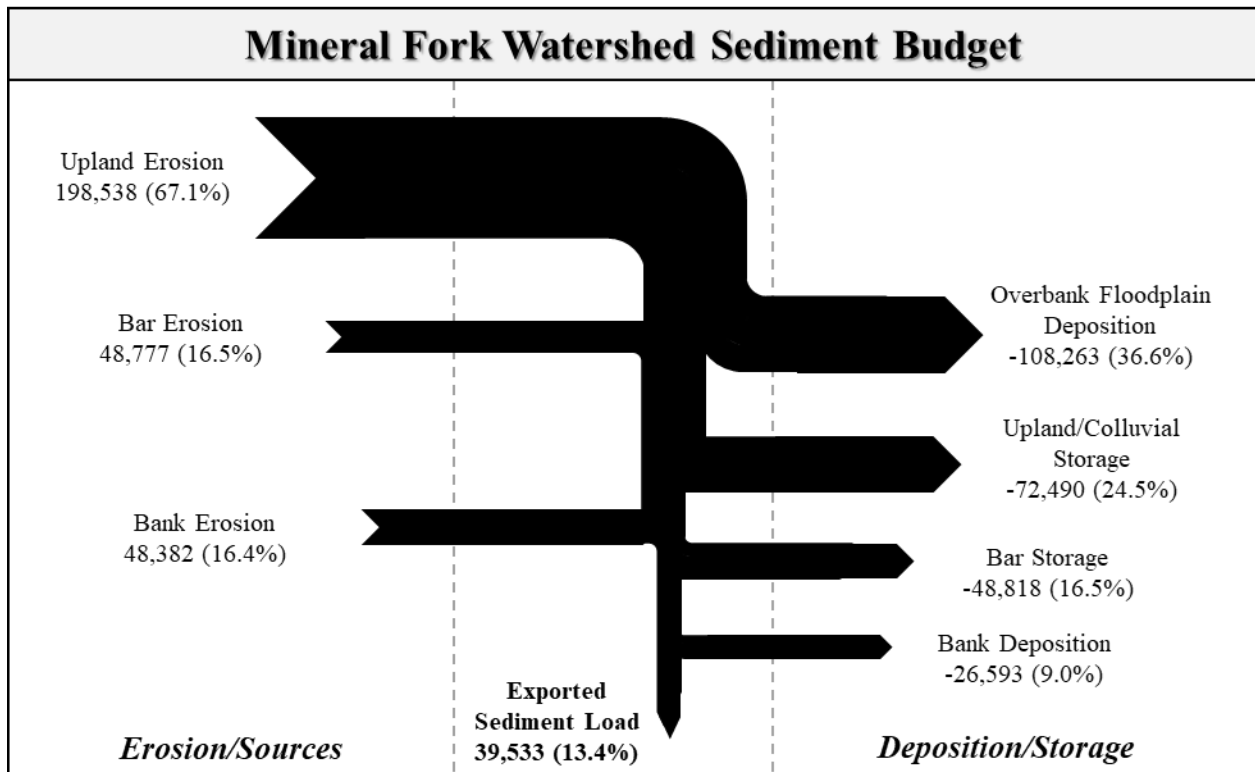
Figure 30. Mass sediment budget for Mineral Fork watershed (Mg/yr).

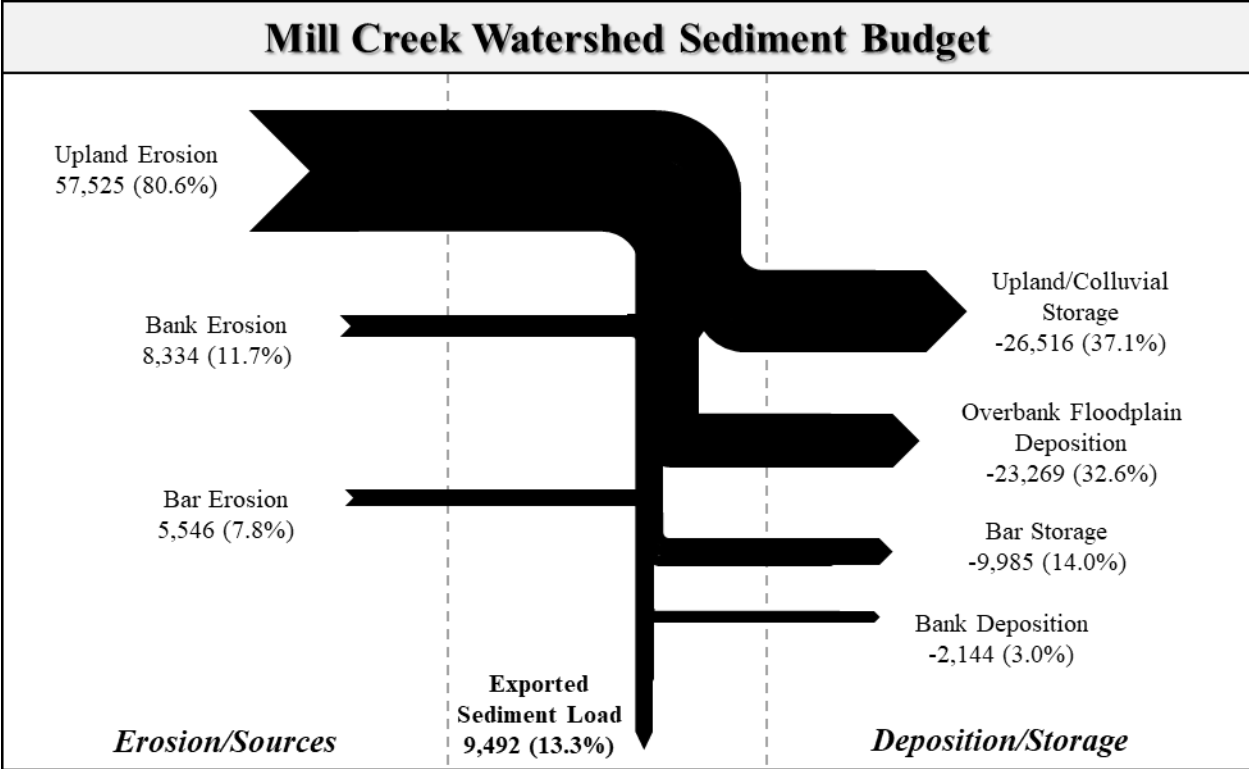
Figure 31. Mass sediment budget for Mill Creek watershed (Mg/yr).

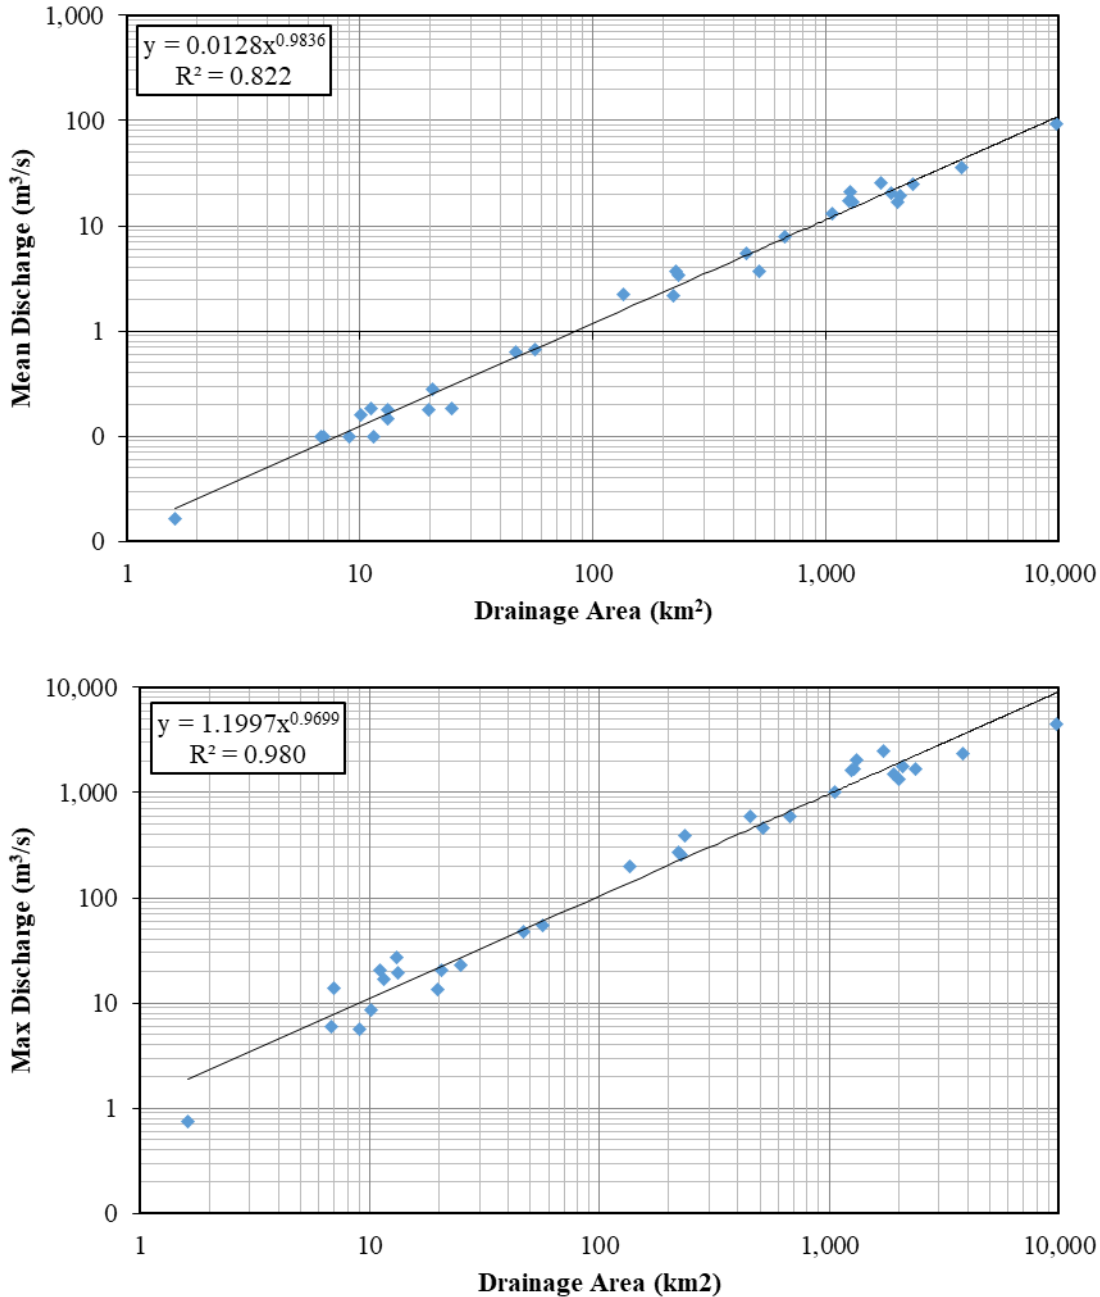
Appendix A-1. Mean and max discharge and drainage area relationships for USGS gaging stations near the study watershed.

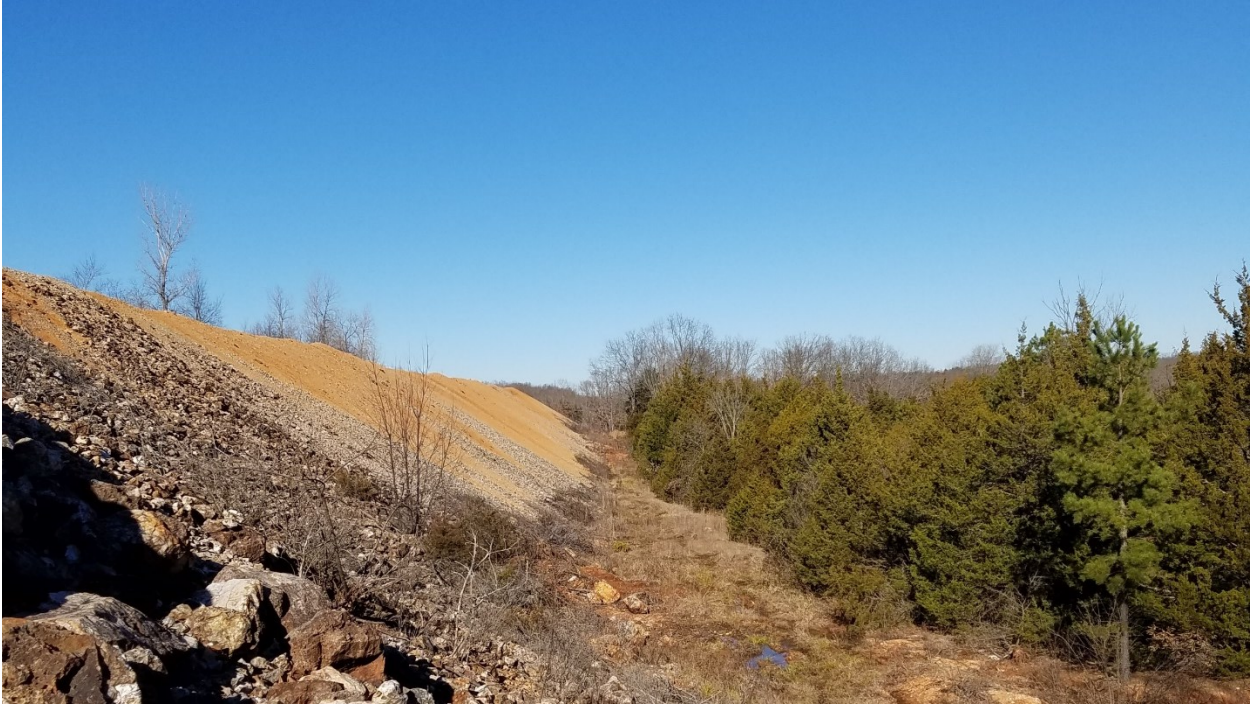
Appendix H-3. Ground view of A) and B), the Cadet Mine Tailings Dam (#MO30715) within the Mill Creek watershed (Photo taken December 18, 2018).
