# Arsenic in Surface Waters: A Report from River Ganga and its Tributary Jamania at Bhagalpur, Bihar, India

An investigation has been carried out to examine the arsenic pollution status of River Ganga & its tributary Jamania during pre-monsoon period of 2017 at Bhagalpur, Bihar (India). Altogether 17 water samples from different sampling sites along with their geo co-ordinates have been investigated for the value of arsenic using FTK test as well as spectrophotometer method. Throughout the study, arsenic value ranged from 10.69 ppb to 55.92 ppb. Out of the 17 water samples, the values of arsenic in 13 samples were from 20ppb to 54.1ppb. The concentration levels of arsenic in all the 17 river water samples and 2 public water supply samples (source: river water) in the present study were found above from the permissible limit of WHO (2008) and BIS (2004-2005) standards for drinking which is 10 ppb (part per billion).

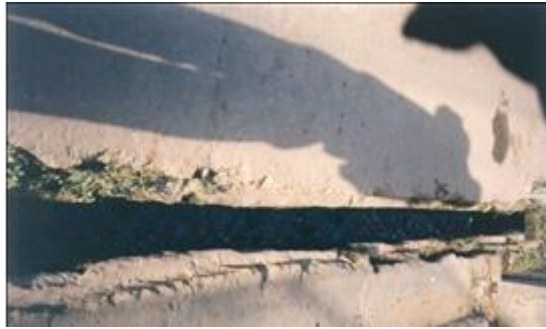
Site no. 1&2-water after dyeing and bleaching of the yarn

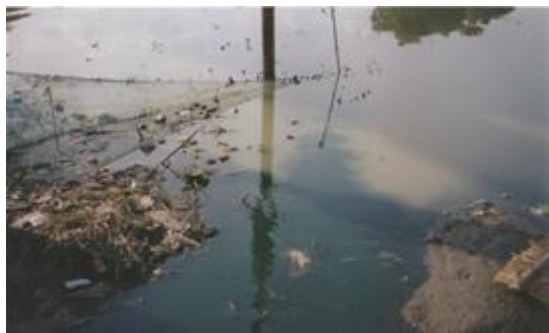
Site no.10&11-Hospital Wastages being dumped in jamunia nala & sites of idols immersion

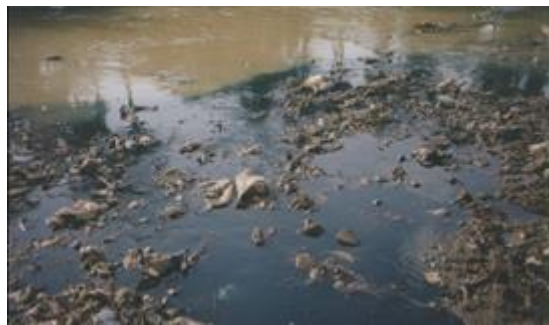
Sample sites no. 12-15-Disposal of domestic wastage and others

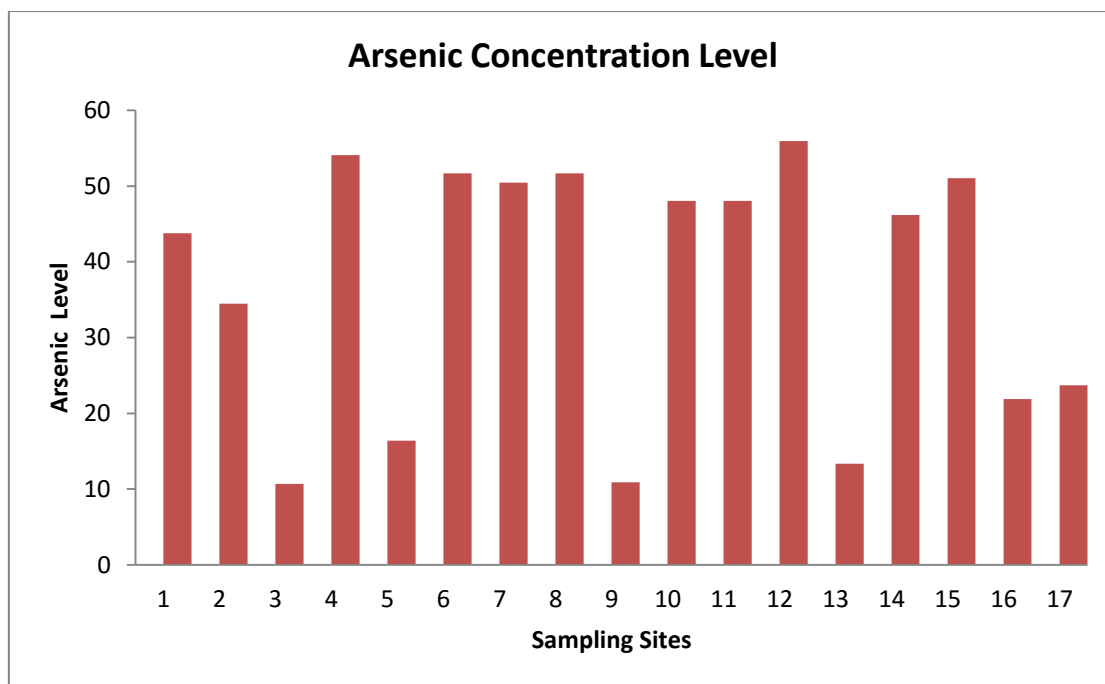
**Figure 4:** Arsenic Concentration Level

All the results obtained during the study are depicted in table 1 and figure 4. The analysis results indicated that the concentration of arsenic in river waters ranged from 10.69 ppb – 55.92 ppb. The maximum concentration of arsenic was found at the confluence point of Jamania channel and River Ganga. Out of 5 public water supply tap points, only two tap points, one each in Barari (51.06 ppb of As) and Khanjerpur (236.47 ppb of As) locality were found contaminated with arsenic, remaining three tap point sources had arsenic below detection limit (BDL). The concentration levels of arsenic in all the 17 river water samples and 2 public water supply samples (source: river water) in the present study were found above from the permissible/desirable (safe) limit [25, 26]. Similar results have been obtained in the Yamuna River (range: 32 – 64 ppb, mean: 51 ppb). From the results, it is obvious that the river water quality with respect to arsenic is not satisfactory. Various anthropogenic activities, such as use of phosphate fertilizers and arsenical pesticides in floodplain agriculture, washing of clothes using detergents, sewage drains opening into the river, discharge of effluents from loom industry, brick making near the river bank, immersion of idols painted with chemical paints into the river, hospital wastes channelized directly to the river etc. may be possible reasons for arsenic in river water. The results are also correlated in the light of possible health hazards from arsenic in river water and public water supply sources above the safe limits of WHO and BIS Standards for drinking. Long term exposure to elevated level of arsenic in surface waters may cause serious health hazards. The random survey and interviews of some families settled in the flood plains of Jamania channel and River Ganga revealed that the people were mostly suffering from arsenical skin lesions, and children and women were often more susceptible to the adverse effects of arsenic than adult males. Some people were found to have *Keratosis* on their palms and soles and some with *Melanosis* on their body parts including face and neck. White and black transverse bands across the finger and toe nails in women were also documented (Figure 3).

Altogether 17 sample sites along with their geo co-ordinates for each sample sites the value of arsenic in FTK test and spectrophotometric test have been detected from the sample water. Out of the 17 sample sites 13 sites are such whose FTK and spectrophotometric value are  $20^+$  &  $10^+$  ppb and 43.76 ppb and 34.48 ppb are due to dying and bleaching of the silk yarn prevalent in the ward no. 26 and 27 through which these two canals pass. As Bhagalpur city is famous for silk; hence dying and bleaching are major activities. The owner of the company uses such chemicals which are restricted in that country from which they import it. Same is the condition of sample sites no. 4, 6, 7 and 8 but the condition become more critical due to use of pesticides, insecticides as well as tanning of the animal skins as their residuals are directly poured into the canal passing through that locality. As in tanning of skins various types of chemicals are used by them. As sample sites no. 6 and 7 along the southern margin of the Jamunia nala brick making is also in practice. All these human activities add to the concentration of arsenic. Sample sites no. 11 and 12 are sites where waste products of JLN Medical College hospitals are directly dumped in it. Sampling site no. 12 (kali ghat) is the sites of immersion of idols during Durga Puja and Kali Puja. The presence of arsenic in sample sites number 14 and 15 are due to the discharge of fertilizers, pesticides, insecticides and domestic wastes along with amount of arsenic being brought down by the Jamunia canal from the upstream positions. Due to confluence of River Ganga with Jamunia canal at sample sites number 16 and 17 the amount of arsenic is not very high due to mixing of fresh water of Ganga river.
