### An Analysis of Coast Guard HH-65 Engine Reliability: A Comparison of Malfunctions to Component Removals

THESIS

AFIT/GIR/ENC/04-01

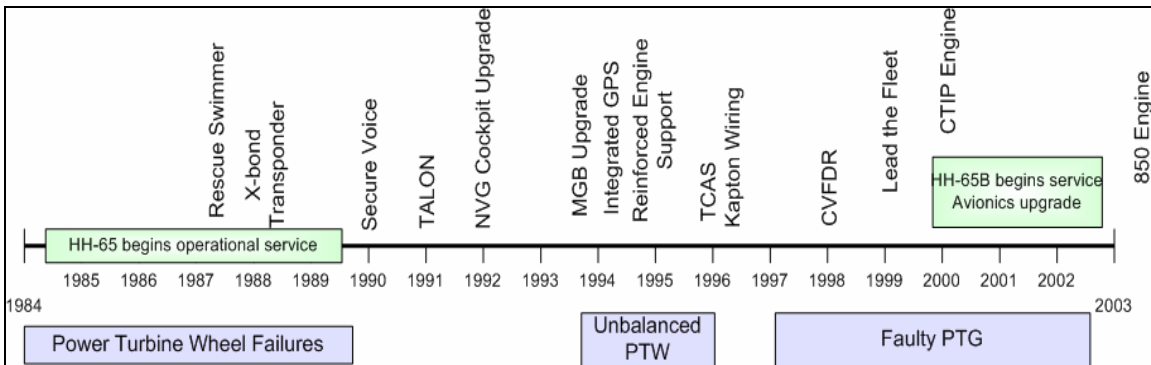
**Figure 1. HH-65 Timeline 1984 – 2003**

Upon initial delivery in 1984, the HH-65A met the mission requirements previously discussed with a crew of three to include a pilot, copilot, and flight mechanic. Modifications made to meet these requirements accounted for a 605 lb. weight increase over the original 366G Dauphin (Schlatter, 1997:3). In all, the modifications resulted in a launch weight of 8895 lbs., which was only five pounds under the maximum allowable gross weight at the time. The initial delivered model could hold a maximum of 1866 lbs. of fuel on takeoff and had only an 8% power reserve due to the increase in weight (Schlatter, 1997:8). Figure 1 outlines the timeline of the various HH-65 upgrades and changes since becoming operational.

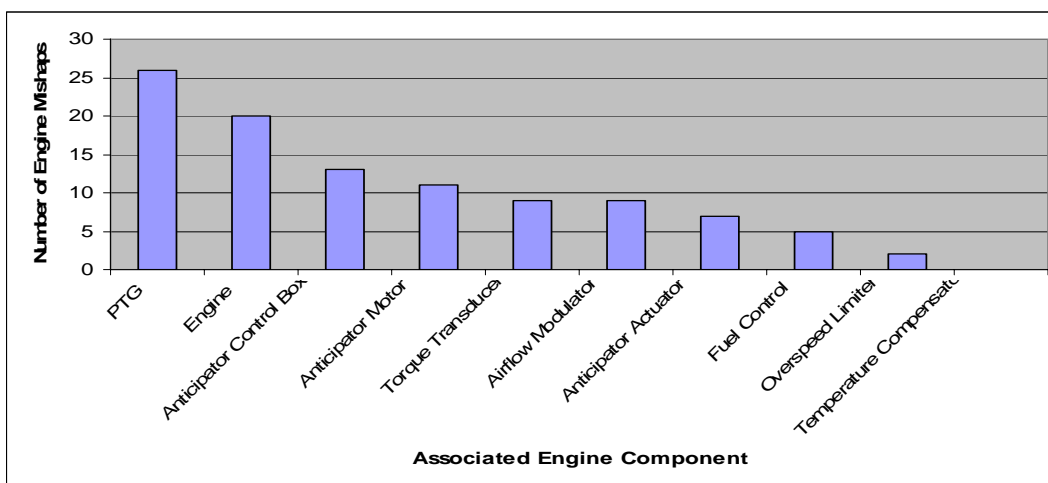
**Figure 8. Engine Related Mishaps by Faulty Component**

We now move to an analysis of mishap data. Figure 8 compares the total number of mishaps by component for the last six years (through May 2003). Since more than one component is at fault during many of these mishaps, the total number of mishaps through the same period is less than the sum of the numbers in Figure 8.

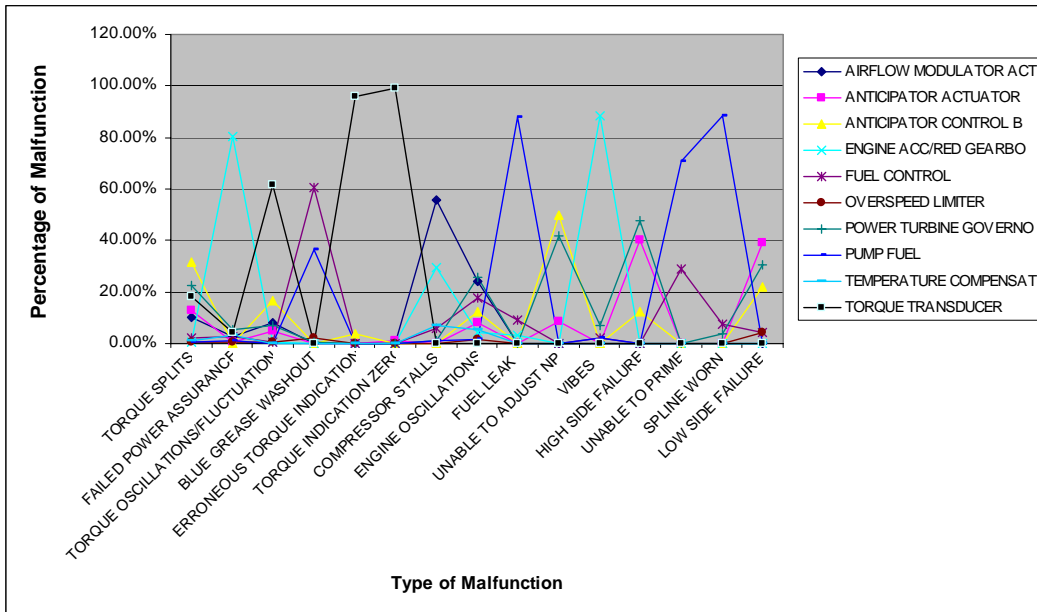
**Figure 15. Percentage of Component Replacement per Malfunction**

Figure 15 shows the percentage of components replaced for the fifteen most frequent malfunctions. For example, this figure shows that a faulty torque transducer causes 100% of the *Torque Indication Zero* malfunction.

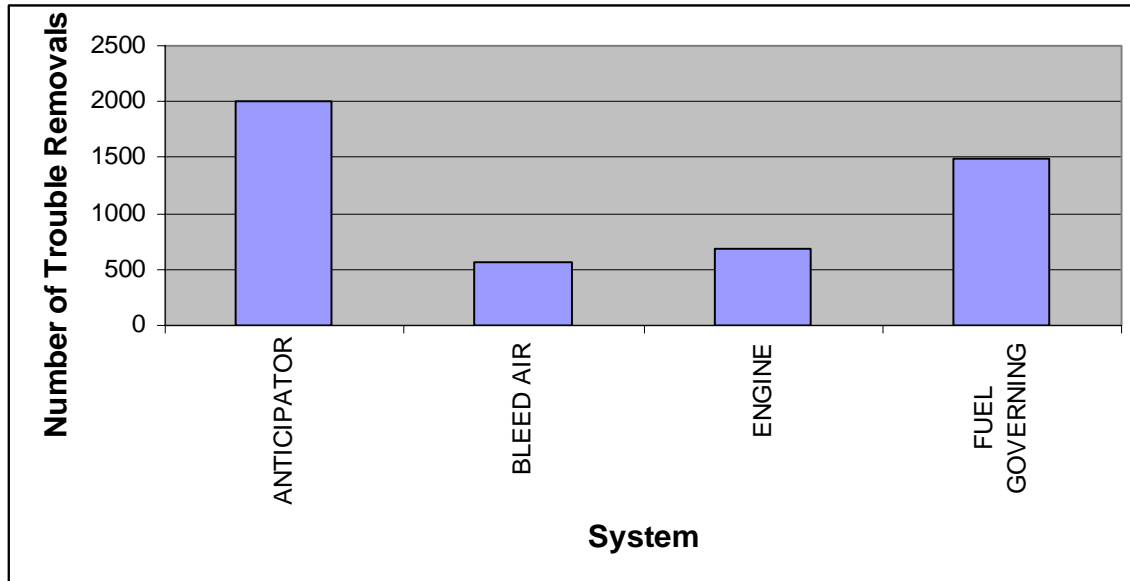
**Figure 16. Number of Trouble Removals by System**

Figure 16 depicts the number of trouble removals by system. The Anticipator and Fuel Governing systems account for the majority of trouble removals.

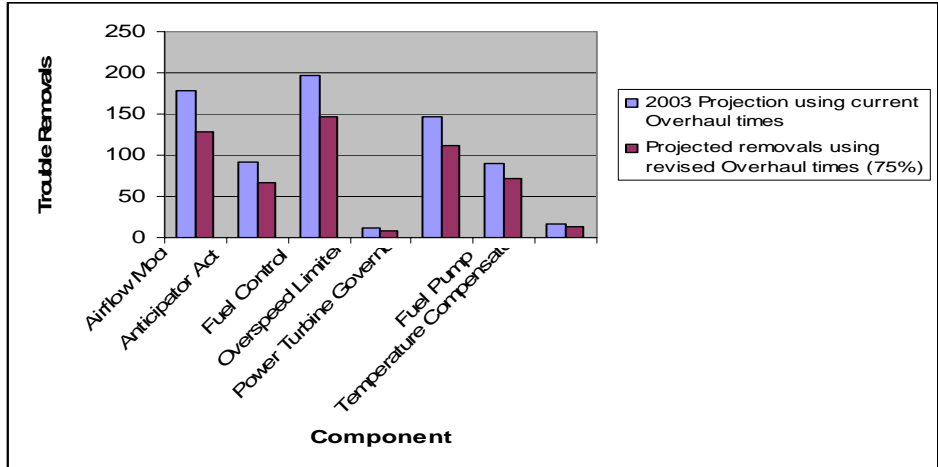
**Figure 22. Comparison of 2003 Projected Trouble Removals**

Figure 22 shows a side-by-side comparison of the projected trouble removals if no changes are made to the overhaul times against the predicted trouble removals using the 75% failure rate.
