Protections 2016
2nd International Seminar on
Dam Protection Against Overtopping
ISBN: 978-1-1889143-27-9 DOI:

Ft. Collins, Colorado, USA, 7-9 September 2016

Lessons Learned from Articulating Concrete Block (ACB) Field Installations

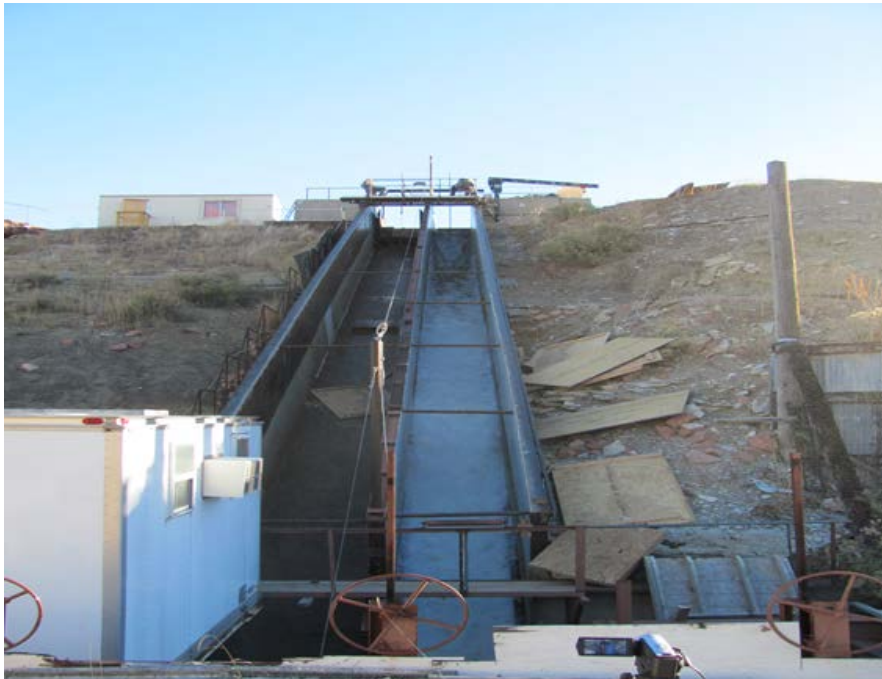
Testing of ACB systems under controlled and reproducible conditions serves, as the basis for developing the design parameters required in the FOS equations. Testing is conducted in a flume where the critical variables (subgrade type and compaction, geotextile installation, slope, and flow) are carefully controlled, measured and documented. These test flumes can be either horizontal, fixed slope or variable slope and can set up a slope length of between 10 feet and 100 feet. ASTM D7277 has set a minimum flume length of approximately 15 feet to ensure enough varied water surface measurements are taken during the data collection to produce meaningful analysis results. The longer the slope length of the flume, the greater the velocity and shear stresses generated, thus pushing the ACB systems being tested towards their threshold of performance limits. A photo of a fixed bed test flume is shown in Figure 1.

Figure 1. Fixed Slope Test Flume at Colorado State University

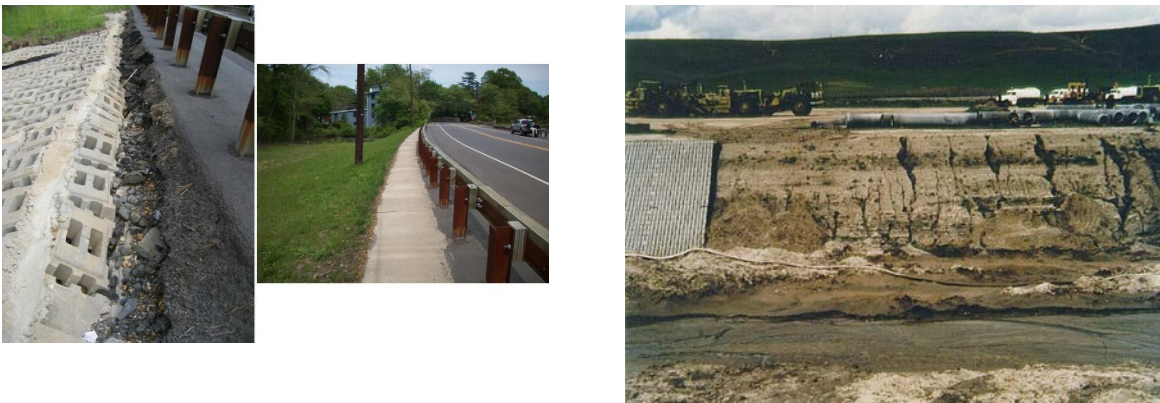
Installation of ACB systems, per the established guidelines developed by the engineering community and manufacturers, is of paramount importance to the successful performance of these revetments. The issues presented here underscore the need for proper language in the specification calling out the specific installation details, the need for a pre-construction meeting prior to laying of the revetment and the proper on-site construction inspection protocols. The left hand photos in Figure 2 show a case where the plans called out that the toe-in trench be filled with non-erodible material. It was determined by the contractor that sand was non-erodible and that is what was placed in the trenches. The embankment experienced an overtopping flow of approximately 6 inches which washed out the sand backfill and caused deformation under the mats resulting in the subsequent removal of the mats, and required repairing of the subgrade and relaying of the mats. Part of the repair consisted of backfilling the trench with concrete, which is considered non-erodible. Subsequent flow events have occurred without incident.

Figure 2. Examples of Installation Errors of ACB systems

The photo to the far right in Figure 2 shows a potential problem with rilled subgrade. The ACB mats cannot be placed on the subgrade in this condition as the rills will only worsen beneath the ACB revetment as each subsequent flow event occurs, thus placing the system at grave risk of failure. This type of scenario occurs when the contractor gets too far ahead on the final grading and a flow event occurs before the slope can be protected. The designer is encouraged to consult ASTM D6684 and the various ACB manufacturers for specific installation details for each unique revetment project.

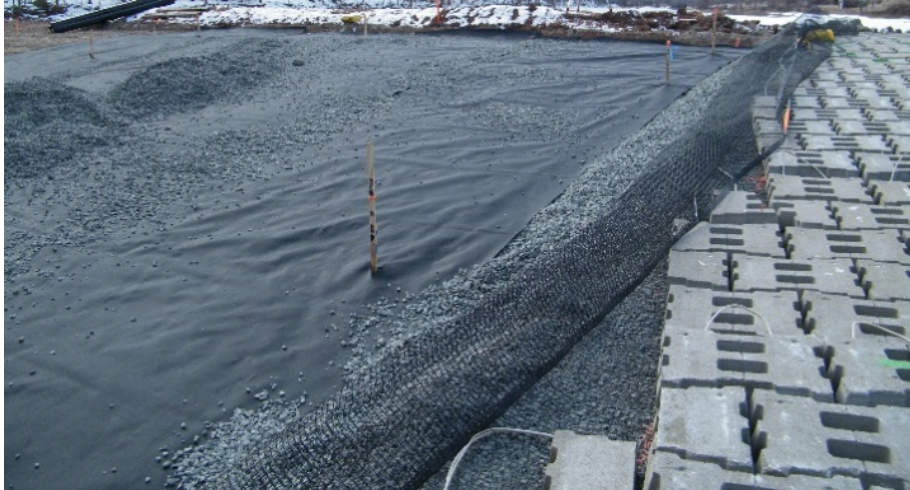
previously discussed and the repair was made during the reconstruction. A second issue with the geotextile is shown in Figure 3. In this case the wind was gusty during the installation of the ACB system so in order to hold the fabric in place, grade stakes were driven through the geotextile to secure it until the stone drainage layer was placed. No effort was made to repair the holes in the geotextile fabric and as a result localized erosion was noted around the majority of the locations where the fabric's integrity was compromised.

Figure 3. Geotextile Installation Issues

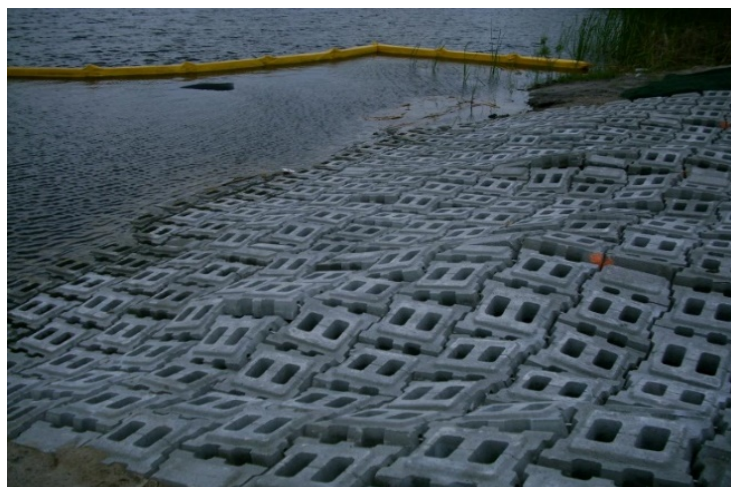
The subgrade conditions at installation and over time are critical for ACB performance. The subgrade should be relatively free draining, adequately compacted and free of organic materials such as stumps and roots. The goal of these specifications of the subgrade is to avoid differential settlement over time. Eliminating pockets of organics and woody materials from the subgrade is an important step towards minimizing differential settlement as is avoiding installing ACB revetments during winter periods where the ground is frozen. Frozen soil is very difficult if not impossible to adequately and uniformly compact and the results typically show up as differential settlement the following spring or summer. The effects of differential settlement of the subgrade is shown in Figure 4. The cause was pockets of peat in the subgrade as well as a generally poor draining material. The remedy was to remove the ACBs, excavate the poor subgrade and replace with adequate borrow material that was free draining, free of organics and compacted adequately to avoid long term differential settlement. Once these fixes were completed, this system has been performing adequately for several years.

Figure 4. Subgrade Differential Settlement

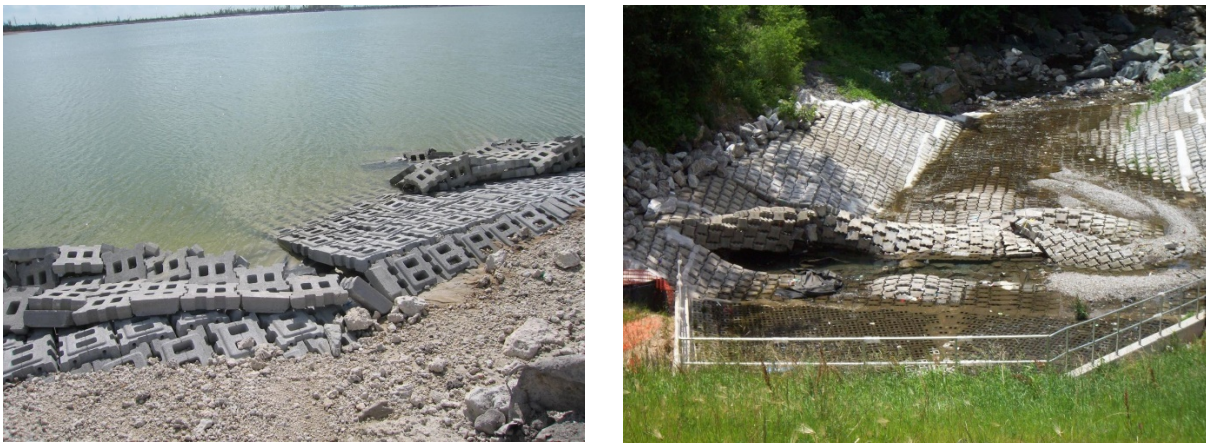
ACB revetment systems, whether utilized in open channel flow or wave attack slope protection are subject to limitations of performance based upon design conditions. Should the actual field conditions experienced by the installed revetment exceed the design conditions used to size the ACB blocks and the FOS cushion, failure of the system is a predictable result. Figure 5 shows two such examples. The left hand photo in Figure 5 shows a revetment system which was subject to wave attack. The owner of this project designed the system himself and specified 4.75 inch thick ACBs. Hurricane Jeanne hit the area around this project and generated waves that exceeded the capabilities of the revetment system installed resulting in damage. The failure mechanism was a combination of mats “rolling” because they were not tied together in a contiguous revetment as well as subgrade loss due to the ACB blocks being lifted from the soil surface due to being undersized. A comprehensive engineering analysis for the revetment system using Pilarczyk’s Method returned a result that an 8 inch thick ACB was the proper design for this project. The photograph on the right in Figure 5 shows an ACB system at a pipe outfall in a highly developed flashy urban watershed. The ACB’s were designed based on a HEC-RAS model run by the design engineer which provided the velocity and shear stress design values needed to size the ACB system. Upon further investigation of this failure, it was determined that the HEC-RAS model upon which the design was based was a “Steady State” model which included several feet of tail water. This system failed because the 8 foot diameter outfall pipe was flowing full before steady state tail water conditions had developed resulting in velocities that exceeded the limits of the ACBs installed. The failure mechanism was most likely due to velocity of the flowing water exceeding the limits of the ACB system either due to the lift generated on the ACBs, which was not accounted for in the NCMA FOS methodology utilized on this project, or the effect of a projecting ACB block or perhaps both of these.

Figure 5. Exceeding Design Conditions

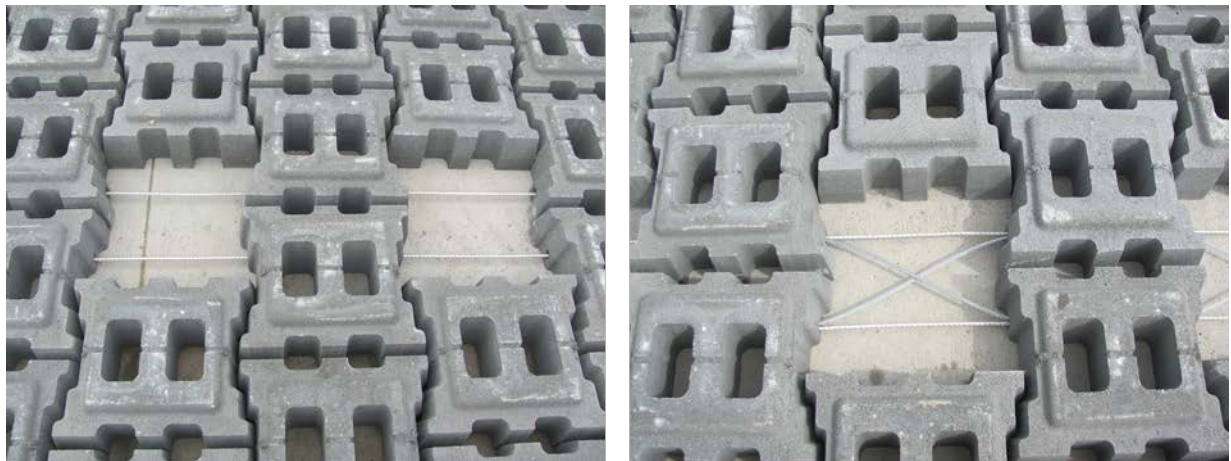
Since the introduction of staggered ACB block mats, half-blocks have been present to keep the manufactured mats rectangular, aiding in the installation process. Half blocks are not truly tested as when they are used in the flume they are retained by an angle iron bar along the edge, thus the focus of the testing is the free floating full blocks. FOS calculations only use the design parameters developed for full blocks in the flume which are not restrained and there is no accepted extrapolation to estimate the performance of the smaller half blocks utilized in the industry. Additionally, half blocks in most staggered interlocking ACB mat systems are secured with only one cable, thus there is a potential for the half block to roll on this single cable, compromising the revetment system. The lacing detail is an installation procedure that involves leaving the half blocks out of the mats creating a void as shown in Figure 6. The mats are placed side by side leaving a full block space. A cable is laced through the cable ducts of the adjacent mats tying them together. Once the lacing is completed, the open area is filled with concrete or grout.

Figure 6. Lacing Detail

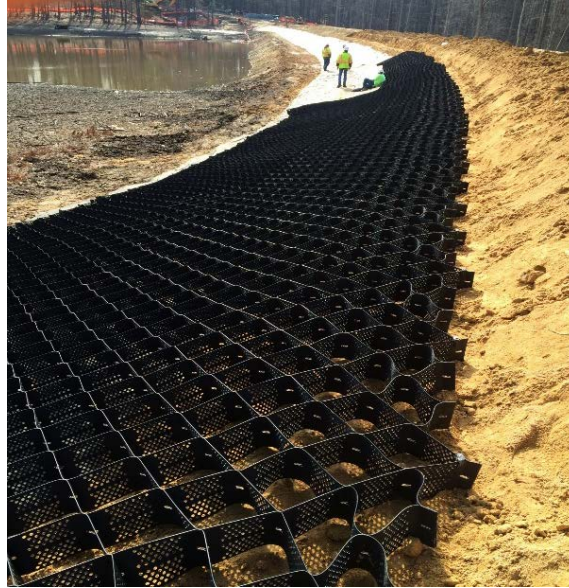
A system has been proposed and is currently being tested at Colorado State University (CSU) where the stone drainage layer is stabilized with the addition of a geoweb, similar to that shown in Figure 7. This system has the potential to increase ACB revetment reliability in terms of long term maintenance requirements after flow events, improve hydraulic jump performance of ACB systems and to help ensure when a 4 inch thick drainage layer is specified a uniform 4 inch thick drainage layer is actually installed in the field. Details of the testing will be published in future papers discussing various topics in ACB technology and application science.

Figure 7. Typical Geoweb System
