Failure Analysis of Hybrid Fibre Reinforced Plastics for Bolted Joint under Thermal Effect

D. Sivakumar*, L.F. Ng, J.W. Ng, M. Z. Selamat
Faculty of Mechanical Engineering,
Universiti Teknikal Malaysia Melaka,
76100 Durian Tunggal, Melaka, Malaysia.
*sivakumard@utem.edu.my

Keywords: Hybrid Composites, Bolted Joint, Thermal Effect, Woven Kenaf

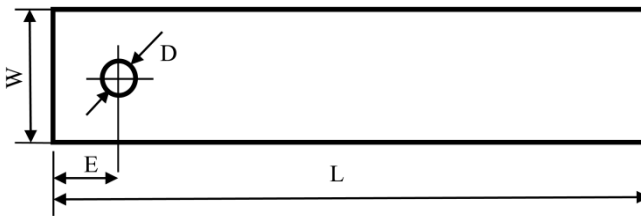
Figure 1: Composite specimen geometry

temperature 40°C for 24 hours to eliminate moisture content. The FRP panels were stacked in a 3mm thick picture frame mould with the stacking sequence of [PP/GF/PP/KF/PP/PP/GF/PP]. The picture frame mould was placed in a hydraulic hot press machine with a temperature of 180°C and pressure of 30kg/cm². Hybrid composite panels were cut into a dimension of 135mm x 36mm using Proxxon table saw in accordance to ASTM D5961. Specimens were then drilled with notch diameter of 6mm at a specific location using laboratory bench drill. Circular file was used to get a good surface finish on the drilled notch to eliminate stress concentration. The notch diameter shall be tight-fit with the M6 bolt. Figure 1 shows the schematic dimension of the specimens (L=135mm, W=36mm, E=18mm, D=6mm).

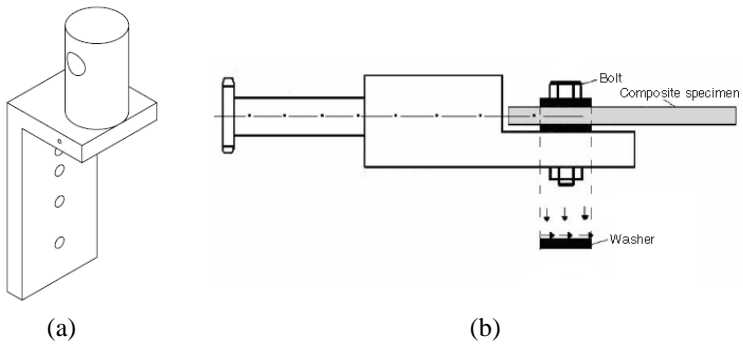
Figure 2: Experiment setup (a) jig design (b) specimen setup

The bearing test was conducted according to ASTM D5961 using INSTRON 5969 Universal Testing Machine (UTM) with a load capacity of 50kN. Specimens were attached and bolted to the special designed and fabricated jig and then placed in the heat chamber at room temperature, 40°C, 50°C and 60°C. The design of the jig and the experiment assembly of specimens are as shown in Figure 2. Specimens were loaded at crosshead displacement rate of 2mm/min until a maximum load has clearly been reached in order to observe and analyse the exact failure mode. The tests were terminated when a 30% load drop from maximum load was detected. The test was repeated three times for each setting. The result from different temperatures and preload moments were recorded and represented in load- extension curves. The result was then analysed and evaluated to deduce the effect of temperatures and preload moments on bearing strength. Figure 3 shows the setup of specimen inside the heat chamber.

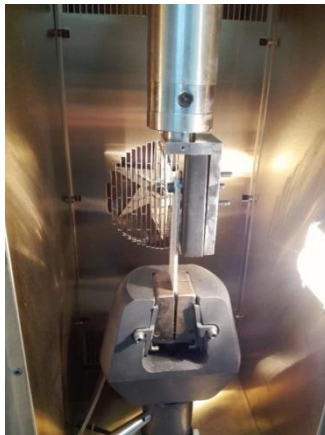
Figure 3: Setup of specimen inside heat chamber

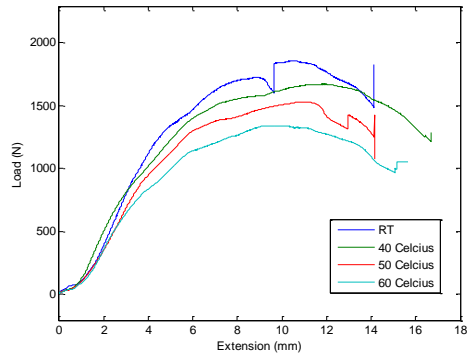
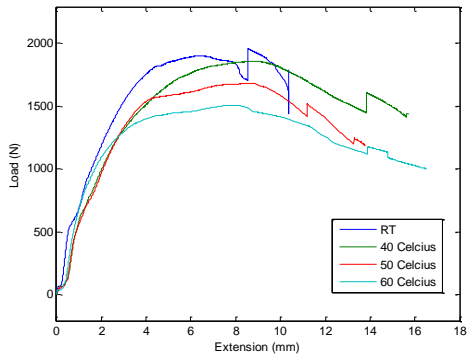
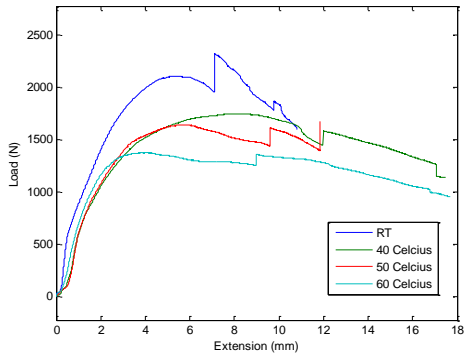
Figure 4: Effect of temperature on load-extension curve of hybrid composite at (a) 0Nm, (b) 5.2Nm and (c) 7.5Nm

Figure 4 shows the effect of temperature on load-extension curve of the hybrid composite under different preload moment of 0, 5.2 and 7.5Nm. As can be seen from the graphs, specimens at room temperature ($\approx 25^{\circ}\text{C}$) have the highest load carrying capability, followed by specimens at 40°C , 50°C , and 60°C for all preload moments. At room temperature, the structure of the PP polymer matrix was not affected by the heat and the PP polymer matrix was able to fully perform its function as a binding agent and hence it allows the applied load to be distributed more evenly to all reinforcing fibres. As a result, the load carrying capability of specimens at room temperature condition was the highest among all tested temperatures. At 60°C , the load carrying capability decreased by about 28% on average compared to at room temperature. This can be attributed to the structure of the PP polymer matrix had been damaged and its role as a binding agent had been adversely affected. This shows the significance of temperature effect on the load carrying capability of FRPs. Generally, the increase in temperature will decrease the load carrying capability of a specimen in a proportional manner, which means the higher the temperature, the lower the load that can withstand.

As for the load-extension relationship, all specimens showed typical behaviour of ductile materials, which is linear at the beginning followed by non-linear relationship. Linear relationship was observed for the first 4 to 5mm of extension and then followed by intensive non-linear load-extension curve. The specimens were able to have higher elongation if exposed to elevated temperature but with bearing carrying capability compromised

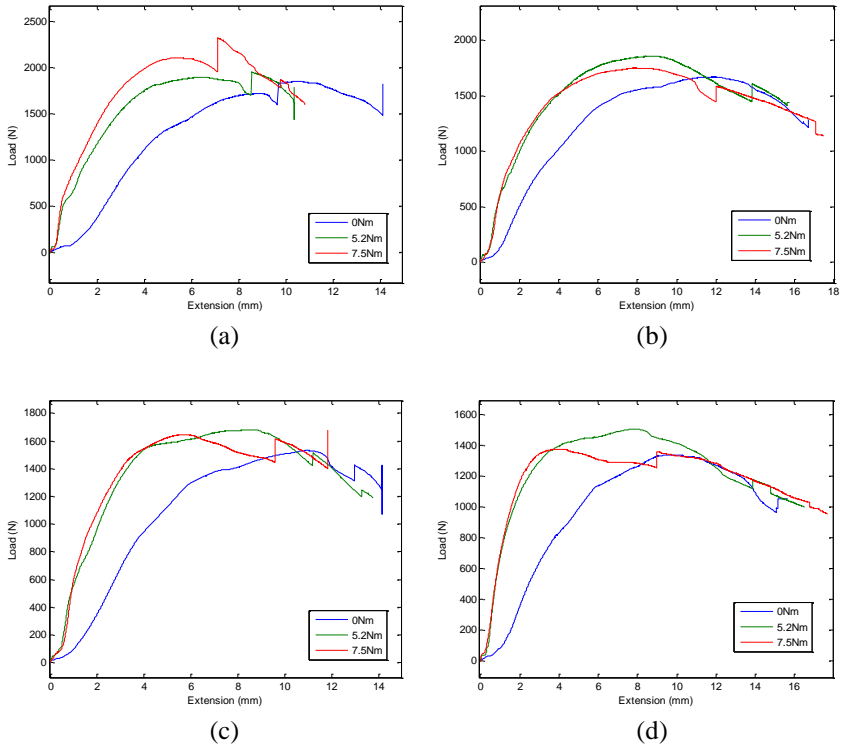
Figure 5: Effect of preload moment on load-extension curves at different temperature of (a) room ($\approx 25^{\circ}\text{C}$) (b) 40°C (c) 50°C (d) 60°C

Figure 5 shows the effect of preload moment on load-extension curve of the hybrid composite at different temperature (25, 40, 50 and 60°C). Figure 5(a) shows the effect of variation of preload moment at room temperature. From Figure 5(a), it can be seen that specimens with preload moment of 7.5Nm had the highest load carrying capacity, followed by 5.2Nm and 0Nm. This can be attributed to the clamping force produced by the tightening preload moments that prevent the delamination of fibre layers. The tightening preload moments held all the layers together at their original position, resulting in an increase in load carrying capacity. When delamination is avoided, the mechanical strength of specimens can be preserved, resulting in higher load carrying capacity. However, this phenomenon only happened in specimens at room temperature. For specimens exposed to temperature at 40, 50 and 60°C, preload moment at 5.2Nm showed the highest load carrying capacity, which was followed by 7.5Nm and 0Nm. Referring to Figure 5(b), (c) and (d), it can be noticed that the maximum loads were lower for specimens with 7.5Nm preload moment compared to specimens with 5.2Nm preload moment. Preload moment at 5.2Nm is the recommended tightening torque for M6 bolts [15]. This is because of the “plunging” effect of the washer that damaged the geometrical integrity of hole due to over-torque beyond recommended value. At elevated temperature, the PP matrix starts to soften due to the breaking of polymer chains. When the preload moment which is higher than the recommended value was applied, obvious engraving marks can be observed on the surfaces of the specimens. During bolted joint test, the washers “plunged” into the specimens, forming a cut-like opening around the hole that damaged both the PP matrix and fibres. As a consequence, the load carrying capability was undermined for over-torqued specimens at elevated temperatures.

In this experiment, preload moments do not have any impact on the extension of specimens. Except for the specimens at room temperature with 0Nm preload moment, all specimens at elevated temperature have a similar total extension before reaching the 30% peak load drop point. To exemplify the extension, from Figure 5(a), the specimens (except for specimens with 0Nm preload moment), reached the 30% peak load drop point at the extension of around 10mm. This also applies to other specimens at 40°C (around 12-14mm), 50°C (around 16-17mm) and 60°C (around 17-18mm). Therefore, this implied that preload moment does not affect the extension of specimens for the same temperature.

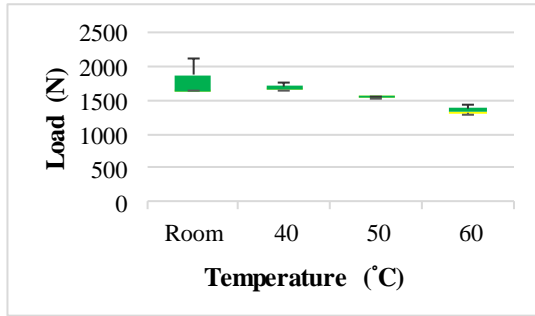
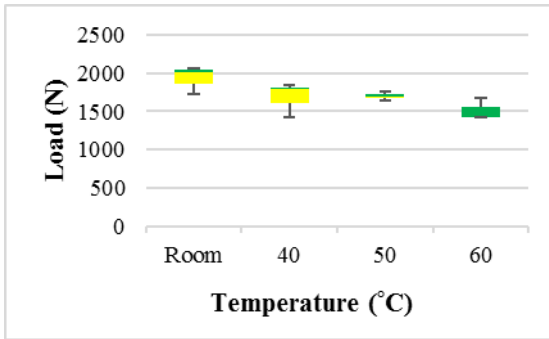
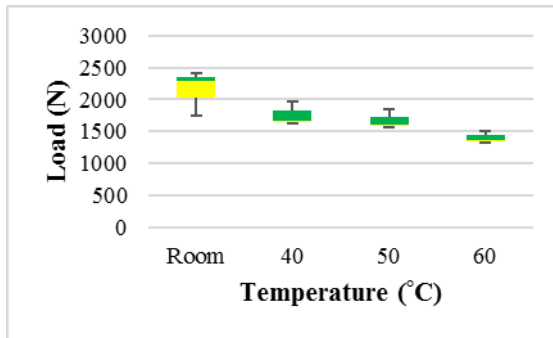
Figure 6: Box plots of maximum loads at various temperatures under (a) 0Nm, (b) 5.2Nm and (c) 7.5Nm preload moment.

Figure 6 shows the box plots for maximum loads at the temperature of room temperature, 40, 50 and 60°C and different preload moments (a) 0Nm, (b) 5.2Nm and (c) 7.5Nm. Generally, most of the test values were close to each other and average value. The deviation and spread in test results were probably due to minor specimen inconsistency since each FRP panels are unique in the way that each panel was fabricated individually using laboratory-level machines and tools. In order to reduce the deviation, precise temperature and preload moment control was executed during the experiment which theoretically reduces the spread of test values. Figure 7 shows the computed 95% confidence interval for the average maximum load at various temperatures under preload moment of (a) 0Nm, (b) 5.2Nm and (c) 7.5Nm. The small deviation of test values from the average values indicates that the obtained test results are in the acceptable range.

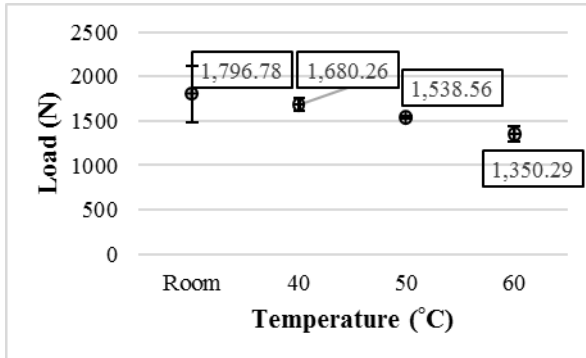
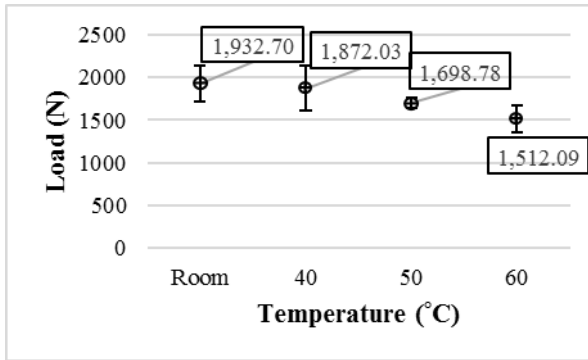
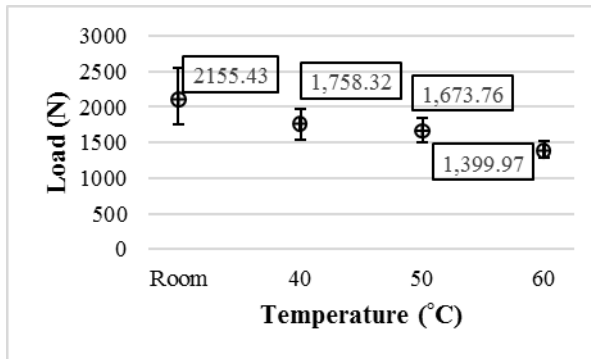
Figure 7: 95% confidence interval of average maximum loads at various temperatures under (a) 0Nm, (b) 5.2Nm and (c) 7.5Nm preload moment.

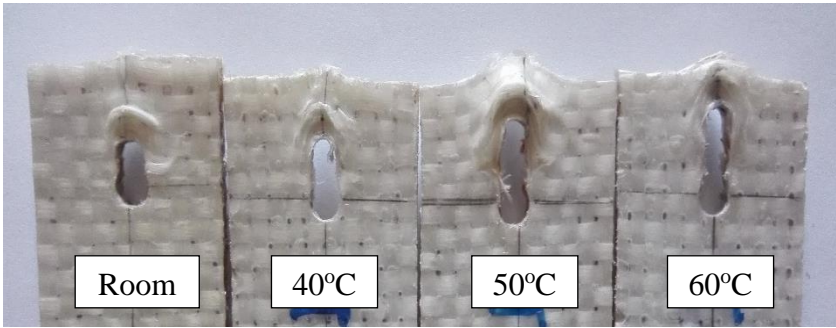
Figure 8: Photo of deformed specimens at various temperatures under 0Nm preload moment

Figure 8, 9 and 10 show the failure mode of the specimens after bolted joint test was performed. It can be seen that increasing the ambient temperature will lead to more damage in terms of notch deformation regardless the effect of preload moment. Figure 11 illustrates the “plunging” effect caused by the washers when specimens were torqued at 7.5Nm. The washer at the front side “sunk” into the specimen, forming a cut-like damage to the notch while the sunk washer forced the specimen to form a “bulge” at the back of the notch. Figure 12 presents the onset of net-tension failure mode at the two sides of the hole. The crack lines can be observed on the front and back of the specimen.

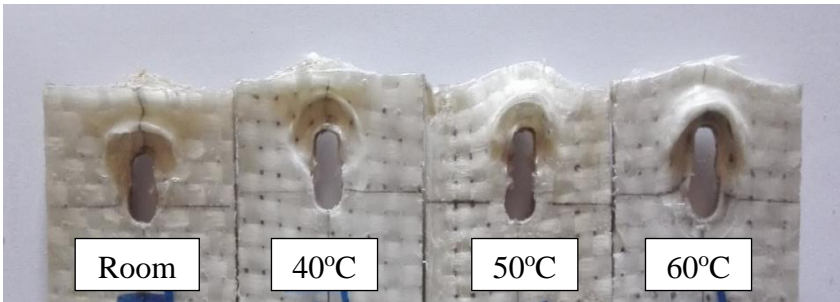
Figure 9: Photo of deformed specimens at various temperatures under 5.2Nm preload moment

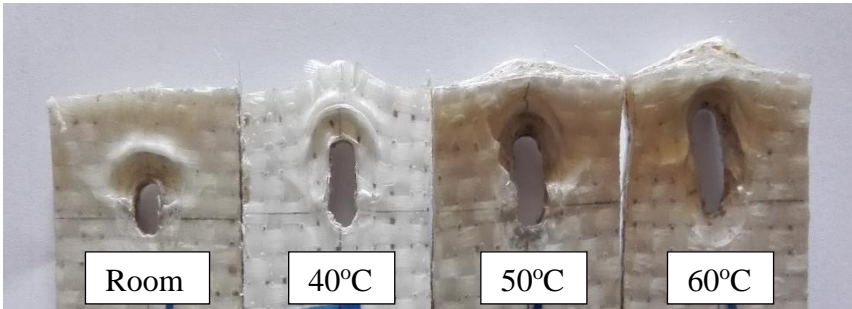
Figure 10: Photo of deformed specimens at various temperatures under 7.5Nm preload moment

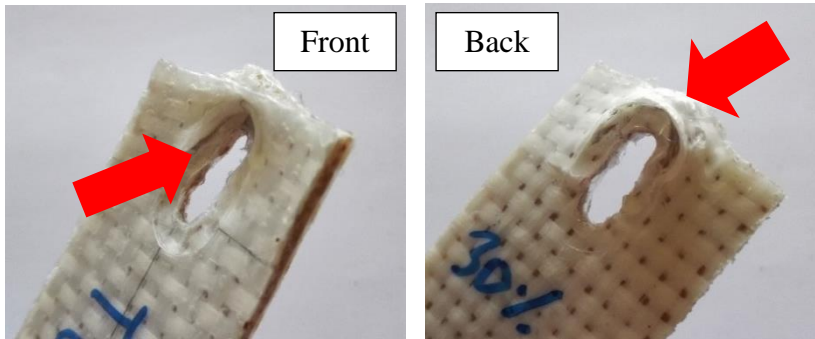
Figure 11: Photo showing “plunging” of washer into the specimen (Left: front side; Right: back side)

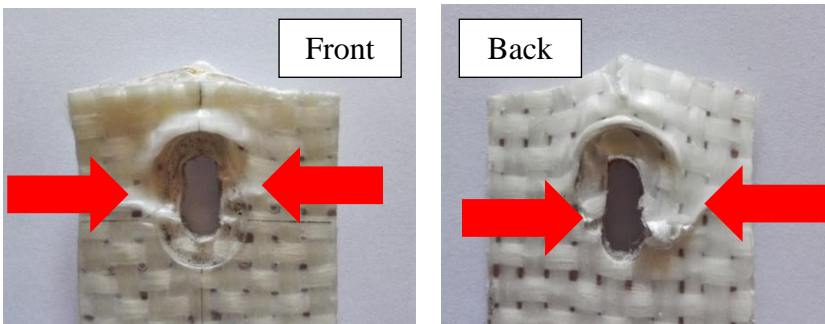
Figure 12: Photo showing the onset of net-tension failure mode (Left: front side; Right: back side)

All specimens showed the same failure mode which was bearing failure mode. This shows that the load was the highest at the contact point between the top side of the hole and the bolt. The bearing deformation continued to propagate and subsequently bearing failure mode was superseded by net-tension failure mode. During the experiment, small crack lines perpendicular to the length of the specimens were observed, the small

crack starts to propagate at the two sides of the holes. However, there was no large net-tension crack line observed due to the 30% peak load drop criterion was reached and the experiment was automatically stopped by the system. This is to comply with ASTM D5961 standard in order to observe the true failure mode and prevent the masking of true failure mode. Table 2, 3 and 4 summarise the test results at various temperatures under preload moment of 0, 5.2 and 7.5 Nm respectively.
