Journal Of Industrial Engineering Management

KRI DESIGN AND MITIGATION STRATEGY ON WATER DISTRIBUTION OF PERUMDA AIR MINUM MAKASSAR REGIONAL IV: A Case Study

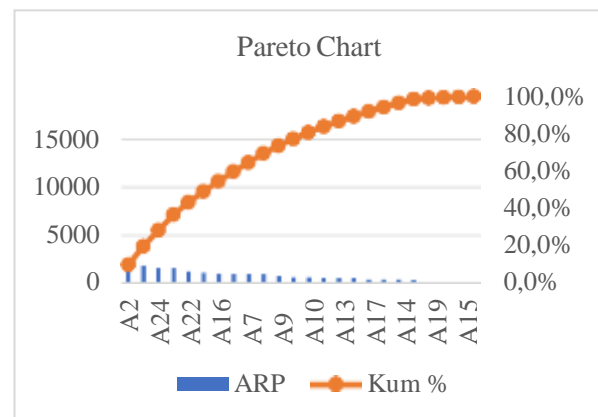
determining dominant risk agent with pareto chart. The measurement was to determine the source of dominant risk. Pareto chart was made by using cumulative percentage of each ARP values of riskagent. Picture 1 below shows the pareto chart of risk agents.

Figure 1. Pareto Chart of Risk Agent

The basis of risk evaluation in HOR phase 1 was a pareto diagram based on ARP value of risk agents which were prioritized for treatment. 80:20 principle ratio was used in this risk

evaluation. 77.3% risk agents were taken to design handling strategy which was expected to help the improvement of other 22.7% risk agents. There were 12 dominant risk agents out
