UCRL-91804  
PREPRINT

Behavior of Stressed and Unstressed 304L  
Specimens in Tuff Repository  
Environmental Conditions

Corrosion 85  
NACE Annual Meeting  
Boston, MA  
March 25-29, 1985

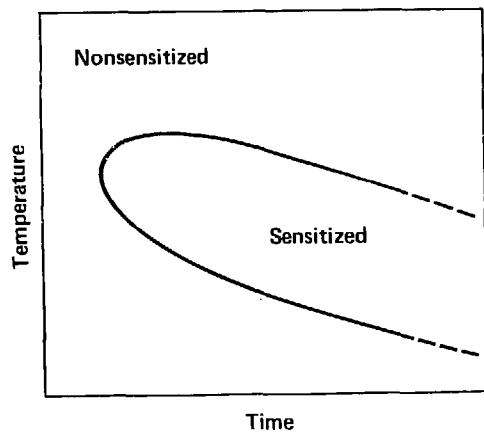
Fig. 2 Schematic time, temperature, sensitization (TTS) diagram

At low temperatures, below the precipitation region of Figure 2, isothermal carbide precipitation does not occur because of the rapid decrease in the rate of nucleation with temperature. The carbide particles, thermodynamically stable if formed at high temperatures, do not dissolve at lower temperatures. At temperatures too low for carbide nucleation, however, existing particles can continue to grow and establish a new and lower interfacial chromium level as well as a new depletion profile. Such a situation has been shown to occur by Fox (aka Povich) and others<sup>(8-11)</sup> and will be discussed later in this paper.

A sensitized microstructure can be produced in the area to the right of the time-temperature-sensitization (TTS) curve (Figure 2). It has also been shown that sensitization can occur at temperatures below the TTS curve previously believed to be immune to carbide nucleation and growth.<sup>(9, 10, 11)</sup> This phenomenon is termed low temperature sensitization (LTS).

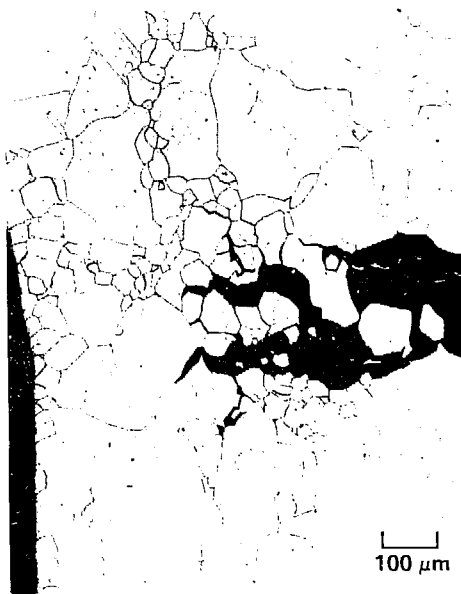
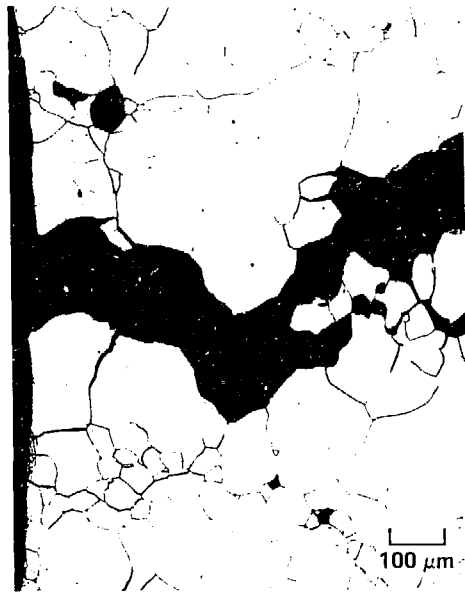
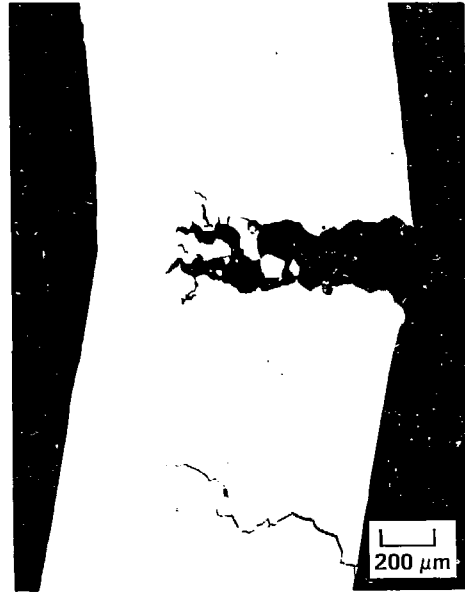
Fig. 5 Metallographic cross-sections of sensitized Type 304 U-Bend specimens showing IGSCC.

Metallographic examination of the fractured specimens in both the 50°C and the 90°C tests revealed only intergranular stress corrosion cracking (IGSCC). An example is shown in Figure 5. Other than the failures noted, the specimens appeared to be in good condition, with no evidence of pitting or other forms of non-uniform attack.
