The performance of carbon fibre composites as ICCP anodes for reinforced concrete structures

VAN NGUYEN, Chinh, LAMBERT, Paul, MANGAT, Pal, O'FLAHERTY, Fin and JONES, Graeme (2012). The performance of carbon fibre composites as ICCP anodes for reinforced concrete structures. *ISRN Corrosion*, 2012, 1-9.

The Performance of Carbon Fibre Composites as ICCP Anodes for Reinforced Concrete Structures

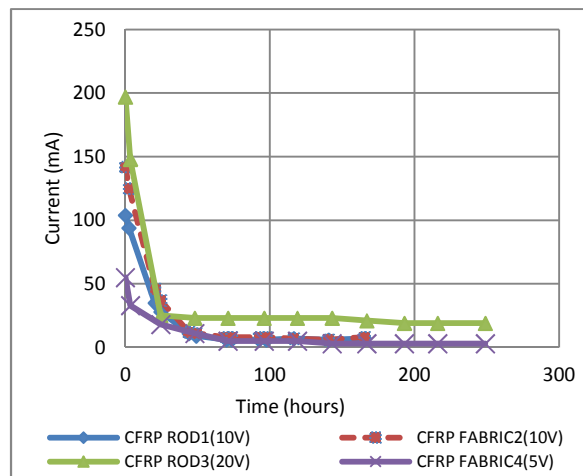
FIGURE 6: Applied current versus exposure time ($\text{Ca}(\text{OH})_2$ electrolyte)

It can be seen from Figure 6 that as the exposure time increases, the current passing to both the CF rod and fabric anodes reduced significantly in the first of 50 hours from 104mA to 9mA and 142mA to 11mA for Rod 1 and Fabric 2, respectively. When operated at 20V the current passing to Rod 3 anode decreased dramatically from 197mA to 25mA after 24.5 hours of exposure, with a further reduction to 19mA at which it appeared to stabilise. Even when operated at 5V the Fabric 4 current dropped from 55mA to 5mA in the first 71 hours, and continued to fall to 3mA after 143 hours, where it remained stable until the test was terminated at 249 hours. This is attributed to the dissolution of the CF rod or fabric anode into the calcium hydroxyl solution, causing an increase in resistance.

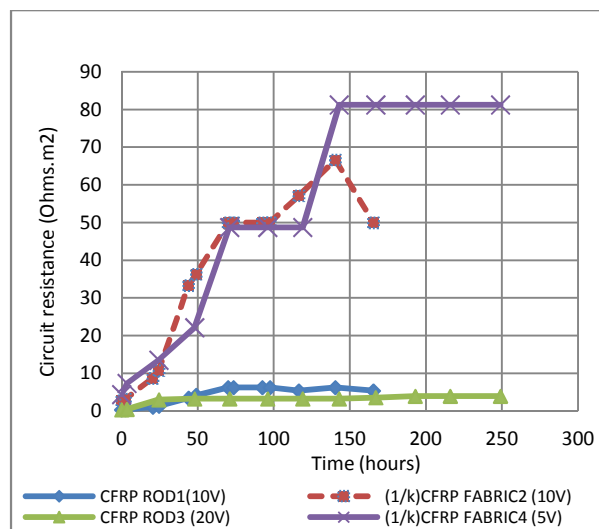
FIGURE 8: The circuit resistance versus exposure time ($\text{Ca}(\text{OH})_2$ electrolyte)

Figure 8 shows the circuit resistance versus exposure time relationships for specimen 1.1, 1.2, 2.1 and 2.2. The Rod 1 anode circuit resistance increased moderately in the first period of 70 hours from $0.4 \Omega.m^2$ to $6.3 \Omega.m^2$. Thereafter, circuit resistance remained fairly constant at around $5.4 \Omega.m^2$ to $6.3 \Omega.m^2$. However, for Fabric 2 anode, the circuit resistance rose significantly in the first period of 70 hours from $2.8k \Omega.m^2$ to $50k \Omega.m^2$ and achieved the highest value of $66.7k \Omega.m^2$ after 140.5 hours of exposure. In addition, after 165.5 hours exposure, the mass loss of Fabric 2 anode was 2.69% compared to 0.51% for the Rod 1 anode. Therefore, it can be concluded that the rate of dissolution of the CF fabric was significantly higher than that of the CF rod for the same period. This may be due to the exposure areas of the CF fabric in the electrolyte solution being much greater than that of the CF rod. Also the circuit resistance in the case of Fabric 4 anode increased dramatically in the first 71 hours of operation from $4.4k \Omega.m^2$ to $48.8k \Omega.m^2$ and remained constant for a further 48 hours before rising again to $81.3k \Omega.m^2$ after 249 hours, presumably due to dissolution of the CF fabric. By contrast, the circuit resistance of Rod 3 anode increased only slightly to $4 \Omega.m^2$ after 249 hours. It can be seen that CF fabric dissolved much more than the CF rod, despite the voltage applied to CF fabric being lower. However, it should be noted that the CF rod anode suffered significant damage (see Figure 4). Therefore, the magnitude of voltage applied to the anode needs to be considered carefully in order to avoid damage to the anodes.

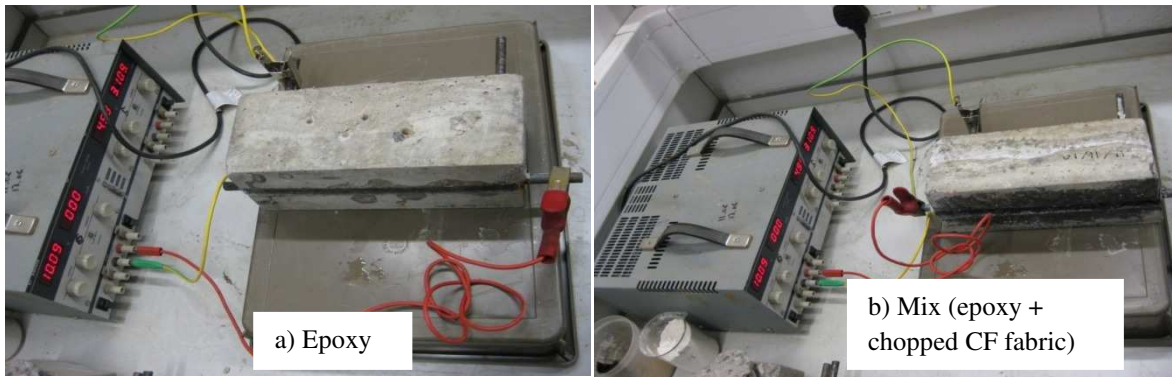
FIGURE 10: Bonding CF rod to grooved concrete prism using a) epoxy (4.2a) and b) epoxy plus chopped CF fabric (4.2b)

Specimens 4.1 consisted of CF fabric bonded to the surface and 4.2a of a CF rod bonded into pre-formed grooves of the beams using epoxy. CP was applied to the reinforced concrete prism with the CF fabric or rod employed as the anode. The CP was applied 7 days after the application of the CF anodes to the concrete prisms.

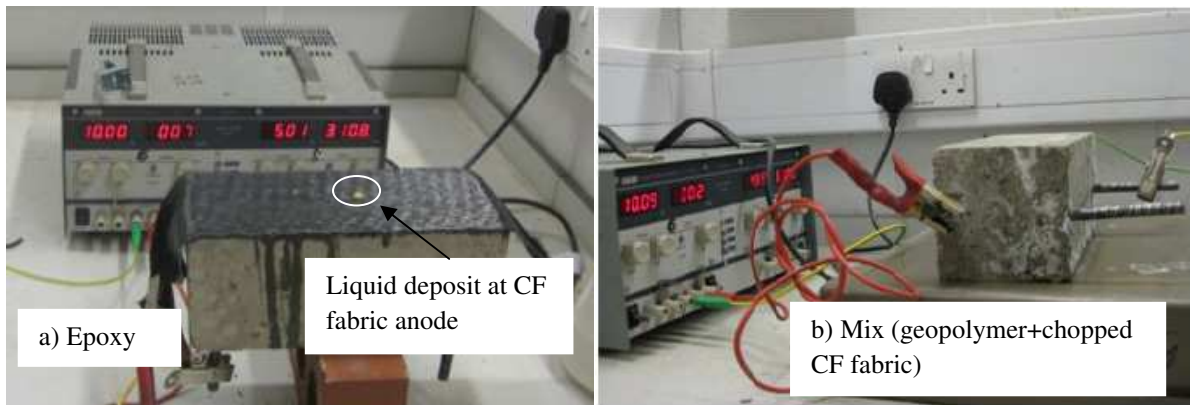
FIGURE 11: The performance of CF fabric anode bonded to concrete surface by epoxy (4.1) and CF rod anode bonded to grooved concrete by geopolymer plus chopped CF (4.2c)

The observed current passing to the CFRP fabric demonstrated that the CF fabric with epoxy had sufficient electrical conductivity to operate as an anode (Figure 11a). However, there was no current passing through the CF rod, demonstrating that the combination of CF rod and epoxy is not sufficiently conductive (Figure 10a). In order to correct this problem a number of alternatives were considered, such as adding carbon powder to the epoxy to increase electrical conductivity, using a combination of fabric with rod either by wrapping or lining the slot before embedding the rod in epoxy, and using a geopolymer or high strength cementitious grout in place of the epoxy.

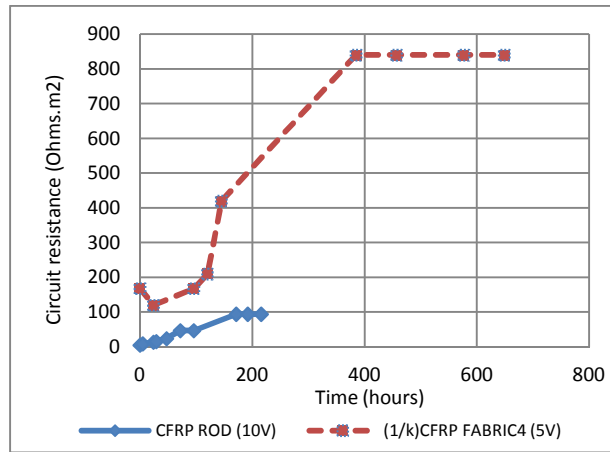
FIGURE 13: Circuit resistance versus exposure time (4.1 and 4.2c)

Figure 13 shows that the circuit resistance of CF fabric anode increased considerably in 385 hours from 168k Ohms.m² to 840k Ohms.m² and stayed at this value for the remaining time of exposure. This indicates that over long periods of operation, the dissolution of CF fabric would appear to be very small and may be tolerable. The CF fabric anode subject to a current of 1mA and applied voltage of 5V showed some limited generation of yellow liquid and gaseous deposits at the concrete-fabric interface.
