Removal of carbon films by oxidation in narrow gaps: Thermo-oxidation and Plasma-Assisted studies

The removal of hard amorphous hydrogenated carbon (a-C: H) films from narrow gaps simulating the macro-brush structures present in controlled fusion devices has been investigated. Films with thickness of 50-150 nm were generated through plasma assisted chemical vapor deposition (PACVD) in glow discharges of CH₄/He on Si and stainless steel plates. The deposited plates were then arranged to form sandwich structures building narrow gaps and were subject to erosion by exposure to O₂/He plasmas and to thermal oxidation by O₂ and by a NO₂/N₂ (1:1) mixture. In the plasma etching experiments, the deposited layers were only partially removed by the plasma at the side wall gap surfaces, but were efficiently removed at the bottom of the gap. In the thermo-oxidation experiments, the deposited films were effectively and homogeneously removed with oxygen at 670 K and with the NO₂/N₂ mixture at T > 570 K.

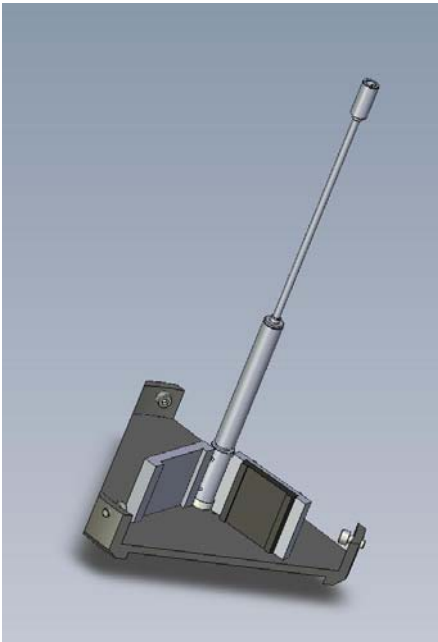
Figure 1

Fig. 1. Scheme of the plates used for deposition and removal of a-C: H films.

In order to simulate the constrained geometry of the gaps of the macro-brush structures, the a-C: H layers previously deposited on two separate plates at direct exposure to the methane plasmas were assembled to build the walls of flat box-like containers having only a slit for access (Fig. 1). The plates had typically a square basis of ≈ 25 mm side and 1 mm thickness. In the thermo-oxidation experiments, the open slit was 1 mm wide. In the case of plasma-assisted removal, entrance slits with widths of 0,25, 0,4 or 1 mm were employed. Both, the side walls and the bottom of the simulated gap structures were covered with the carbonaceous films at the start of the removal experiments. The film was deposited with the structure open (see figure 1), and the structure was closed under vacuum before the cleaning.

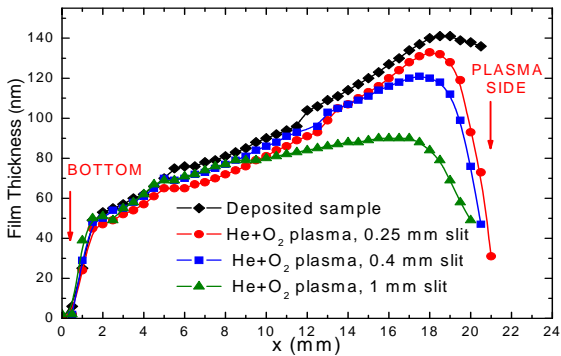
Figure 2

Fig. 2. Film thickness profile before and after its exposure to cleaning plasmas for different gap widths.

A plasma composition of 20% O₂ and 80% He (1 Pa) was used for the erosion of the carbon layers measured by mass spectrometry. The plasma current was fixed at 100 mA, corresponding to an averaged ion flux of $\approx 3 \cdot 10^{14}$ cm⁻² s⁻¹. Langmuir probe measurements yielded electron densities of $\approx 5 \cdot 10^9$ cm⁻³ and temperatures of ≈ 3 eV. A consumption of a 30% of injected O₂ was measured by mass spectrometry. For the gas flow values used, this corresponds to atom fluxes about one order of magnitude larger than ion fluxes, assuming 100% losses at the walls. Erosion rates for direct exposed samples under these conditions [9] are $\sim 0,18$ nm/s, so that complete cleaning of the external walls was achieved in less than 15 min. For a better attack into the gap, 20 min exposure time was used. After exposure to the plasma, the film thickness profile along the covered wall was measured by ex-situ laser interferometry. Thickness profiles for the three values of the gap width used are shown in the upper panel of Fig. 2, together with the profile before the plasma erosion. These measurements were carried out on a silicon sample inserted in the gap, modifying the set-up shown in figure 1. The samples were supported with a Teflon plug (5 mm length) bolted to the structure at the bottom of the gap (giving a non deposited surface that was used as reference). These steps represent the first 4 mm in figure 2. As this point was used as reference the top of the gap corresponds to 21 mm position.

Only the few uppermost mm of the covered plate (i. e. those closer to the plasma) are eroded, and the extension of the eroded area is larger for wider gaps, as expected. The spatial resolution of these measurements is limited by the laser spot size (0.5 mm). The structure observed in the depth profile is due to the shadows produced by the structure. At the bottom face of the gap, i.e. at the face opposite to the open entrance slit, 25 mm away from the plasma, full carbon removal was found (similar results were observed in previous

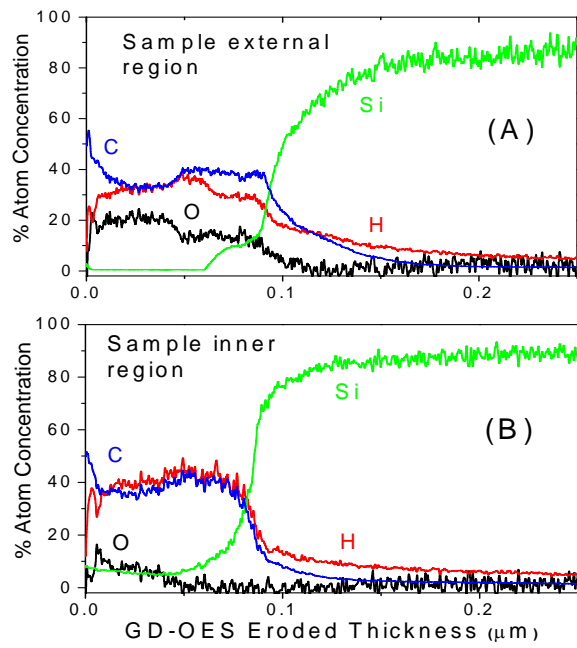
Figure 4

Fig. 4. GD-OES measurements of relative atom concentrations at the surface of an a-C: H covered Si plate, after exposure to He/O_2 plasmas through a 0.25 mm slit. (A) 5 mm from the gap entrance. (B) 15 mm from the gap entrance.

Fig. 4 shows the atomic composition at the surface of a deposited Si plate after exposure to the He/ O_2 plasma. The two panels correspond to two points from the inner face of the gap located at about 5 and 15 mm from the slit entrance, for a slit width of 0.25 mm. Under these conditions no significant film erosion was observed (see Fig 2) and a C/H layer was found at the surface. The layer closer to the entrance slit has a 20% proportion of O_2 atoms. Deeper inside the gap, the amount of oxygen is much smaller. In neither case does the oxygen enter the bulk of the plate.

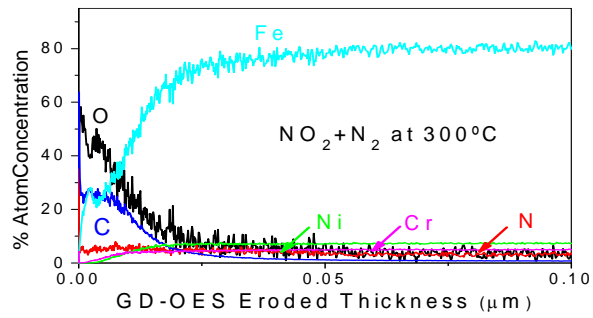
Figure 5

Fig. 5. GD-OES relative atom concentrations in SS plates after thermal oxidation in NO_2/N_2 at 570 K, inside a gap 1 mm wide.

In the experiments of thermal oxidation leading to a significant surface cleaning (i.e. with O_2 at 670 K and with NO_2/N_2 for $T \geq 570$ K), the percentage of O atoms found at the surface was always high (close to 60%), but the penetration of O atoms inside the bulk of the SS plate was also small. After oxidation in O_2 at 670 K, only a small amount of C atoms (always less than 15%) was found at the surface. After oxidation in NO_2+N_2 at 570 K, a percentage of C atoms up to 25% is found in a very thin layer at the least eroded areas (Fig. 5), whereas for 620 K, the corresponding proportion of C atoms is about 7%.
