## Review

## Biodiversity of cyanobacteria and green algae on monuments in the Mediterranean Basin: an overview

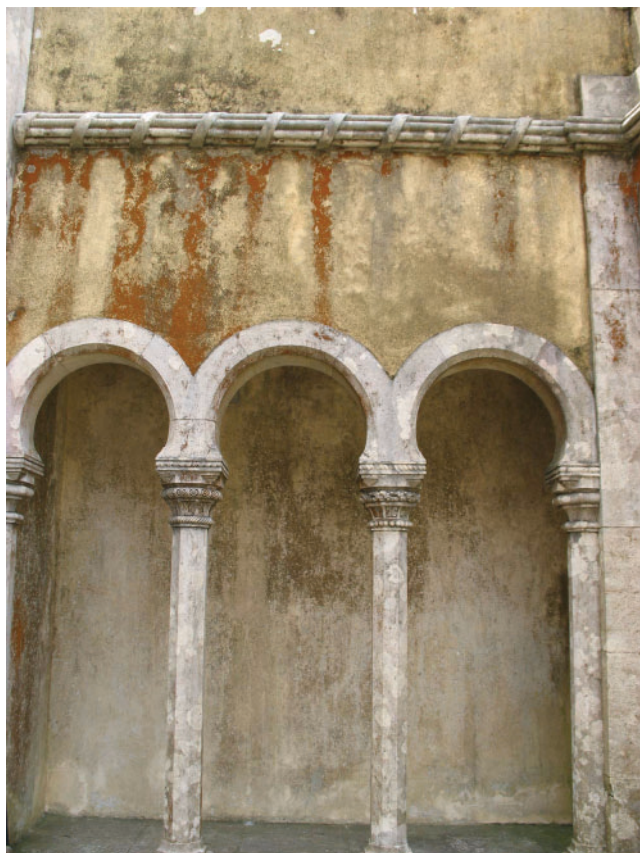
**Fig. 1.** Wall of the Palácio Nacional da Pena, Sintra (Portugal), showing extended colonization by *Trentepohlia* sp.

patinas and incrustations (Fig. 1) (Tomaselli *et al.*, 2000b). Identifying the micro-organisms involved in biodeterioration is one of the most important steps in the study of the microbial ecology of monumental stones. It can help us to understand the microbial biodiversity, the phases of colonization and the relationship among populations on the surfaces and between micro-organisms and substrata.

*Klebsormidium*, *Trebouxia* and *Trentepohlia* (Fig. 1) also showed a significant representation among the chlorophyte genera colonizing stone substrata in the Mediterranean Basin. The occurrence of *Trebouxia* and *Trentepohlia* indicates that these microalgae could be involved in the lichenization process leading to colonization by lichens. In fact, the genus *Trebouxia* occurs in approximately 20% of all lichens and has rarely been found free-living. Regarding endolithic growth of green algae, *Trentepohlia*, *Chlorella* and *Klebsormidium* were found growing under a black patina, probably a cryptoendolithic niche, in the Ordem de São Francisco Church, Portugal (Pereira de Oliveira, 2008; Pereira de Oliveira *et al.*, 2008). Cryptoendolithic growth of *Stichococcus bacillaris* was also observed in granite from the Cathedral of Toledo, Spain (Ortega-Calvo *et al.*, 1995).

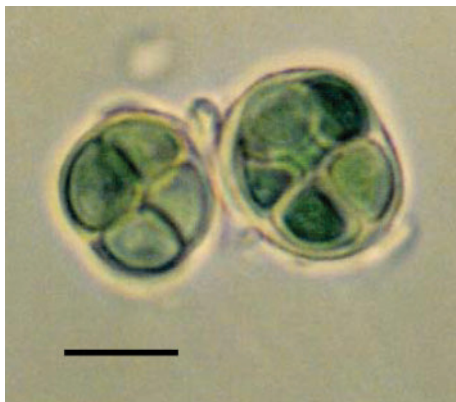
**Fig. 3.** *Gloeocapsa* sp. observed by optical microscopy. Scale bar, 20  $\mu\text{m}$ .

substratum. The data on cyanobacteria occurring on stone monuments and works of art is rather wide. A total of 96 taxa of cyanobacteria were found. The genus *Gloeocapsa* (Fig. 3) was the most widespread, occurring on 20 of the 45 monuments reported, on all substrata and represented by eight species. Cyanobacterial species from the genera *Phormidium* and *Chroococcus* were able to colonize five of the six stone substrata considered and they were represented by high species diversity: eight species of *Phormidium* and four species of *Chroococcus* were reported. *Chroococcus* species were detected colonizing 13 different monuments while *Phormidium* was found on 15 monuments. *Pleurocapsa* occurred on 13 monuments but only one species was identified, while the genus *Scytonema* occurred with five species and colonizing eight different monuments. Therefore, we can consider that *Gloeocapsa*, *Phormidium* and *Chroococcus* are the most common cyanobacterial genera on the monuments of the Mediterranean Basin. This is in accordance with Ortega-Calvo *et al.* (1995), who stated that the most common species found on monuments located in Europe, America and Asia belong to the genera *Gloeocapsa*, *Phormidium*, *Chroococcus* and *Microcoleus*. These genera are ubiquitous and therefore their presence is not strictly related to a specific lithic substratum or climate. Tomaselli *et al.* (2000b) also found that the data reported in the literature did not establish a clear relationship between organisms and the nature of the substratum. Nevertheless, these authors contend that *Phormidium tenue*, *Phormidium autumnale* and *Microcoleus vaginatus* prefer siliceous substrata.

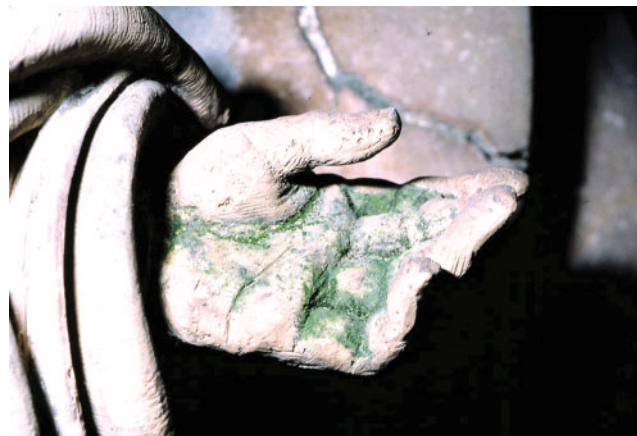
**Fig. 5.** *Klebsormidium flaccidum* biofilm on a terracotta statue, Cathedral of Seville.

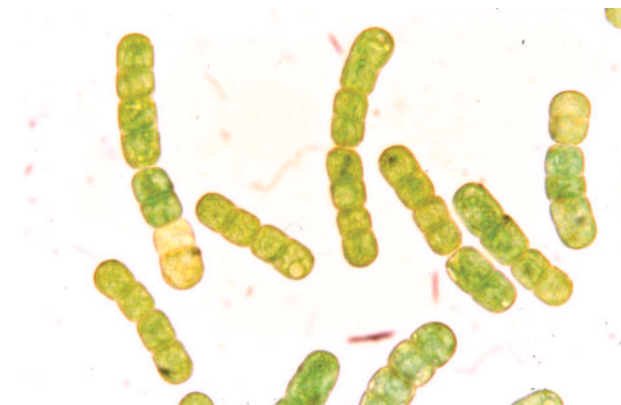
**Fig. 6.** Light micrograph of trichomes of *Borzia perikleii*, composed of 4–8 cells. Cells are 5–6  $\mu\text{m}$  wide and 5–11  $\mu\text{m}$  long.
