# **A descriptive and quantitative approach regarding erosion and development of landforms on abandoned mine tailings: new insights and environmental implications from SE Spain**

**Short title: landforms on abandoned mine tailing deposits**

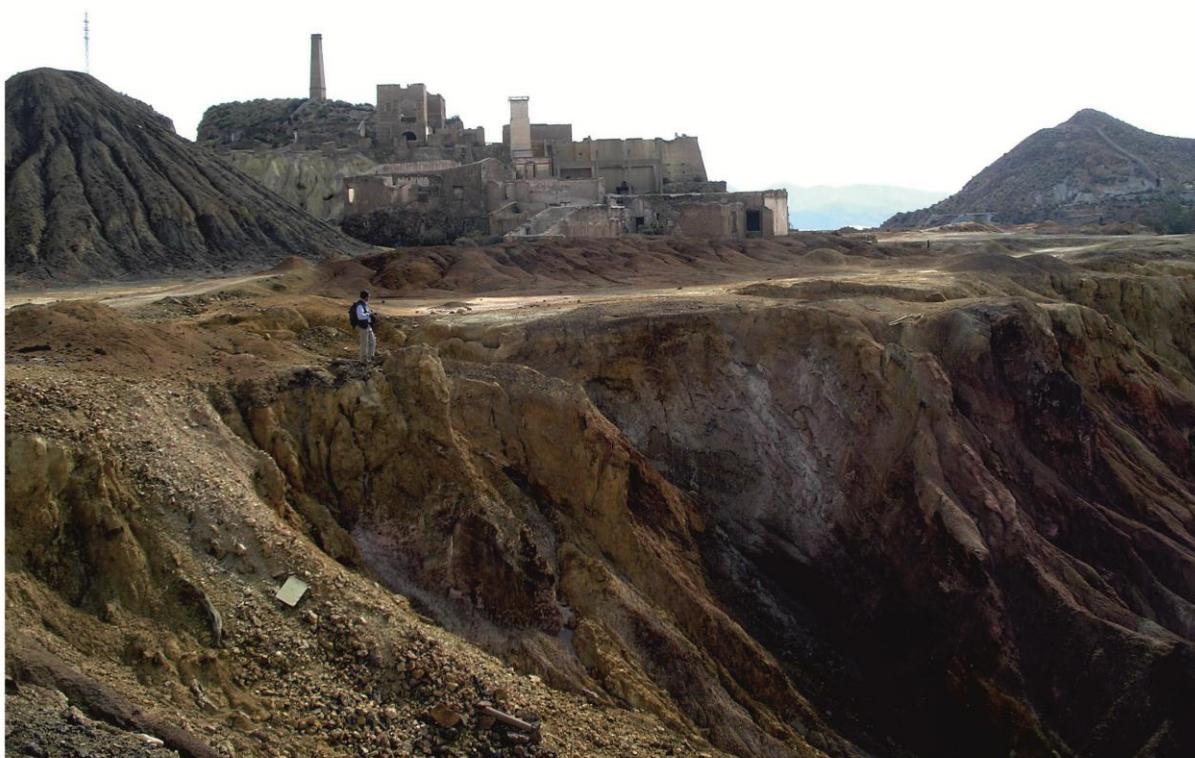
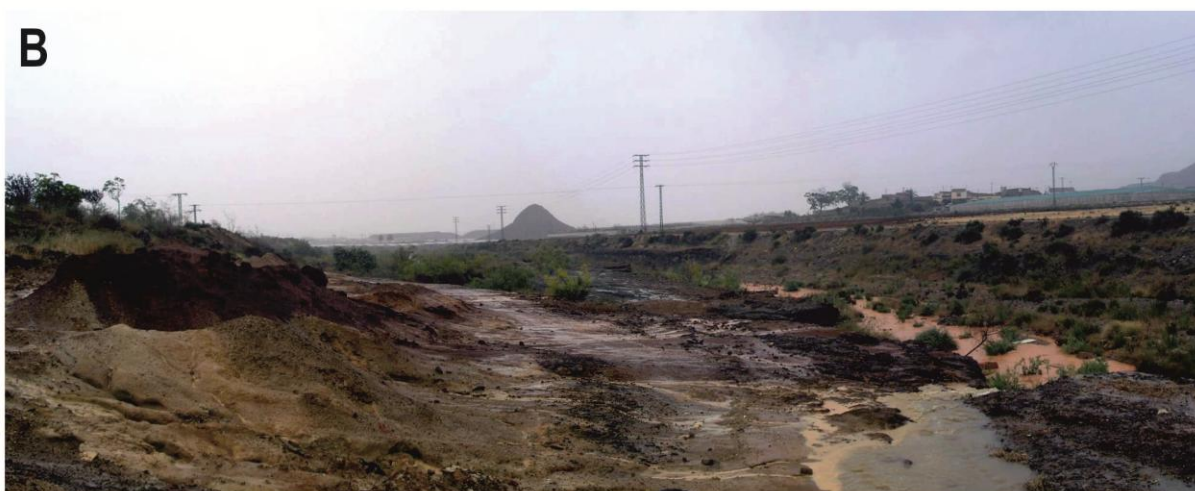
Figure 1

Fig. 1. (A) The Mazarrón district at the Iberian Peninsula. (B) Digital elevation model for Mazarrón displaying major physiographic features. (C) Climatic diagram. (D) Regional geology of Mazarrón (after Crespo et al., 2013), displaying major mining sites and location of towns. The study area is located at the San Cristóbal–Perules site.

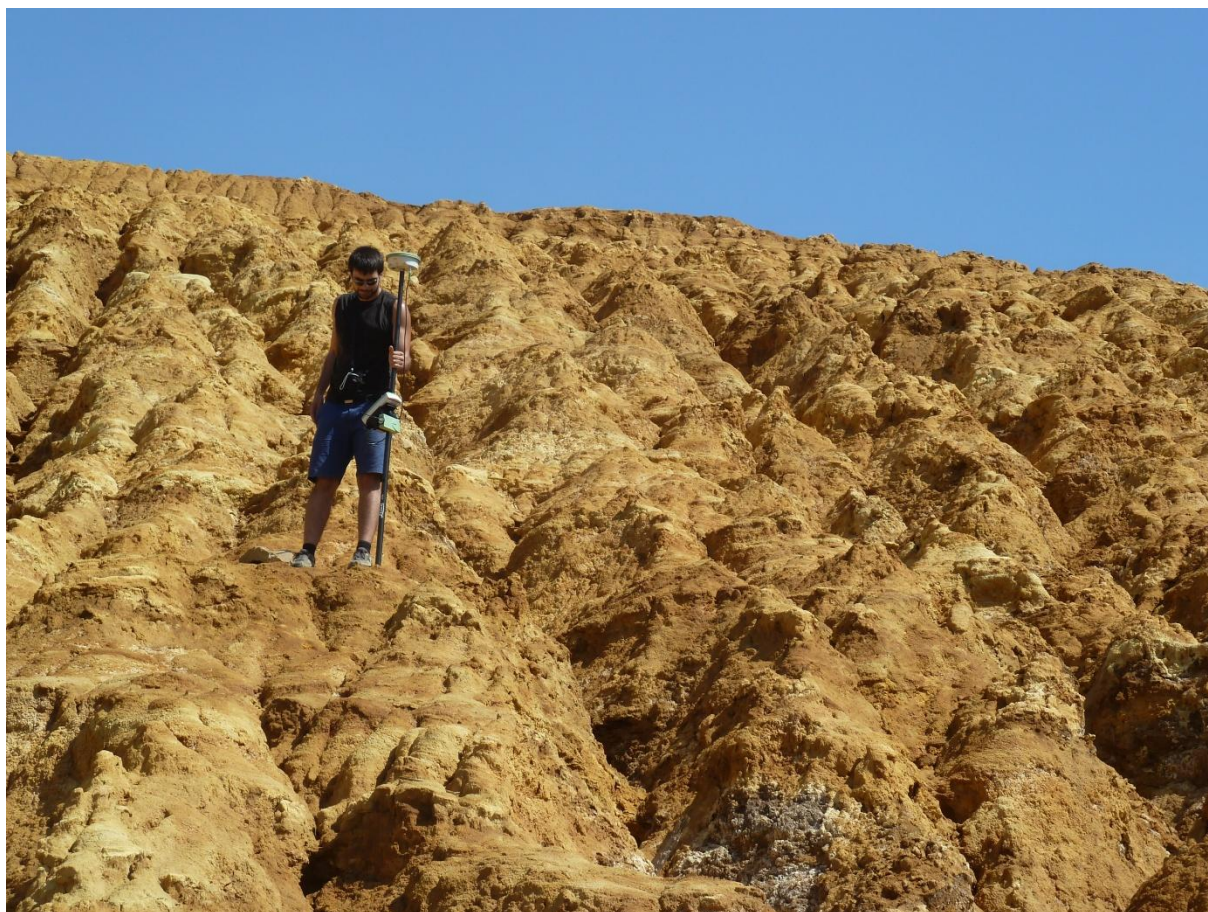
Figure 7

Fig. 7. Tailing mine deposits of El Roble, which are the focus of this paper. (A) Oblique aerial photograph as of 1968 (Paisajes Españoles S.A.). (B) Orthophotograph raised with MDE

Fig. 10. Location of the photos that constitute the catalogue of landforms of Fig. 7.

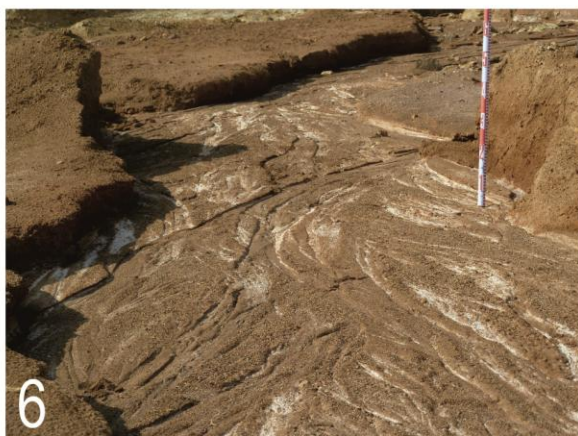
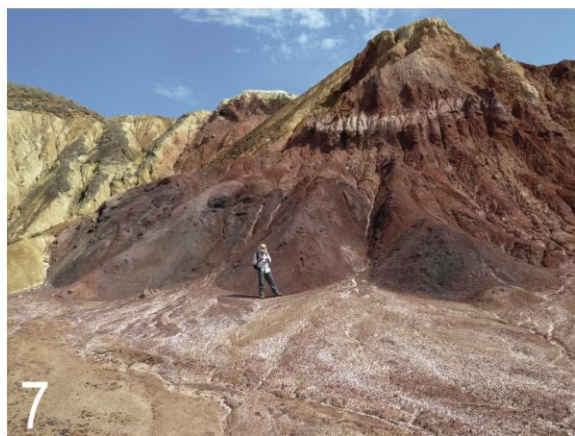
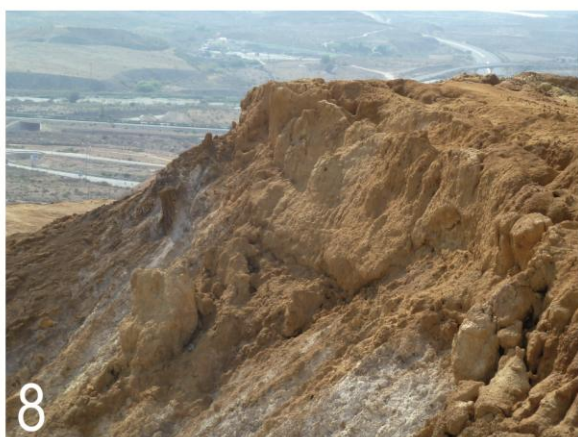
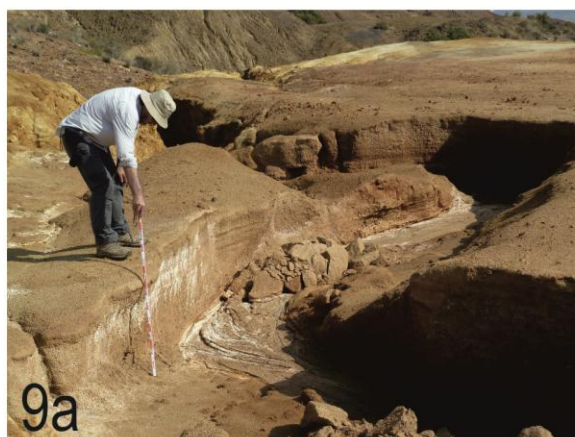
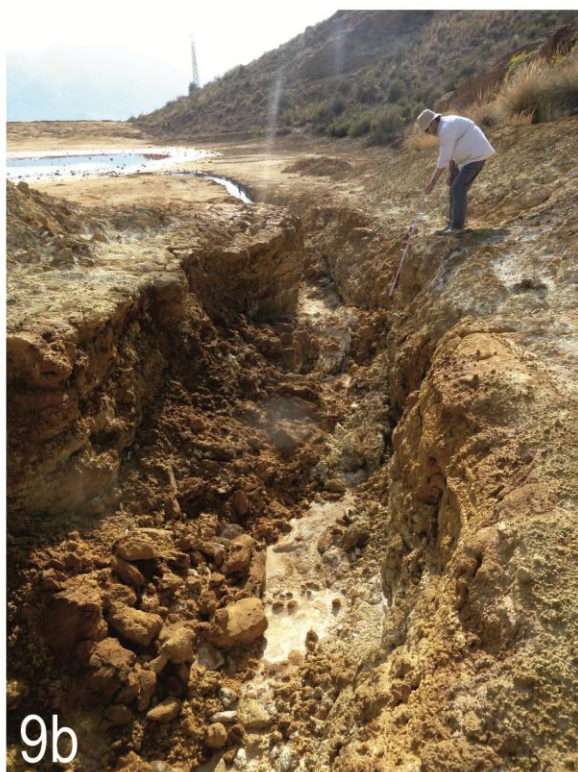
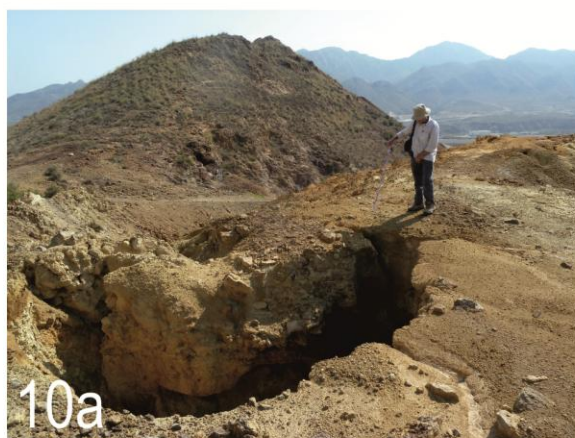
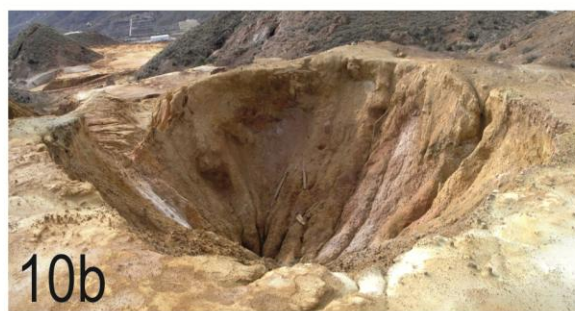
Figure 9 compiles a selection of representative examples of the inventoried landforms, and Fig. 10 shows their location. A description and analysis of the forms follow.

Sandpaper-like surfaces (3 in Fig. 9) develop at silt and sandy low-gradient slopes, mostly located just downslope of rounded divides along the tailing deposits. This denotes sheet erosion — a continuous sheet of water that covers the surface completely, mobilizing the smallest particles downslope. The location of these surfaces at the convex part of rounded

A network of dry washes develops on the flat surfaces of the tailing deposits, showing braided, sand-bed channels (6 in Fig. 9). Their beds are comprised of bedforms with a well-defined braided pattern with complex bars on which chutes are developed. At the surface of the wash complex, hydrated sulfates of variable composition appear (e.g., gypsum:  $\text{CaSO}_4 \cdot 2\text{H}_2\text{O}$ ; rozenite:  $\text{FeSO}_4 \cdot 4\text{H}_2\text{O}$ ; etc.). We deduce that these bedforms are a result of the interactions between coarse and fine fractions during bedload transport of the intrinsically heterogeneous-sizing tailing deposits. We also interpret the freshness of the landforms as a frequent activity of small (low-depth) flash flood events. Small coalescent alluvial cones (7 in Fig. 9) form where gullies on slopes and badlands-like slopes on tailings emerge to flat surfaces. Sedimentation occurs as a consequence of change of slope, where the loss of channel confinement and flow velocity propitiates the sedimentation with cone morphology, with the apex located at the mouth of the gully. Most of the identified cones are located on the top of tailing platforms at lower elevations than the eroded slopes, consequently without hydrological connection with the environment outside the mine but with risk of connection

A series of scars of earth slides (8 in Fig. 9) occur at the platform–slope edges of the tailing deposits. Despite the dominant dry conditions of the area, we interpret that these movements occur in wet conditions after either intense or continuous rainfall events. During these events, the flat-top surfaces of the tailing deposits infiltrate water, which increases the water pore pressure buildup of the mine deposits. An increasing of the pore pressure decreases the material's cohesion, triggering slope instability. Earth topples (9a in Fig. 9) appear at the steep (almost vertical) slopes of gullies on upland surfaces. The movement is rotational toward the exterior of the gullies' banks. These movements are triggered by flow undercutting at the base of the gullies' walls, mostly at external banks of meanders, where the flow concentrates. These gravitational processes move material from the gullies' walls to their bottoms, where they are temporally stored, waiting to be transported downstream in subsequent flow events. Earth falls (9b in Fig. 9) are different from the topples because in this case the material falls from the gullies' banks to their base without any rotational movement, forming a continuous small debris (talus) slope. This process is triggered by flow undercutting

Waste and tailing deposits of the El Roble surroundings are also affected by collapses. When the collapses occur in linear caves, they form collapse headwalls (10a in Fig. 9), initiating gully formation. We interpret these collapses as a consequence of piping processes (also called tunnel erosion or pseudokarst) — a subsurface erosion process in which percoline-controlled flowing water removes soil particles. Therefore, a subterranean drainage network forms. Once these cavities collapse, their surfaces form gullies' headwalls. We interpret the occurrence of piping here as a consequence of any of the following factors: (i) the soil particles of the tailings are cemented by sulphates — unstable chemical byproducts in the tailings — so that dissolution processes at wet conditions of these hydrated sulphates dissolve the cement and soil particles become loose; or (ii) the presence of alternating layers of permeable and impermeable materials at the tailing deposits, which may have facilitated lateral flow of water within them, coupled with the presence of outlets of the pipe systems at the tailing slopes, favoring the formation of the pipes. We interpret that piping has a key role in this minescape of the Mazarrón abandoned mine deposits. When the collapses happen in a specific point, they have a truly funnel morphology (collapse sinks, 10b in Fig. 9), very similar to that of limestone sinkholes. Collapse sinks are also interpreted as a consequence of piping. Spontaneous combustion of carbon spoil heaps has been reported to give rise to similar subsurface cavities in coal-mined areas (Bell, 1996).

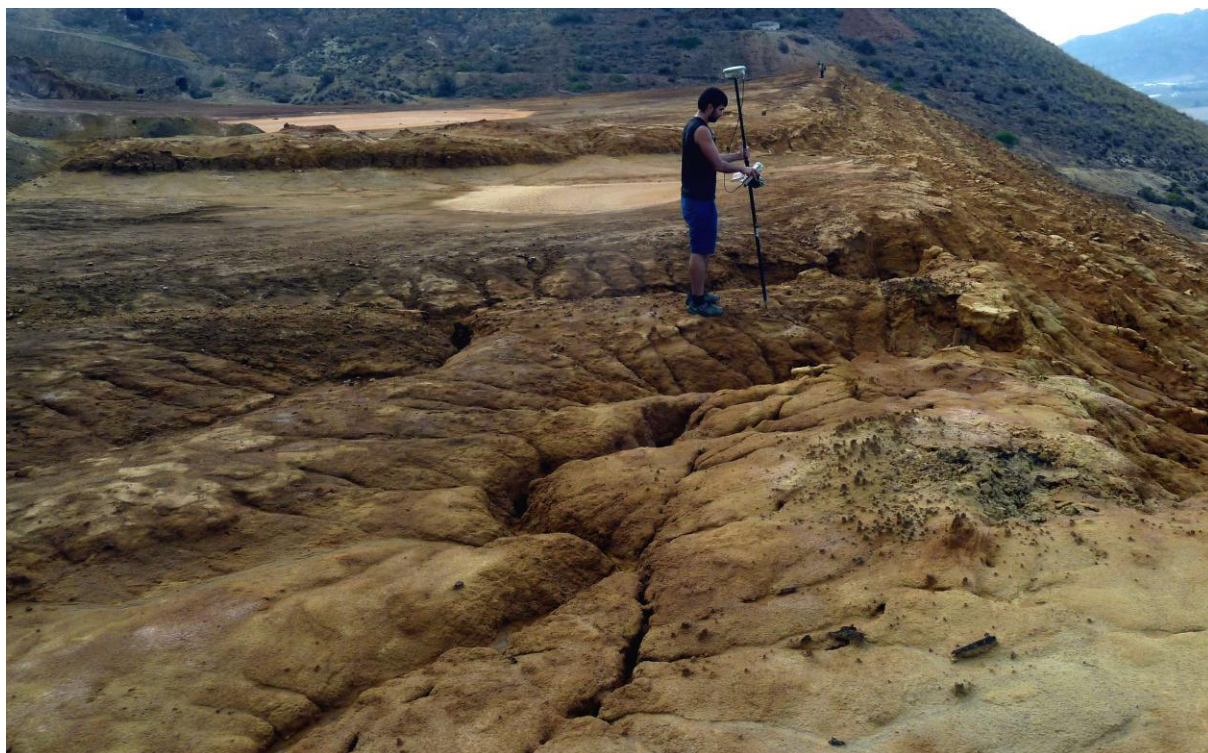
Figure 13

Fig. 13. Edge of the El Roble tailings dam. The slope toward the right of the image is the tailings dam, formerly the only element hydrologically connected with Las Moreras fluvial system. As geomorphic instability progresses, the platform toward the right of the image (that was the beach area of sedimentation behind the tailings dam), originally forming a closed basin, connects with the Las Moreras fluvial system by gullies' headcutting (see gullies at the lower half of the image).

the slopes of two tailings' dams in the El Roble area —but also other areas of the San Cristóbal–Perules mined site— are hydrologically connected with the Las Moreras fluvial system. That causes, during intense storms, flash floods at Las Moreras that are loaded with sediments coming from this mined site (Figs. 2 and 12). As this geomorphic system evolves, new areas of the minescape connect with the Las Moreras wadi. The process of a progressive increase of mined areas hydrologically connected with Las Moreras fluvial system is caused by the process in which gullies of the upland surfaces ('tailing platforms') expand on undissected surfaces by headcutting (Fig. 13).
