Open Journal of Ecology, 2014, 4, 565-570

The Vascular Vegetation Populating the Flora in Building Materials of Historic Monuments Cities of the West Central Region of Morocco

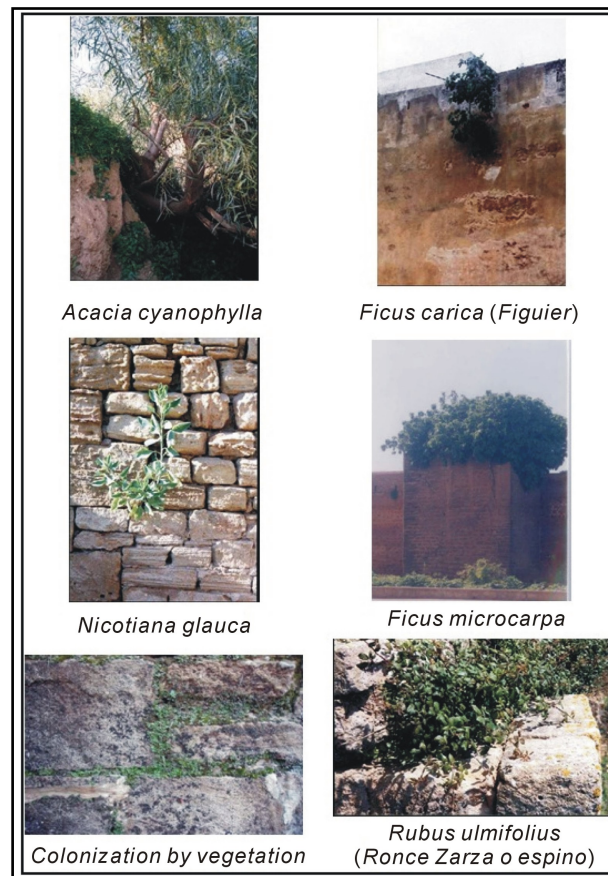
Figure 2. Some species growing on the walls.

cyanophylla, *Olea europea*, *Celtis australis*, *Rubus ulmifolius*, *Ficus elastica*, *Ficus carica*, *Prunus amygdalus*, *Nicotiana glauca* et *Jasminum fruticans* (Figure 2). These species have fleshy fruits and are often spread by birds.

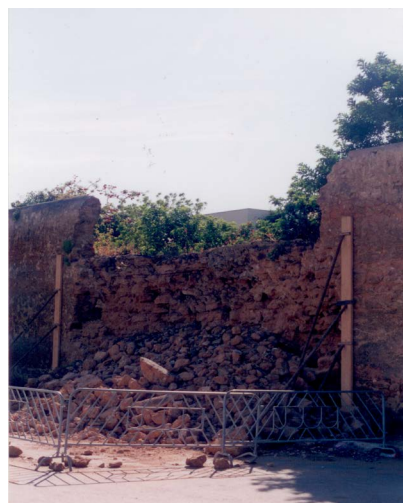
Figure 3. Thrashing has the effect of tree roots (Wall of Rabat).

In the case of carbonates rocks, the phenomena of dissolution by roots and recrystallising of calcite inside the cortical cells were established well by [12]. This leads to the reconstruction of real structures of calcitized rhizomorphes forming ribbons from 1 to 2 mm wide; calcitized cells of a size of 100 µm belong as well to the skin, the cortical parenchyma and the endoderm. The most dangerous category is phanerophytes (trees) which, by their volume of roots explode walls and create deep cracks.

Obviously for historic monuments, the presence of mosses and vegetables already supposes certain degree of alteration which it is necessary to remedy (Figure 3).
