# Fracture Properties of Ductile Cast Iron used for Thick-Walled Components

**Philip Minnebo**

DG JRC  
Institute for Energy

EUR21841EN

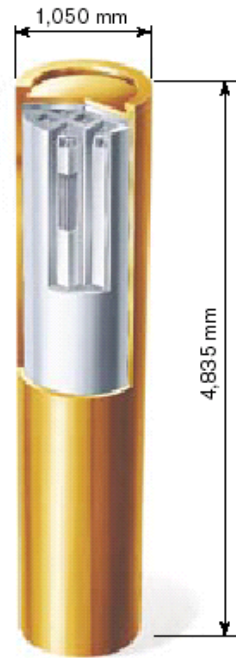
Figure 1:  
overall KBS-3 canister dimensions

Within the scope of the Joint Research Centre's Action "SAFE-CASK" (EURATOM Framework Programme 6), a comprehensive experimental programme was carried out at the Institute for Energy addressing the inserts of three KBS-3 nuclear waste canisters. Figure 1 shows the overall dimensions of these canisters, which are designed for the deep geological disposal of Boiling Water Reactor spent fuel. The outer shell consists of 50 mm thick copper, providing resistance against corrosion and inside is a thick-walled insert of ductile cast iron to guarantee sufficiently high mechanical strength to withstand the pressure in the deep repository. [1]

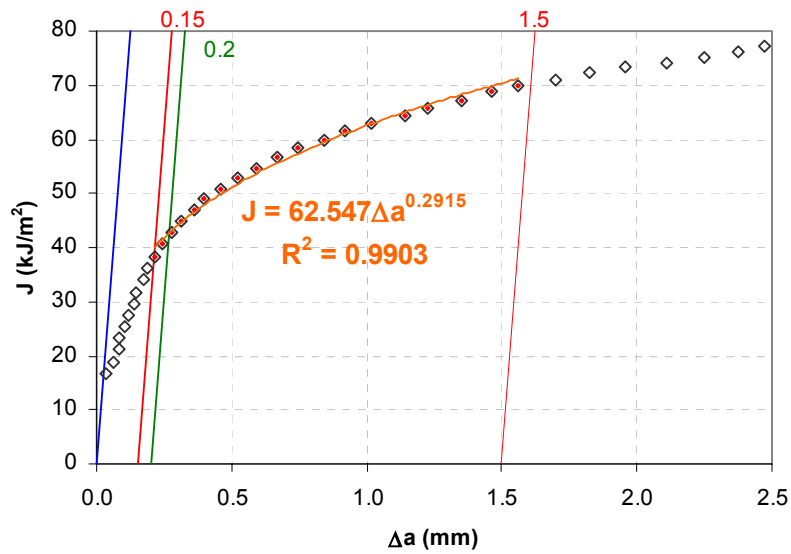
Figure 6:  
R-curve obtained from canister insert I25 material (top transversal specimen)

Figure 6 shows an example of an R-curve related to insert I25. As is apparent from this figure, the R-curve is in fact defined as a power law fit considering the “qualified” ( $J, \Delta a$ ) data points in between the 0.15 mm and 1.5 mm exclusion lines:

$$J = C_1 \Delta a^{C_2}$$
