# Seismic Retrofitting of RC Frames with RC Infilling

The effectiveness of seismic retrofitting of multi-storey multi-bay RC-frame buildings, by converting selected bays into new walls through infilling with RC, was studied experimentally at the ELSA facility at JRC, Ispra, and the results are reported here. The full-scale model tested with the pseudo-dynamic method consisted of two parallel frames, linked through 0.15m slabs, having three bays each (8.5m long), with the central bay (2.5m) infilled with RC wall, and being four storeys tall (12m). The frames were designed and detailed for gravity loads only and are typical of similar frames built in Cyprus in the 1970's. Different connection details and reinforcement percentages for the two infilled frames were used in order to study the effects of these parameters. The results of the pseudo-dynamic and cyclic testing performed are presented and conclusions are drawn.

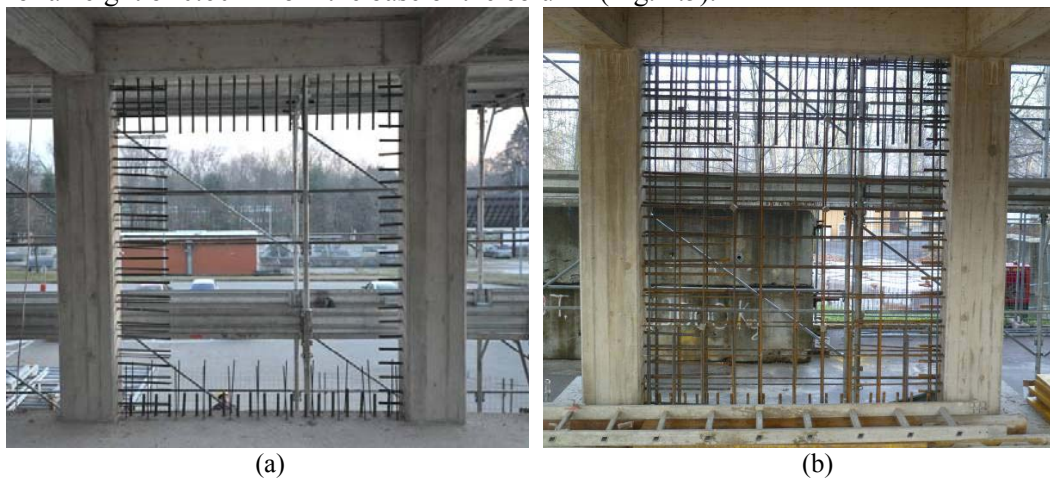
**Figure 2.4.** (a) Dowels and starter bars, (b) Dowels, starter bars and web reinforcement

Two parameters were examined: a) the amount of web reinforcement in the walls and b) the connection detail between the wall and the bounding frame. The web reinforcement in the two walls is shown in Table 2.1. Regarding the connection detail, two distinct connection details were used. In the first detail, the web bars are connected to the surrounding frame through lap-splicing with the same diameter starter bars epoxy grouted into the frame members. Short dowels are then used in order to transfer the shear at the interface between the wall and the frame member. This detail was used to connect the wall at the bottom beam and right column at the 1<sup>st</sup> and 2<sup>nd</sup> floors of the specimen (Fig. 2.4a).

In the second detail, longer dowels were used to double as dowels as well as for anchorage of the web panel to the surrounding frame; to this end, the dowels are considered as lap-spliced with the nearest – smaller diameter – web bars. However, in this case, the clear distance between the dowel and the nearest web bar, violates the maximum clear distance of 50 mm or 4 $\Phi$  between lapped bars, specified in Eurocode 2. This detail was used to connect the wall at the top beam and left column at the 1<sup>st</sup> and 2<sup>nd</sup> floors of the specimen (Fig. 2.4a). In the 3<sup>rd</sup> floor of both the north and south frames only the second detail was used, while for the 4<sup>th</sup> floor only two dowels per wall interface were used to provide safety against falling of the wall out of plane. The reinforcement details for the dowels and the starter bars are shown in Table 2.1. The completed wall reinforcement (including web, starter bars and dowels) for the 1<sup>st</sup> floor of the south wall is shown in Fig. 2.4b.

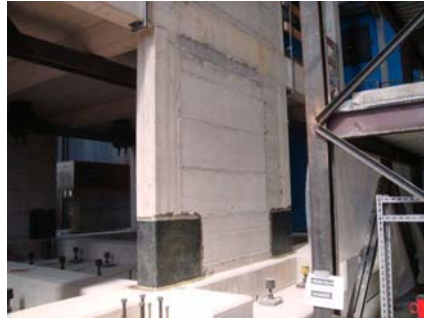
**Figure 2.5.** Reinforcing of the column with CFRP to safeguard against column lap-splice failure

Since the lapping of the column reinforcement could take only compression, then it was obvious that there would be lap splice failure, which could be detrimental to the whole experiment. Therefore, in order to safeguard against this type of failure and allow the experiment to be performed without any premature failure, it was decided to reinforce the edges of the wall at the 1<sup>st</sup> floor with three-sided CFRP for a height of 0.60m from the base of the column (Fig. 2.5).
