Article

Postmortem Analysis Using Different Sensors and Technologies on Aramid Composites Samples after Ballistic Impact

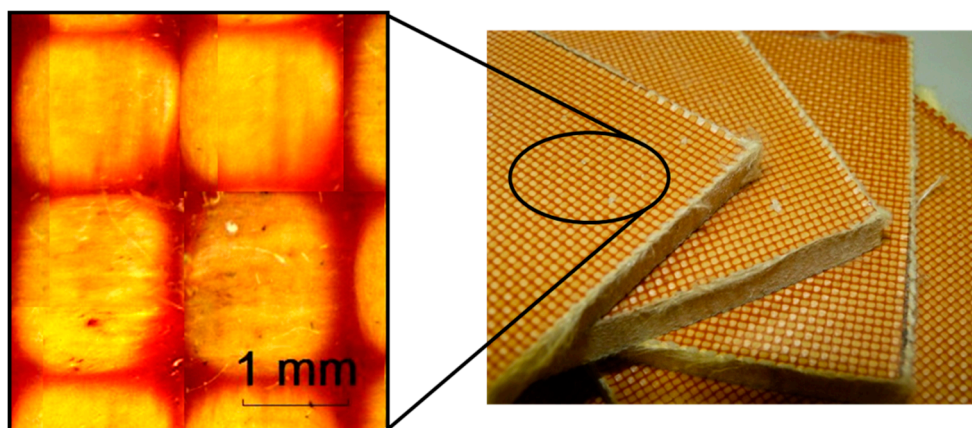
Figure 1. K129 aramid composite used in this work and description of the size of the fibres.

Aramid composite material used in this work is shown in Figure 1. The scale presented gives an idea of the size of the fibre in the compound and leads to a more macroscopic analysis of the induced damage.

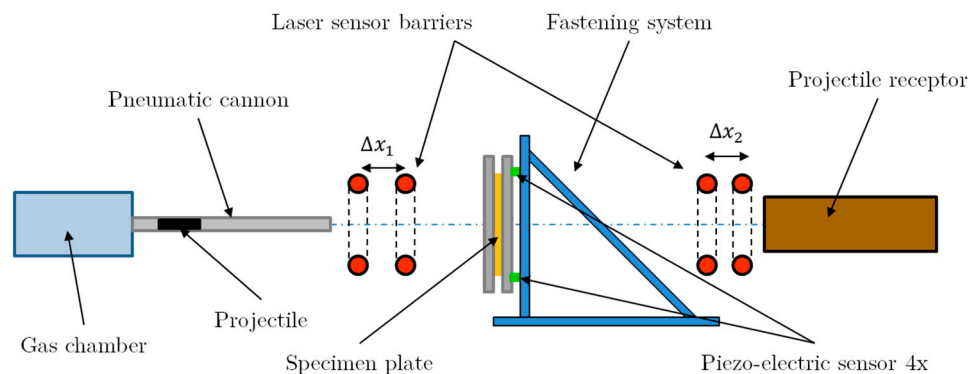
Figure 2. Experimental impact setup description.

The experimental setup has been used in several ballistic studies with different materials [30–33]. The main device has been designed in LEM3 (Laboratory of Microstructure Studies and Mechanics of Materials) and is based on a 13 mm barrel diameter pneumatic launcher, Figure 2. Once the projectile is ejected from the muzzle, the impact velocity of the projectile is measured by two laser-gate sensors separated 50 mm. Measuring the time interval that the projectile takes to travel that distance, the impact velocity is determined by the expression, $\Delta X/\Delta t$. It has been verified that the maximum error on impact velocity is approximately ± 1 m/s [30–33]. In the case of specimen perforation, another similar laser barrier separated 5 mm system measures the residual projectile velocity.

The plate fixation device is a rigid structure that allows the secure placement of the specimen. Two steel frames fasten the sample in the perimeter, allowing an effective impact area of 100×100 mm². This structure is close enough to the cannon muzzle to ensure the normality of the impact and placed in the centre of the plate.

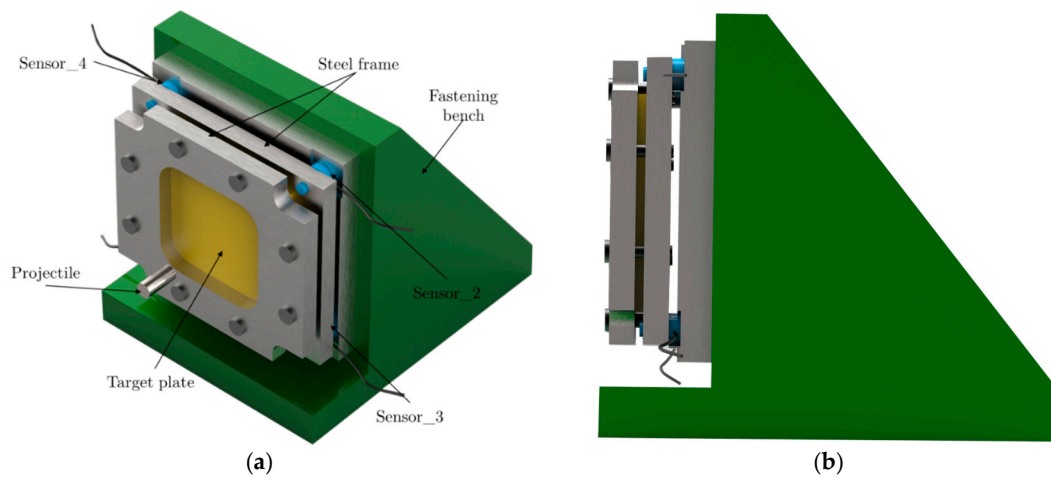
Figure 3. Target elements locations. (a) Perspective view; (b) Lateral view.

Four piezoelectric force sensors (9011A Kistler) are used to measure the global force induced by the projectile on the target during impact. These sensors are fixed over the plate holder (Figure 3) and allow measuring the dynamic force along the impact velocity direction. The range of the maximum force that the sensors system can measure is 60–80 kN (15 ± 5 kN), and the natural frequency is 65 kHz for each sensor. The four sensors are coupled to an amplificatory device.

The structural support has been designed by Kistler and presents a high stiffness and yield stress ($\sigma_y \approx 850$ MPa) to avoid bending during an impact event. The mass of the complete structure is close to 40 kg (Figure 3).

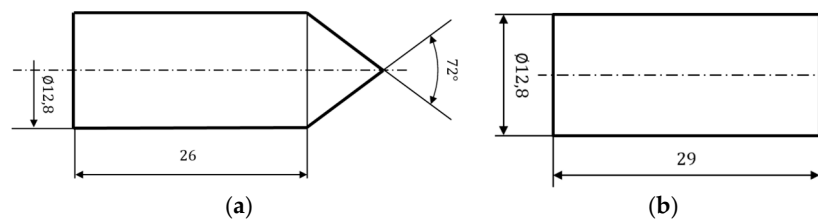
Figure 4. Dimensions of the projectiles for impact. (a) Conical projectile; (b) Blunt projectile. Dimensions in mm.

To compare the results obtained with similar impact energies, two types of rigid projectiles of 28grams mass and different geometries (conical and blunt-nosed shape) have been manufactured of maraging steel with heat treatment to increase their hardness close to 600 HV. Therefore, the local and global failure modes in the aramid composite plate depend on the projectile nose. The diameter of the

projectile is 12.8 mm which is slightly smaller than the diameter of the barrel, to avoid the use of the sabot. The dimensions of the two projectiles are shown in Figure 4.

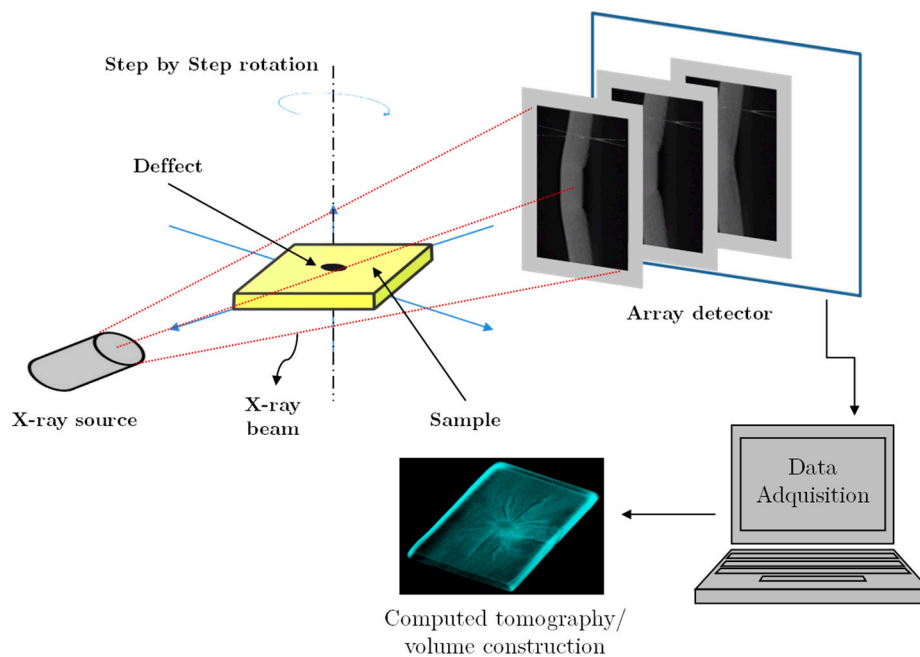
Figure 5. Computerised micro-tomography (CT) process scheme for measurement and acquisition.

Computerised micro-tomography (CT-scan or CT) is a powerful technique which consists of X-Ray scanning axial images of high quality and precision. An X-ray beam is projected on the sample to be analysed, and part of the radiation that has not been absorbed by the object is collected by detectors like a spectrum. A data acquisition system transforms the data obtained by the sensors into digital images. From this, a grayscale voxel image that depends on the number of electrons that has been absorbed by the object is obtained. Greyscale is limited by white colour, associated with undamaged material, and black colour, due to a change in density because of the presence of air as a result of breaks or defects. A scheme of a CT process is shown in Figure 5.

In this work, the internal damage of aramid plates after impact has been analysed using the CT-scan technique. Images were obtained by an X-ray micro-tomography device (model EasyTom Nano, Rx Solutions) with a minimum X-ray beam power of 160 kW which is possible to scan with a precision of 50 μm . Each plate takes around 4 h of scanning, requiring later image post-processing (AVIZO and X-Act 2.0 software was used). Tomography on aramid composites is a technique that has been rarely used, so it is a promising process of damage measurement with a wide range of applications in this material [22,24]. Some representative parameters used to scan the samples are presented in Table 2.

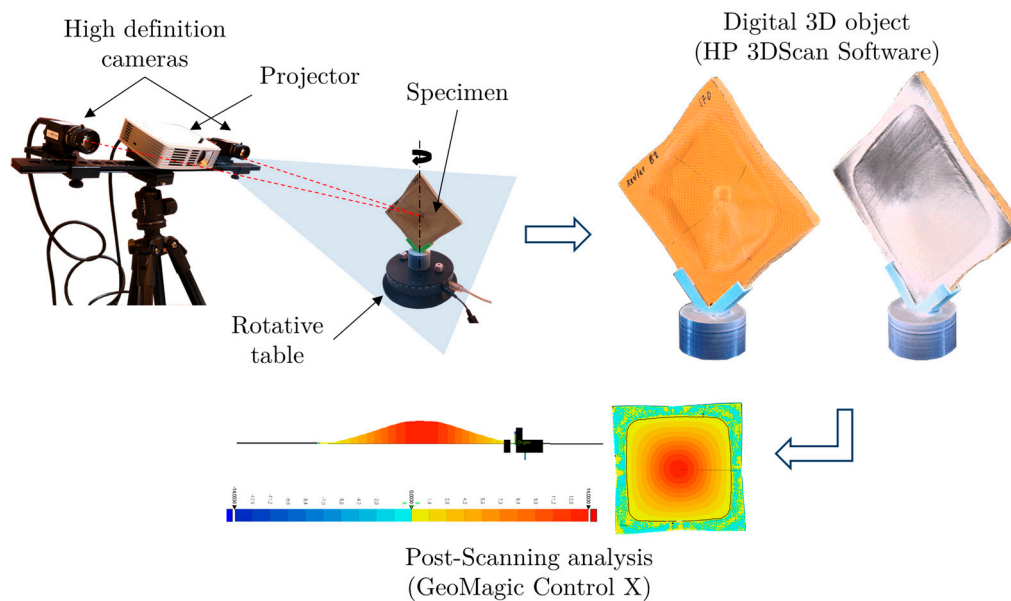
Figure 6. 3D scanner equipment to measure permanent deformation on samples.

The surface damage and the local and global deformation measurements of the tested plate have been obtained using an HP brand scanner (model HP 3D Structured Light Scanner Pro S3, scanning volume 60–500 mm³ and up to 0.05 mm resolution). The minimum scan time for single image capture is 2 s. The equipment has two HP high definition cameras for stereoscopic image capturing combined with a structured light projector (ACER, model K132). It projects a beam of black/white line patterns on the object (structured light) with different orientations. The object to scan is positioned on an automatic 360° rotating platform while the cameras capture the light reflected on the object. The images of the object taken during the process need to be aligned for the final shape representation.

As part of the post-processing of the scan, final shape representation is exported to the GeoMagic Control XTM software that allows the display and quantification of dimensions, superficial defects, wear and tear compared with the no tested specimen, among others. In our case, it allows us to determine the induced deflection in the plate due to the type of projectile and impact velocity. A scheme of the scanning process is represented in Figure 6.

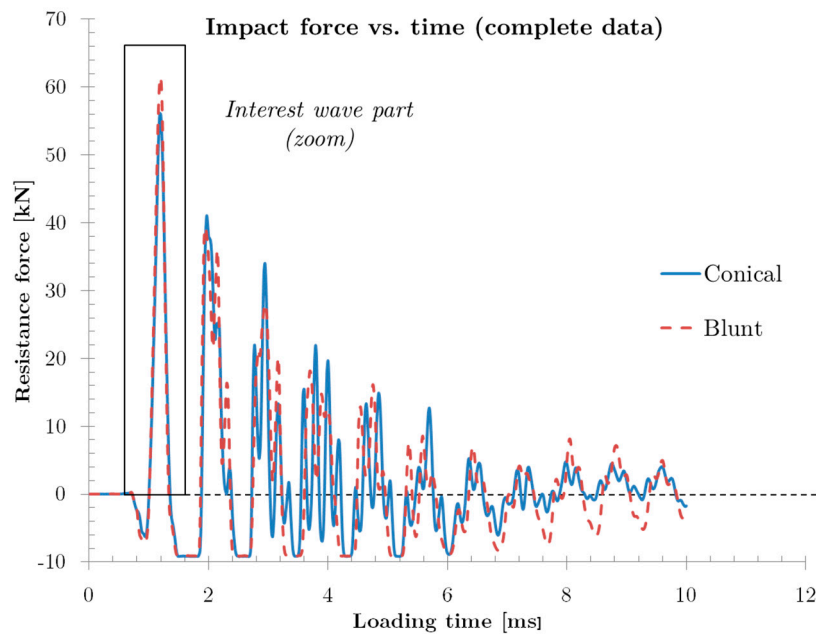
Figure 7. Resistance force history recorded using piezoelectric sensors for blunt and conical projectile (impact velocity $v = 174$ m/s).

In Figure 7 is showed the force history transmitted by the plate during the impact process and recorded using the four piezoelectric sensors for both projectiles impacting at 174 m/s . The represented wave is the sum of the individual waves of each sensor. The two curves in Figure 7 are quite similar as it is a non-perforation test using two different projectiles with the same mass. Therefore, because in these cases where the projectile does not produce complete perforation on samples, the plate absorbs most of the impact energy (around 454 J at $V = 174 \text{ m/s}$) through failure mechanisms.

The most remarkable part of this figure is the first peak (shown in detail in Figure 8), corresponding to the time when the impact takes place; the rest of the curve history represents wave reflections due to little rebounds of the plates and frame on the sensors.

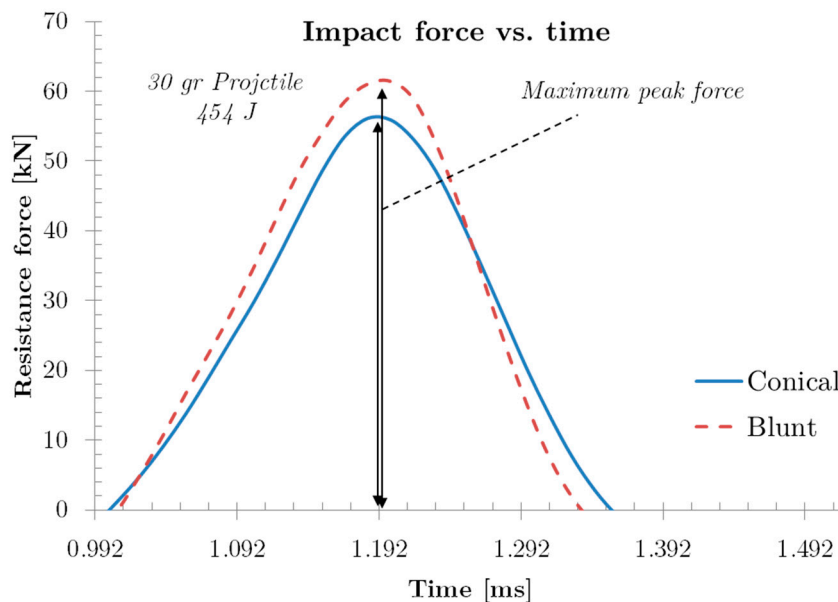
Figure 8. Detail of peak force obtained from resistance force history.

As mentioned, all the projectiles analysed in this work have the same mass, although the nose shape may be different. Curves represented in Figure 8 for projectiles with similar impact energy lead to different maximum impact force peak due to the different shape nose. Blunt projectile presents higher values ($F_{\text{impact}} = 62$ kN) than the conical one ($F_{\text{impact}} = 56.0$ kN). The maximum peak force occurs when projectiles transferred all kinetic energy to the plate. The time amplitude of the force-time curve of the blunt projectile ($\Delta t = 0.333$ ms) is smaller than for the conical projectile ($\Delta t = 0.388$ ms), this may indicate lower overall plate deformation as will be shown below.

Another interesting parameter observed in this analysis is the impulse transmitted to the plate by the projectile, which is possible to determine calculating the area under the curve of Figure 8. For the conical projectile, the impulse transmitted is 9.73 N·s and, for the blunt projectile, it is slightly higher, 9.27 N·s for the same impact energy, because less perforation occurs in the specimen with this projectile.

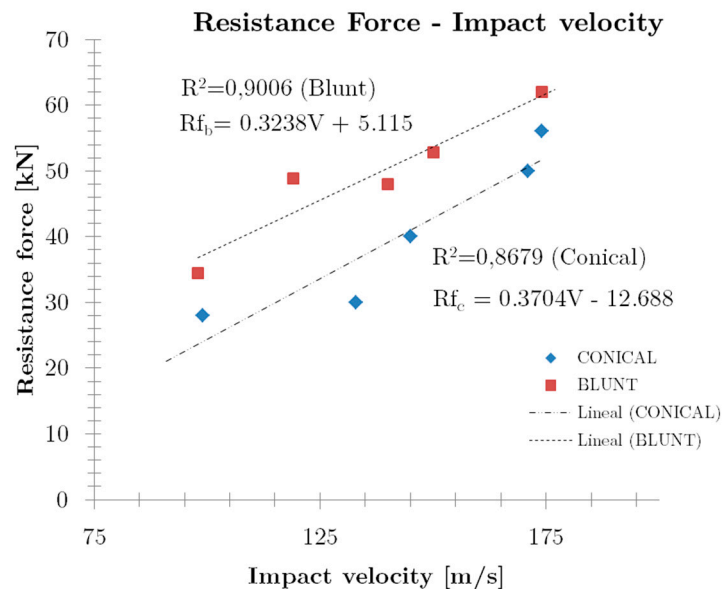
Figure 9. Impact velocity and resistance force comparison for both projectiles.

A correlation for the impact velocity with the maximum peak force from each test, obtained using the piezoelectric sensors, is presented in Figure 9.

The results for the impact range considered have been adjusted to a linear trend for every nose-shape. The correlation coefficients (R-value) are $R^2 = 0.9006$ and $R^2 = 0.8679$ for the blunt and conical case, respectively, representing a good (and adequate) correlation with experimental values, as can be seen in Figure 9. Although both slopes are quite similar, resistance force for any impact velocity is always lower in the conical case, due to its greater penetration power than the blunt projectile, reducing the stiffness of the plate and producing a lower peak force for the same impact load.

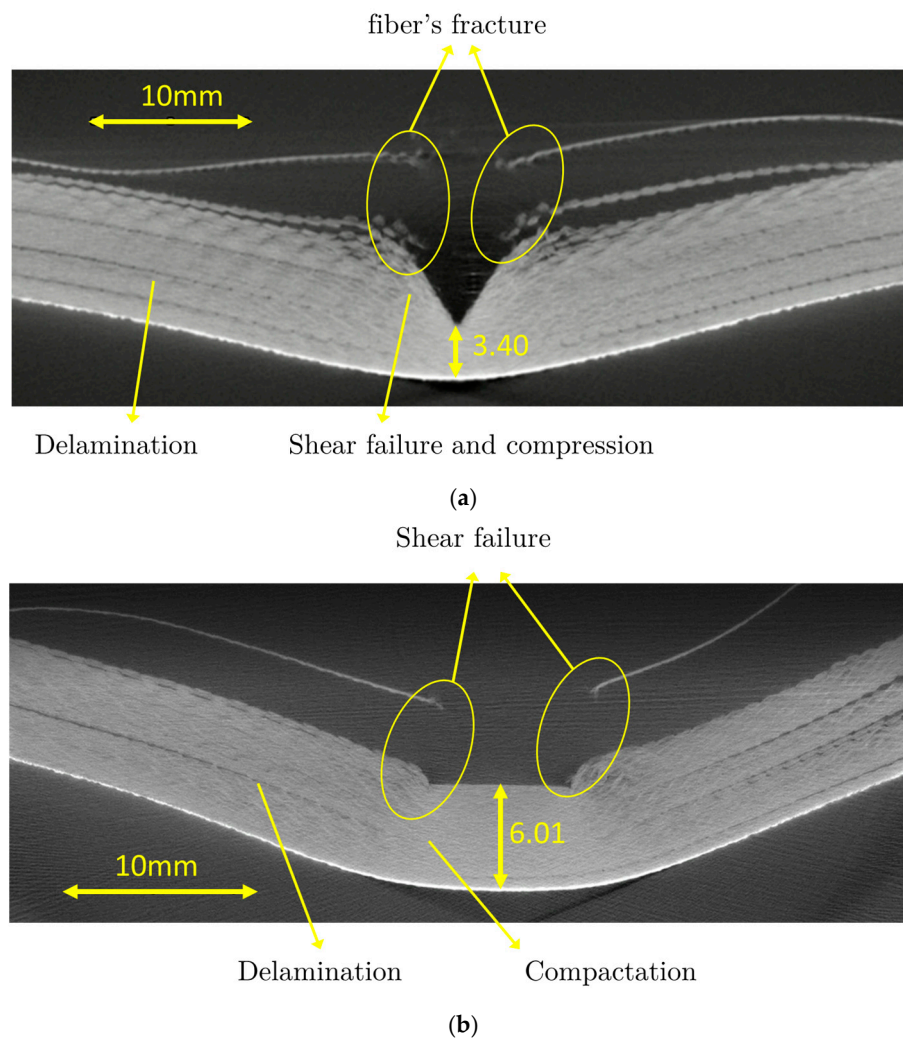
Figure 10. Tomography of different plates impacted to 454 J ($V_0 = 174$ m/s). (a) Conical projectile test; (b) Blunt projectile test.

The failure mechanisms and the morphology of the penetration process have been analysed through computed tomography, described in Section 2.3.1. Figure 10 demonstrates the capacity of this technique to report, in a non-destructive mode, the internal damage of the specimen after impact. These images are taken close to the impact zone, where the most significant penetration of the projectiles is observed. The high-resolution images allow distinguishing delamination, ruptures and crushing.

According to Min et al. [35], the region where delamination is most widespread is the area where the impactor stopped, which is the last penetrated layer. Thus, the delamination is most notable with the conical projectile where the penetration into the specimen is higher than the blunt, Figure 10a.

Moreover, conical projectile leads to higher layer breakage compared to the blunt-shaped projectile, Figure 10b. In the first layers at the impact zone, higher delamination is found for the conical projectile. However, in the case of the blunt projectile, fibre breakage of the first two layers is caused by pure shearing. This statement is commonly observed in the literature [18] due to the geometry of the projectile. Crushing of the fibres along the generatrix of the tip cone is caused by the conical projectile. For the blunt projectile, Figure 10b, compression and crushing of the layers in the impact zone along the thickness of the specimen is found. For the case of conical shape, a thickness reduction of 54% was

observed due to penetration and compressing action of the projectile. On the other hand, as stated above, the blunt projectile does not produce a remarkable penetration, providing a reduction in the thickness of 18% due to layers compression principally. This thickness reduction generates a residual stiffness higher for the blunt projectile than the conical projectile.

Comparing differences in deflection due to the projectile, these are according to the internal damage observed in the previous section. A conical projectile localises impact in a smaller zone, leading to more significant failure of layers and enhanced penetration into the composite (see Figure 10) with a higher stiffness plate reduction.

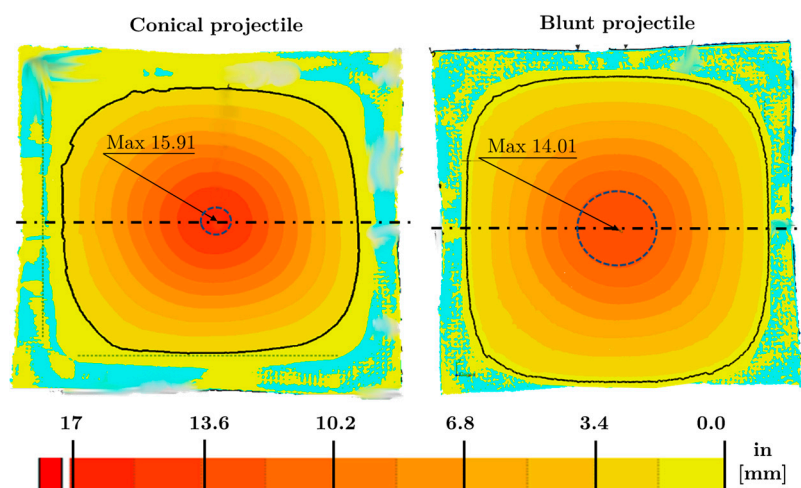
Figure 11. Impact direction displacement map. (left) Conical and (right) blunt projectile ($V_0 = 174$ m/s).

Figure 11 shows the displacement map in the projectile impact direction on plates impacted by a conical and blunt projectile at 174 m/s. In all cases, the maximum displacement is obtained at the impact zone, close to the specimen centre, decreasing to the encastred perimeter. For the velocity presented, these maximum values are 15.91 and 14.01 mm for the conical and blunt projectiles, respectively. Due to the characteristics of the problem, symmetric patterns are displacement is achieved. Contour lines indicate higher displacement gradient for the conical tip-shape. For a particular impact velocity, the larger area of deformation is obtained with the blunt projectile (marked with the continuous black line built thanks to by the GeoMagic Control XTM software), being very close to the encastred boundary.

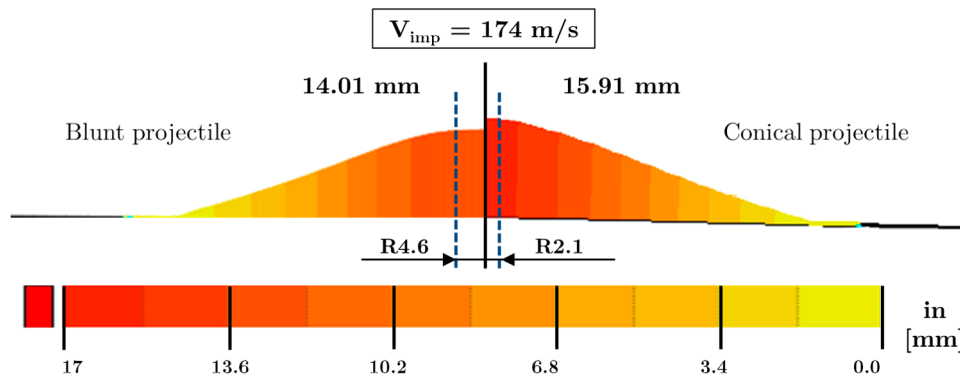
Figure 12. Results of the permanent back face deformation (Pbfd) measured with GeoMagic Control X™ from the 3D scan.

The 3D scanner allows analysing any virtual cut section of the specimen through the thickness. In particular, virtual sections by the dotted line (through thickness plane) sketched in Figure 11 are presented in Figure 12 for a better comparison. It can be observed that the specimen impacted with a blunt projectile has a lower displacement gradient and a more permanent deformation than the conical one, and it is flattened due to the morphology of the projectile, being less pronounced than with the conical projectile. The maximum deflection, reached in the conical case, is obtained strictly at the projectile/plate impact point; meanwhile, the blunt projectile presents an almost constant value close to the impact zone.

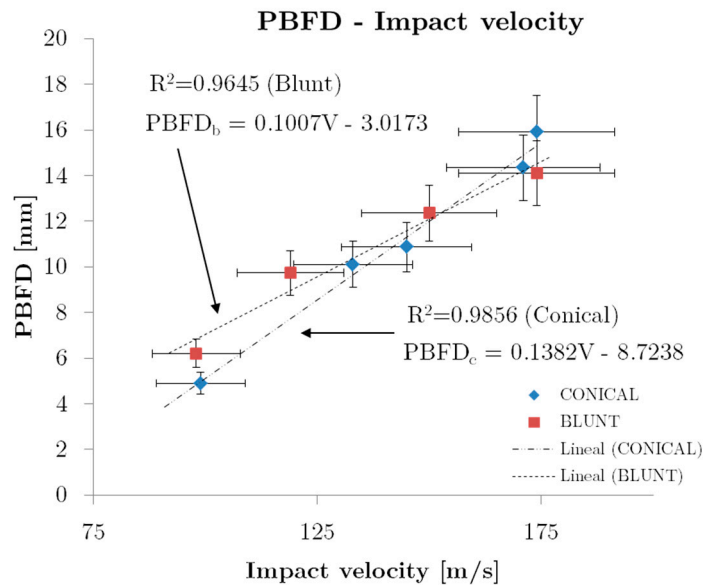
Figure 13. Back Face Deformation—Impact velocity correlation.

A correlation between the permanent back face deformation and the impact velocity for both tip-shapes are shown in Figure 13. A linear dependence of the back-face deformation with the impact velocity for both projectiles can be observed. The correlation coefficients (R-Value) are 0.9645 for blunt and 0.9856 for conical, showing a good correlation of experimental values obtained with linear regression. Although both trends are very similar, the fitting line slope is slightly higher for conical projectiles than blunt ones due to the penetration power of this projectile.

In the author’s opinion, this correlation for Pbfd as a function of the impact velocity in conjunction with the resistance force versus impact velocity as presented in Figure 9, are of great interest to better understand the impact behaviour of aramid composite panels for personal protections in the impact energy range considered.

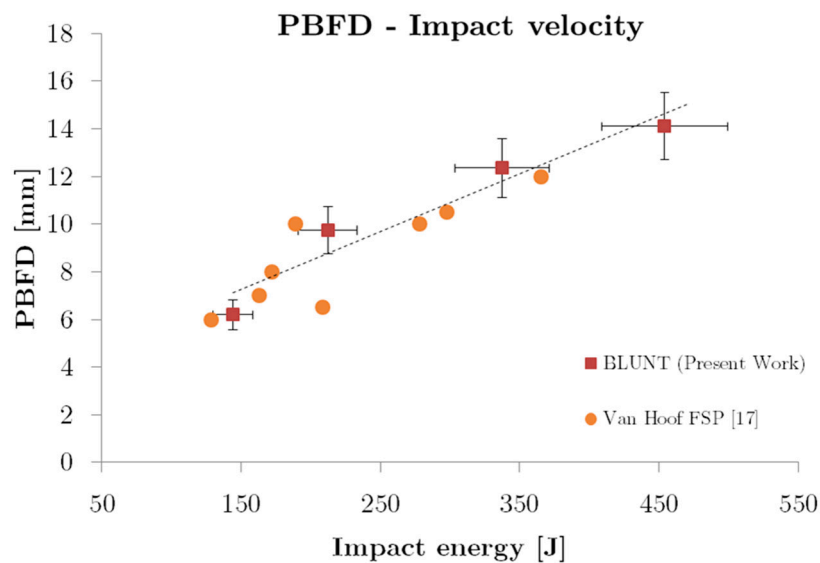
Figure 14. Comparison between existing data on literature and present work.

Although there are other works in the literature about ballistic impact testing on aramid composites, there is a wide variety of impact range (mass, velocity tip-shapes), types of aramid and specimen dimensions that complicate comparisons with the present results. However, within the limited literature for the blunt projectile, the results have been compared with the work developed by Van Hoof [17], see Figure 14. In that work, the dimensions of the specimen, number of composite layers, and the boundary conditions are similar, although the projectile used (FSP) has a reasonably similar geometry to the blunt projectile, the size and the aspect ratio is lower, hence the possible differences that can be observed. Both results present similar trends for the back face deformation (Pbfd) in the impact energy range studied, where the Pbfd increases linearly in all cases with energy, with a similar slope considering a linear regression.

After this analysis and the content presented in Section 1, it is difficult to compare the results obtained in this study due to the great differences with other works, however, when studying the same material and similar loading situations (impact energy), it provides an idea of the level of deformation when it is subjected to high energy impulsive loads.
