## JOURNAL OF THE SOUTH AFRICAN INSTITUTE OF CIVIL ENGINEERING

Vol 54 No 2, October 2012, Pages 86–93, Paper 806

# The effects of placement conditions on the quality of concrete in large-diameter bored piles

G C Fanourakis, P W Day, G R H Grieve

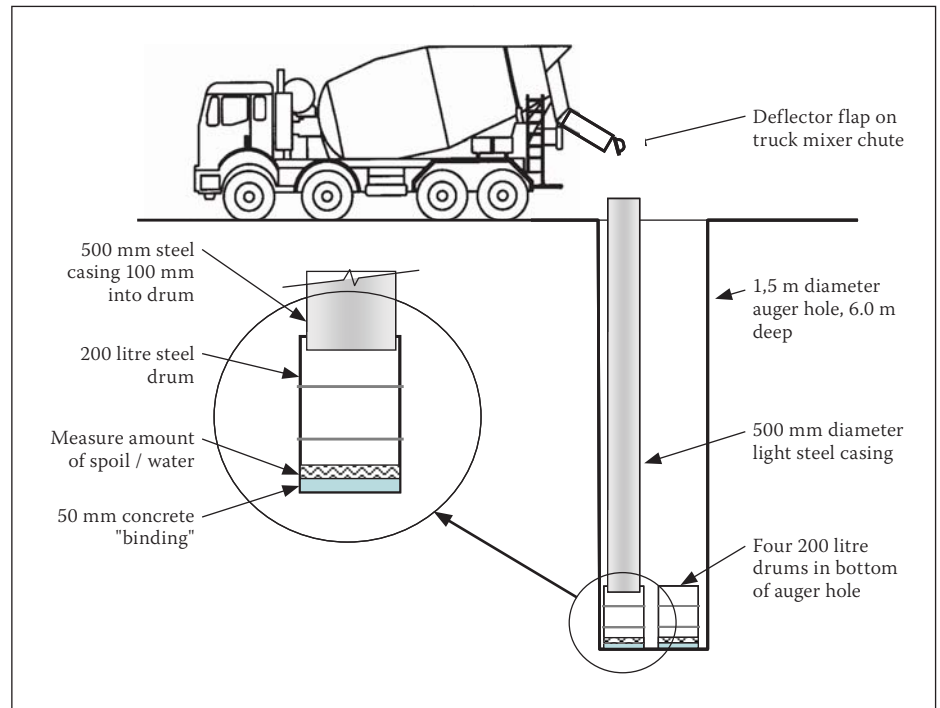
Figure 1 Method of casting test "piles"

During the field work phase of the programme, which was carried out on 11 and 12 July 1991, 20 trial "piles" were cast using free-fall placement of concrete with various amounts of water and/or spoil at the bottom of the pile hole, as schematically indicated in Figure 1. The "piles" consisted of 200-litre

steel drums placed at the bottom of a 6 m deep, 1.5 m diameter auger hole. The drums had a diameter of 560 mm and a depth of 870 mm. A 50 mm thick concrete blinding layer was cast at the bottom of each drum, to provide a solid base onto which the “pile” concrete could be cast. Before lowering the drums into the hole, measured amounts of water and/or spoil were placed into the drums to simulate inadequate cleaning of the pile.

Concrete was discharged into the drums through a 500 mm diameter light-weight steel casing inserted about 100 mm into the top of each drum in turn, as shown in Figure 1. The hole was large enough to accommodate four drums at its bottom, and these were filled in turn. On completion of the pour, the drums were lifted from the hole and left to cure on the surface.

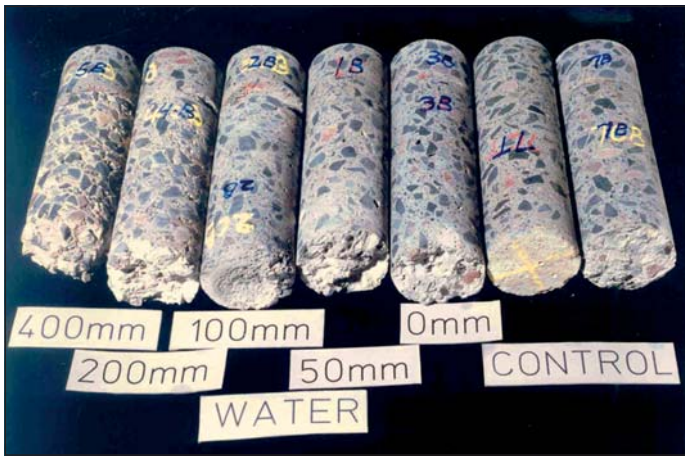
**Figure 2** Concrete cores from concrete cast into water in “pile holes”

Figure 2 shows cores drilled through the bottom of the “piles” cast through various depths of water in the “pile hole” at the commencement of the pour. The sample reference numbers are indicated on these cores (left to right: 5B, 4B, 2B, 1B, 3B, 7T and 7B).

In this figure, the bottom of the “pile” is facing away from the reader. The contact between the 50 mm blinding concrete cast in the drums and the “pile” concrete is visible in some of the cores.

In all these cores, there was an even distribution of coarse aggregate, despite the higher void content of the concrete for greater water depths. A similar, even distribution of aggregate was observed in Test R1 which simulated the effect of allowing concrete to impinge on the

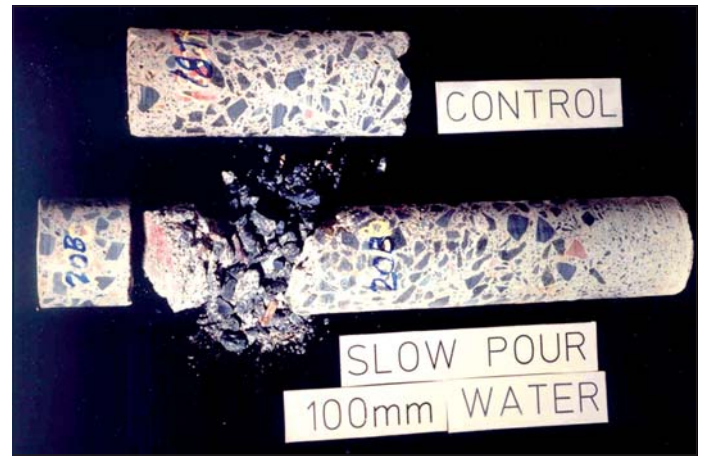
**Figure 3** Segregation of concrete poured slowly into 100 mm of water

reinforcing cage during free fall into 100 mm of water. The only case where segregation was evident was where the concrete was poured slowly into 100 mm of water as shown in Figure 3.

In Figure 3 the bottom of the core is to the left of the picture. The disc of blinding concrete has separated from the “pile” concrete. The “pile” concrete shows classical signs of segregation, with unbonded aggregate at the toe of the “pile” and decreasing aggregate content with the accumulation of fines and laitance towards the top of the pour.

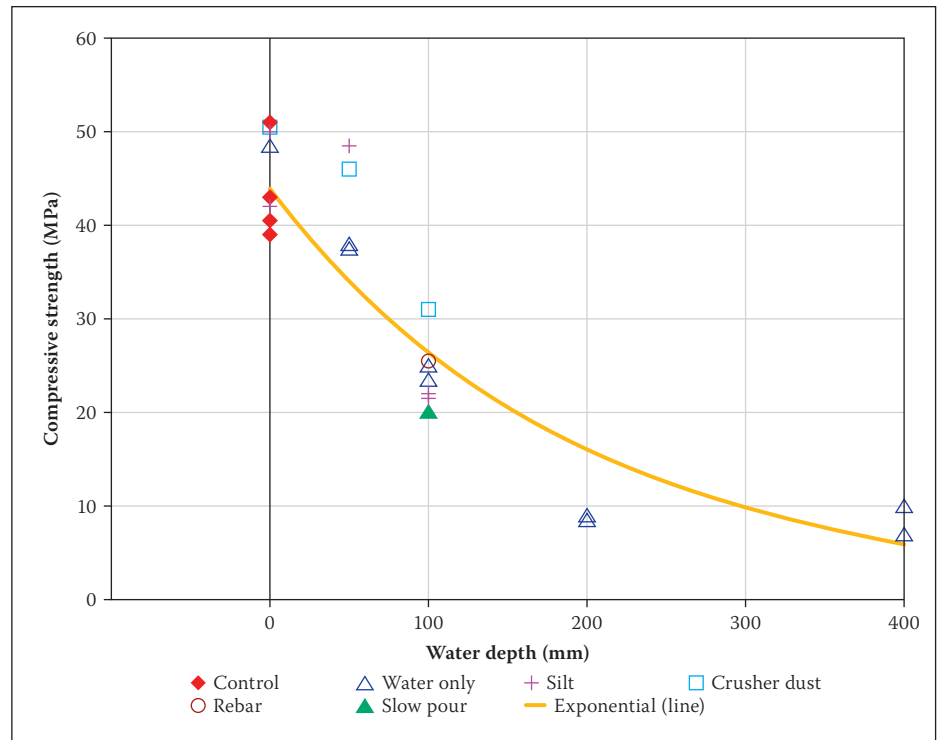
**Figure 4** Effect of water depth on compressive strength

The effect of the depth of water in the “pile hole” prior to commencement of concreting on the strength of the concrete is shown in Figure 4. An exponential curve was fitted to the data.

Figure 4 clearly demonstrates that the free fall of concrete in dry holes did not affect the strength of concrete. However, free-fall casting of concrete into water adversely affected concrete strength. As little as 100 mm of water in the bottom of the “pile hole” resulted in an approximately 50% decrease in the strength of the concrete. For water depths in excess of 200 mm, the concrete strength was reduced by approximately 80%. Further increases in the amount of water in the bottom of the “pile hole” appear to have little effect. This was probably caused by the concrete not being able to absorb the excess water which was carried upwards during pouring of the concrete.

No trend was identified when comparing the results deriving from each of the control samples. The declining trend shown in Figure 4 was not improved when normalising the compressive strength by expressing it as a percentage of the compressive strength of the relevant control sample.

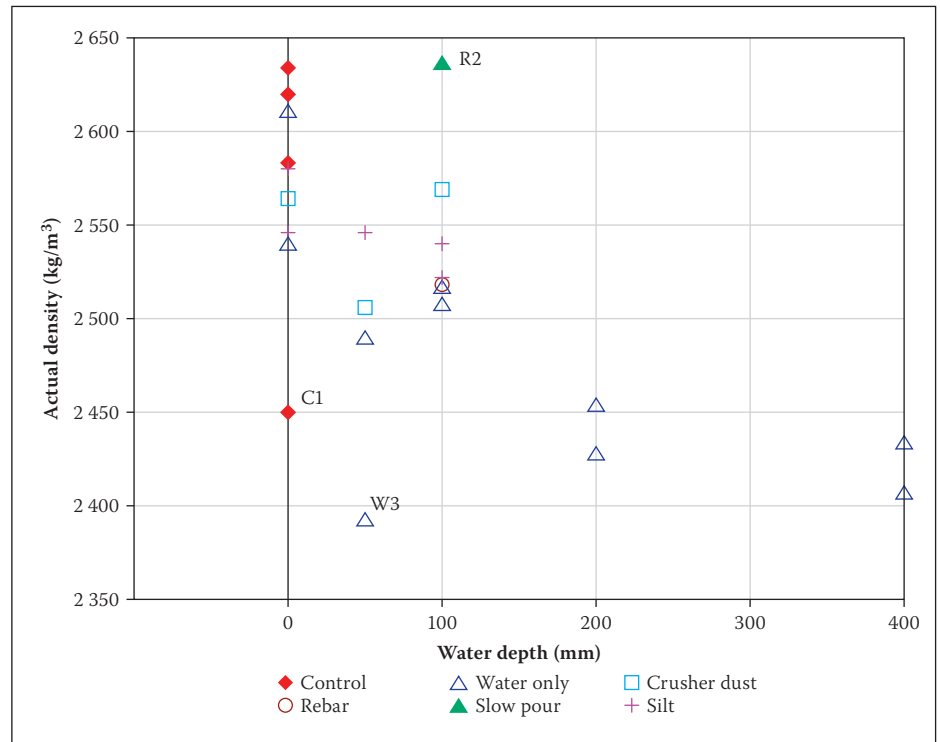
Figure 5 Effect of water depth on actual density

Figure 5 indicates the effect of water on the actual density of concrete in the cores. It is evident from this figure that the actual density of the concrete was, on the whole, adversely affected by the depth of water in the “pile hole”.

As is evident from Figure 5, 200 mm of water in the “pile hole” reduced the concrete actual density by approximately 90 kg/m<sup>3</sup>. Increasing the amount of water to 400 mm had an insignificant additional effect. It is

interesting to note that the relatively wide range of densities for water depths of 0 and 50 mm are not reflected in the compressive strength results shown in Figure 4. Furthermore, the results of tests on samples C1, W3 and R2 are “outliers” as they fall out of the band of one standard deviation ( $s = 80$ ) either side of a linear regression line. There is no apparent reason for these “outliers”. The exclusion of the “outlier” samples resulted in an increase in the linear correlation coefficient,  $r^2$  (from 0.369 to 0.701). This correlation was not improved by normalising

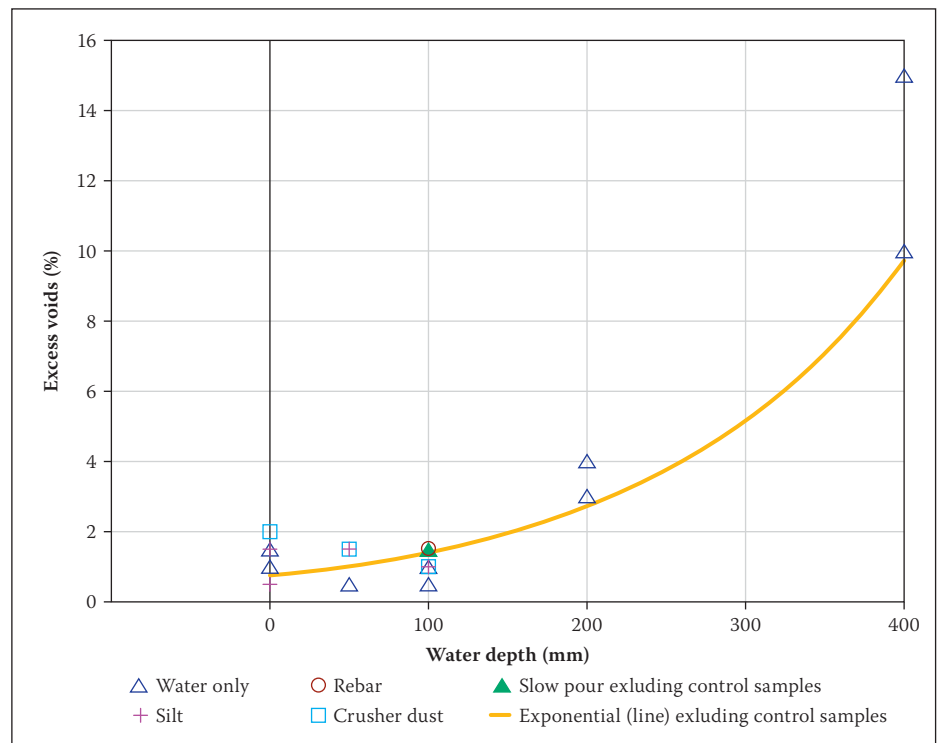
Figure 6 Effect of water depth on percentage excess voids

Figure 6 indicates that the percentage excess voids increases with depth of water. The control samples were excluded from this relationship as they were vibrated. An exponential curve was fitted to the data.

Referring to Figure 6, for water depths of less than 100 mm, the excess voids were

typically less than 2% and are thought to be due to the entrapment of air. However, as the depth of water increased, the excess voids increased to between 10% and 15%. The reason for this trend is that the water at the bottom of the “pile hole”, due to its relatively low density, rose into the concrete (during pouring), displacing the mortar and creating voids. Hence, the greater the volume of water in the “pile hole”, the greater the volume of excess voids in the concrete.

In contrast to Figures 4 and 5, however, no plateauing was evident with water depths in excess of 200 mm. The increase in voids with increasing water depth is clearly visible in the photograph in Figure 2 where, for water depths of 200 mm and 400 mm in particular, the matrix to the coarse aggregate appears to have been eroded during the

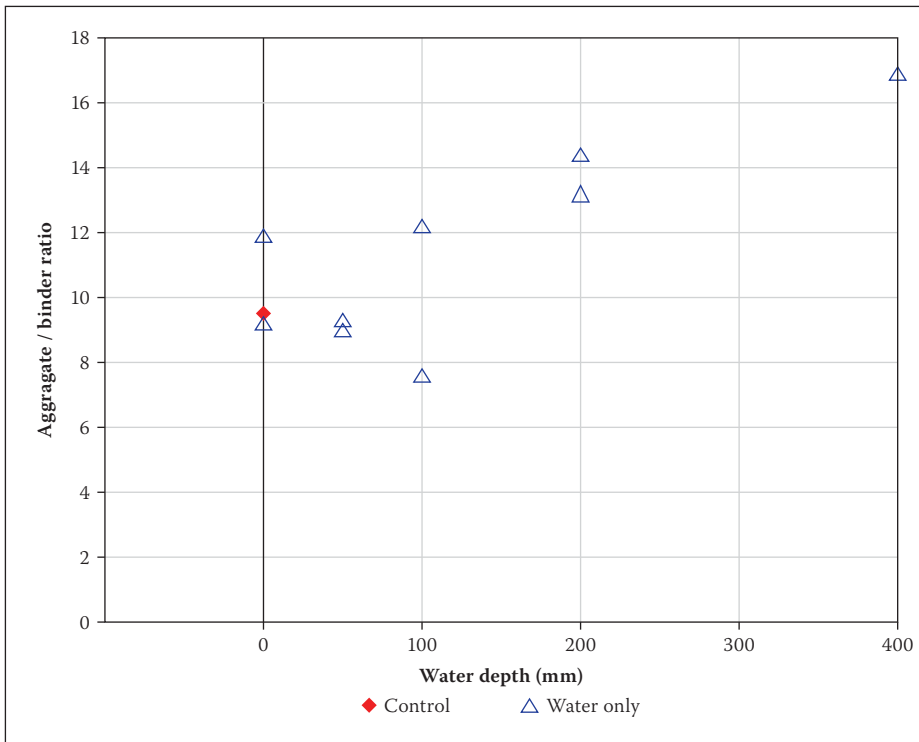
**Figure 7** Effect of water depth on aggregate–binder ratio

Figure 7 shows the correlation between the depth of water in the “pile hole” and the aggregate–binder ratio. For water depths of less than 100 mm, the average aggregate–binder ratio was of the order of 10. However, this increased to as much as 17 where the concrete was placed through 400 mm of water. This trend is attributable to the upward displacement of mortar, from amongst the coarse aggregates in the lower section of the “pile hole”, caused by the upward movement of water through the concrete during pouring. Hence, the more water present, the more mortar displaced.

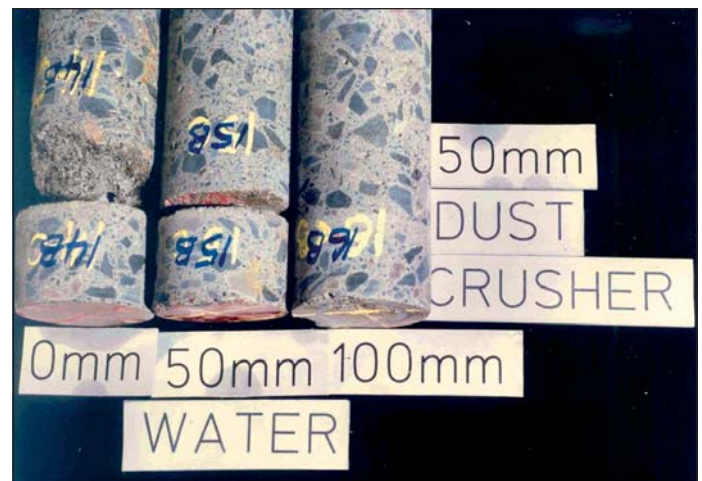
**Figure 8** Close-up of contact between “pile” concrete and blinding concrete for “piles” cast with a 50 mm layer of crusher dust at the bottom of the “pile hole”

Figure 8 shows the contact between the blinding concrete at the base of the drum (representing the *in situ* founding material) and the “pile” concrete for “piles” cast onto a 50 mm layer of crusher dust at the bottom of the “pile hole”. The dry crusher dust (0 mm water – left core sample) was trapped between the “pile” concrete and the bottom of the “pile hole”, resulting in a total lack of contact of the “pile” with the founding material. With 50 mm of water in the “pile hole”, the crusher dust over the middle of the hole was displaced by the falling concrete and this material was assimilated into the “pile” concrete as a result of the remixing of the concrete as it falls to the bottom of the hole. With 100 mm of water in the hole, the contact over the central portion of the “pile” was visually tight. However, the strength of the “pile” concrete had reduced to 77% of that of the control sample (40.5 MPa to 31 MPa) and

the bearing area was reduced by about 50% due to trapping of crusher dust around the perimeter of the “pile” base.

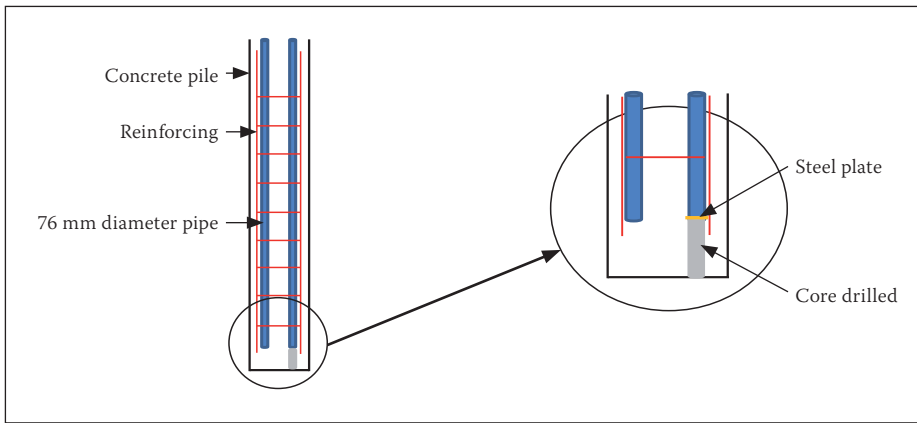
**Figure 9** Section through pile showing integrity testing arrangement

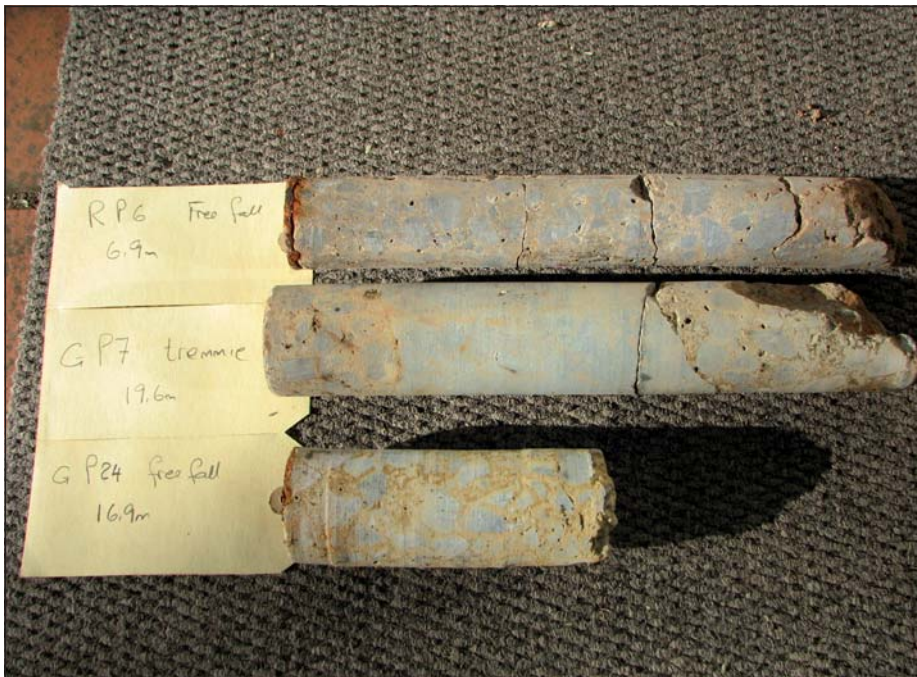
**Figure 10** Relative comparison of free-fall and tremie-placed concrete
