City of Chesapeake, Virginia Shoreline Inventory Report Methods and Guidelines

Special report in Applied Marine Science and Ocean Engineering No. 404 of the Virginia Institute of Marine Science

October, 2008

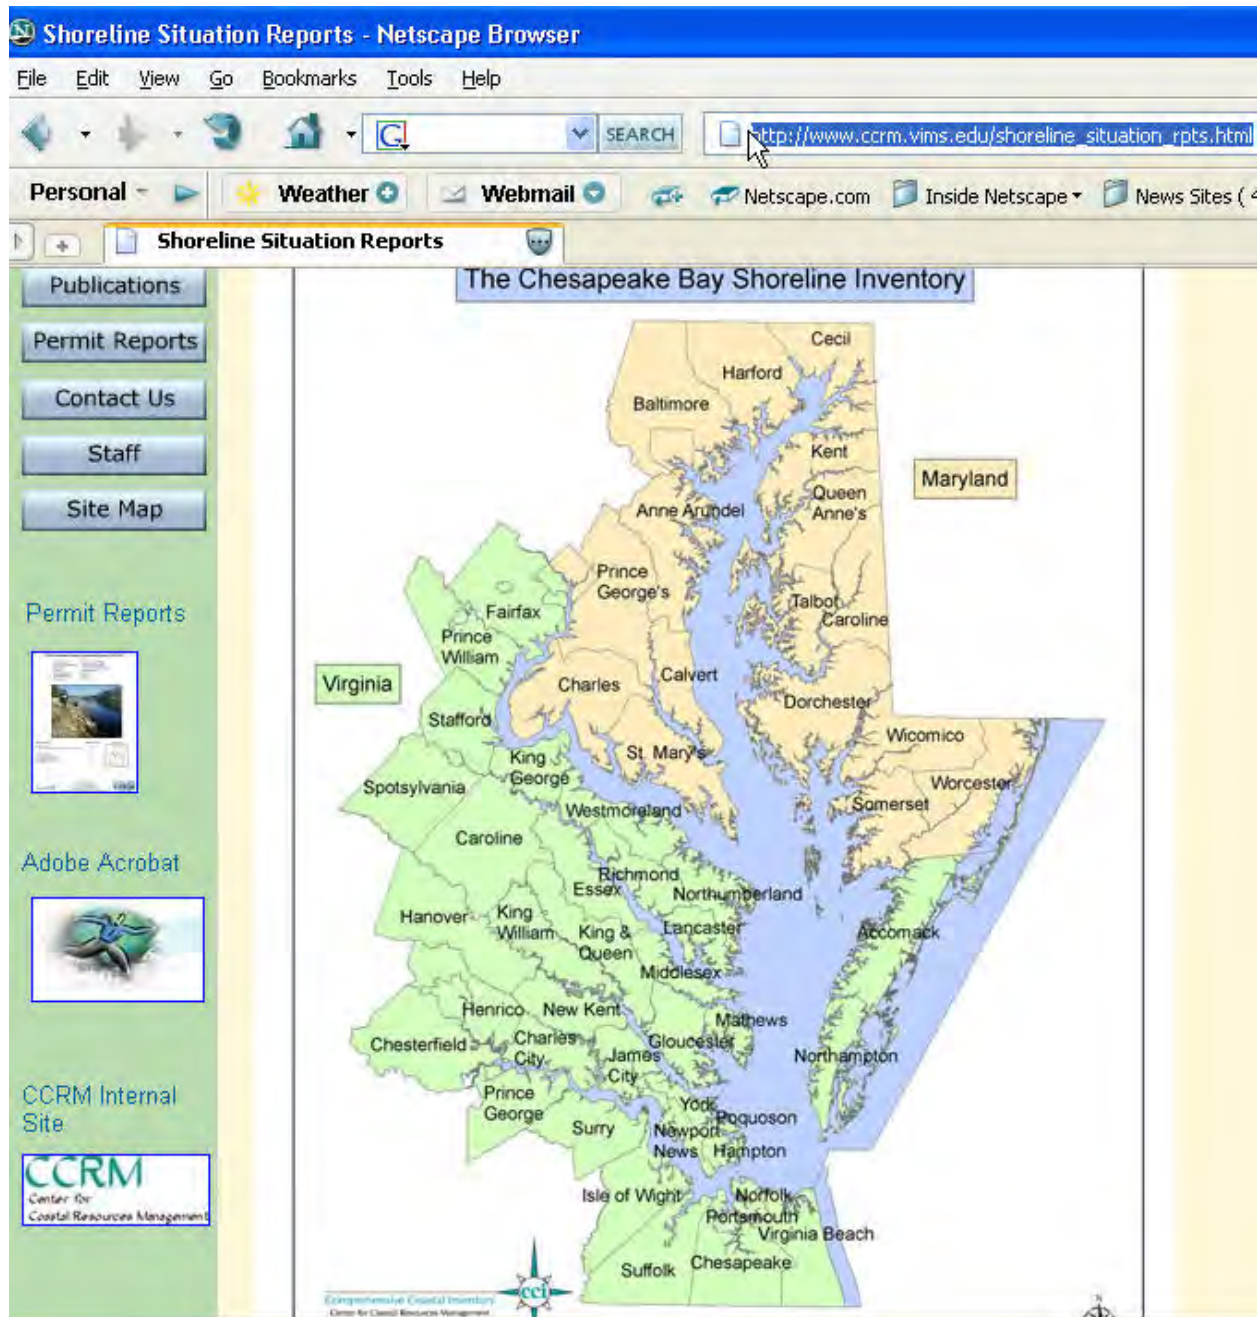
Figure 1. Shoreline Inventory Website

From the City homepage, the user will be presented with a project review and disclaimer explaining data use limitations. The link to “maps” will take you to an index page illustrating the plate boundaries (Figure 2). The index illustrates the distribution of plates geographically. This is useful if you are interested in a specific area. There are 5 self explanatory links at the bottom of the disclaimer page.

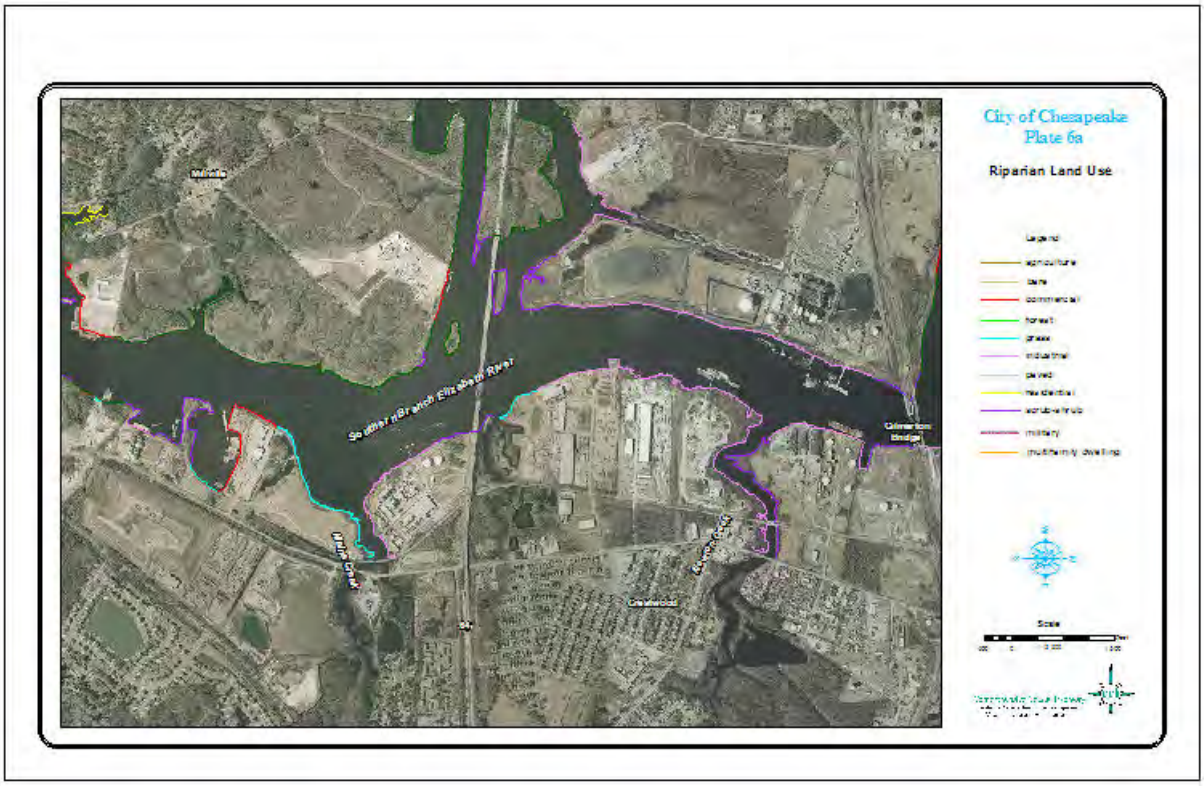
Figure 4. Sample riparian land use map for the City of Chesapeake

2.2a) Riparian Land Use: Land use adjacent to the bank is classified into one of twelve classes (Table 1). The classification provides a simple assessment of land use, which hints of land management practices that may be anticipated. GPS is used to measure the linear extent along shore where the practice is observed. The width of this zone is not measured. Riparian forest buffers are considered the primary land use if the buffer width equals or exceeds 30 feet. This

Once you determine which plate you want, the scroll down menu on the left has links to the four part series for each plate (Figure 3). At the top of the scroll bar Riparian Land Use (plate a) is first. You can scroll down to see links to maps illustrating Bank Conditions (plate b), Shoreline Features (plate c), and Natural Buffers (plate d). The content and details of the four part plate series was described in detail in Chapter 2. The actual map will come up when you click on the plate number. For example, Figure 4 is the riparian land use map for plate 6. Figure 5 is the map illustrating bank conditions for plate 6. Figure 6 shows all the shoreline features for that same area, and Figure 7 the natural buffers associated with that section.

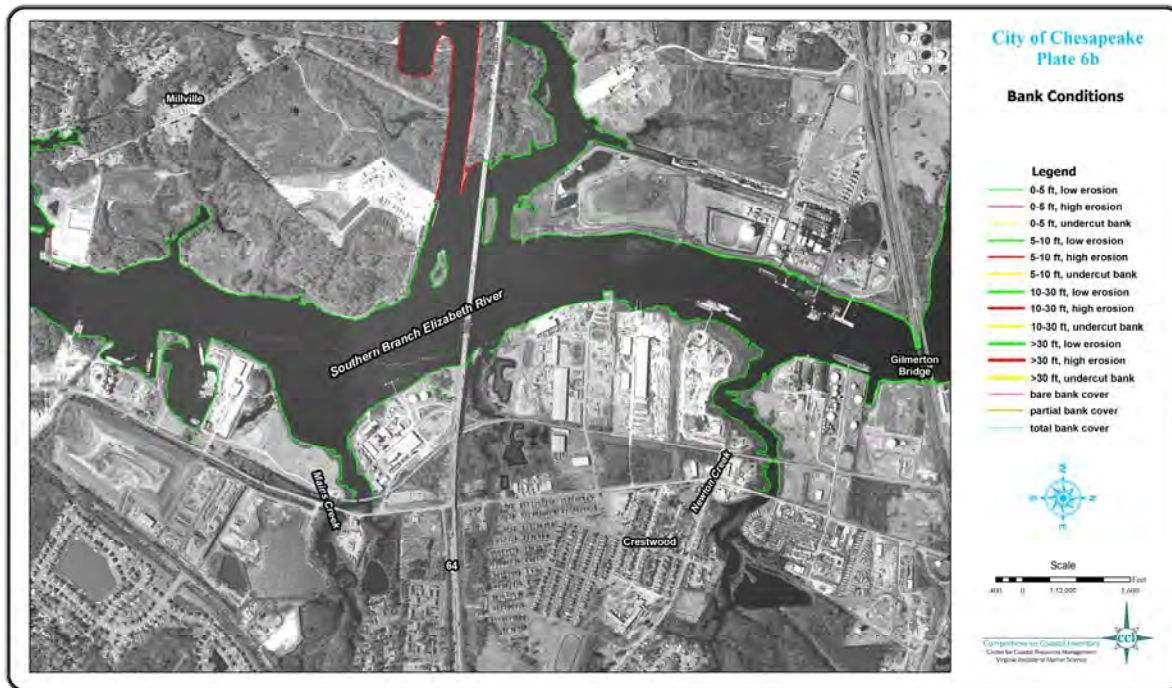
Figure 5. Map illustrating bank conditions for plate 6 in the City of Chesapeake

Plate B depicts the condition of the bank. The colors green, red and yellow are used to report if the bank is stable, unstable, or undercut, respectively. The thickness of the line reflects the bank height; where the thickest lines designate the highest banks (> 30 feet). Plate B uses a grey scale version of the natural color image for the backdrop.
