DIAGNOSIS AND TREATMENT METHOD OF IMPACTED TEETH ON THE UPPER JAW

Postnikov, Mikhail A.; Trunin, Dmitriy A.; Kirilin, Maksim M.; and Stepanov, Grigoriy V. (2019) "DIAGNOSIS AND TREATMENT METHOD OF IMPACTED TEETH ON THE UPPER JAW," *Central Asian Journal of Medicine*: Vol. 2019 : Iss. 4 , Article 25.

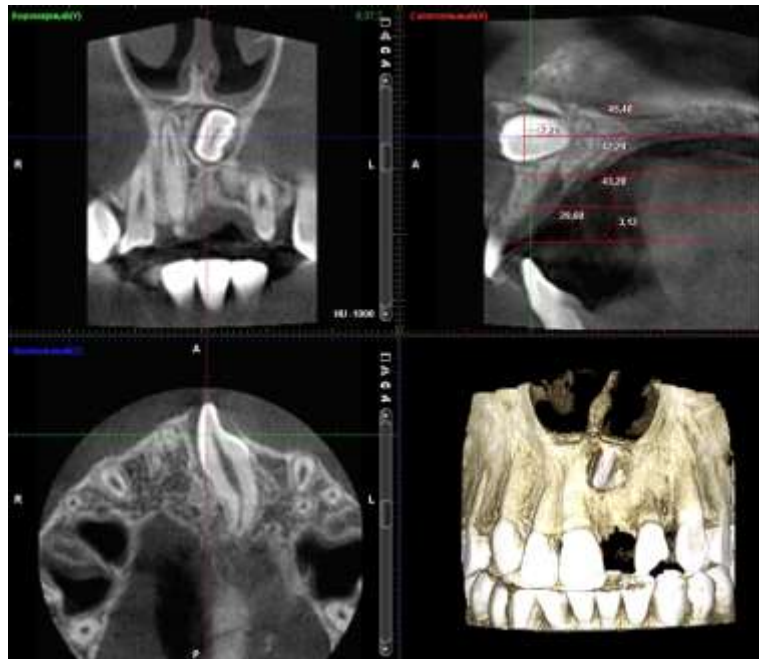
Fig.1. Determination of three levels of the impacted teeth location (incisors and canines of the upper jaw) on the CBCT of patient A., 14 years old (III level of tooth 2.1 location)

The method proposes determination of the location of levels of the impacted maxillary frontal teeth (incisors, canines) with using of cone beam computed tomography. Two horizontal lines are drawn on the computed tomography of the patient: one through the points Spina nasalis anterior (Sna) and Spina nasalis posterior (Snp), and the other through the apical base of the upper jaw. The vertical distance between these lines is divided into three equal parts and horizontal lines are drawn through the resulting points. The first level of the tooth is located between the two lower lines, the third - between the two upper lines, the second - in the middle (Fig. 1).

To determine the level of location of the impacted tooth on the CBCT, an image in the sagittal plane was used. It was found that it is advisable to distinguish precisely three levels of location of the impacted tooth, since the vertical distances between the horizontal lines correspond to the size of crown of the impacted tooth. We determine the level of location of the impacted tooth by the zone, where tooth's crown is.

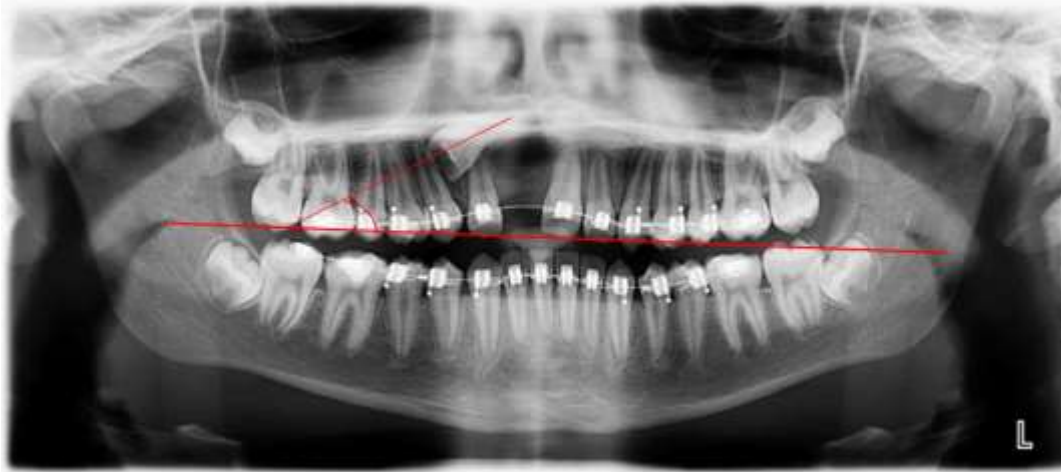
Fig.3. Location of the impacted tooth 1.1 of patient O., 13 years old, before orthodontic treatment (angle of inclination of tooth is 30 °)

An X-ray examination of the patient included orthopantomography, telereöntgenography of head in lateral projection, using Dolphin Imaging software to analyze cephalometric radiographs and cone beam computed tomography of the tooth 1.1. The study of orthopantomogram was carried out according to the method of Yu.I. Zhigurt. The location level of the impacted tooth 1.1 was determined, as well as the angle of inclination of its longitudinal axis (Fig. 3). We noted three levels of the impacted teeth location in the sagittal plane on CT scan of the upper jaw according to our method. The 3rd level of the impacted tooth 1.1 location was determined (Fig. 4).

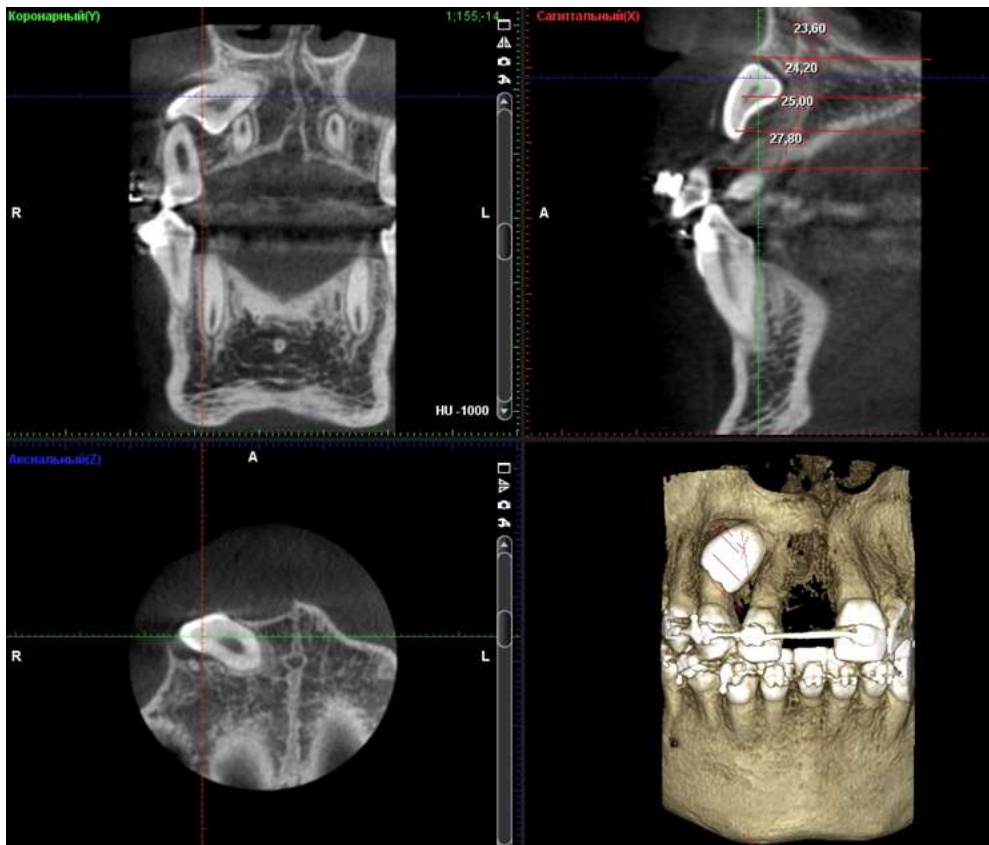
Fig.4. Location of the impacted tooth 1.1 of patient O., 13 years old, in three projections before orthodontic treatment (3rd level of the tooth 1.1 location)

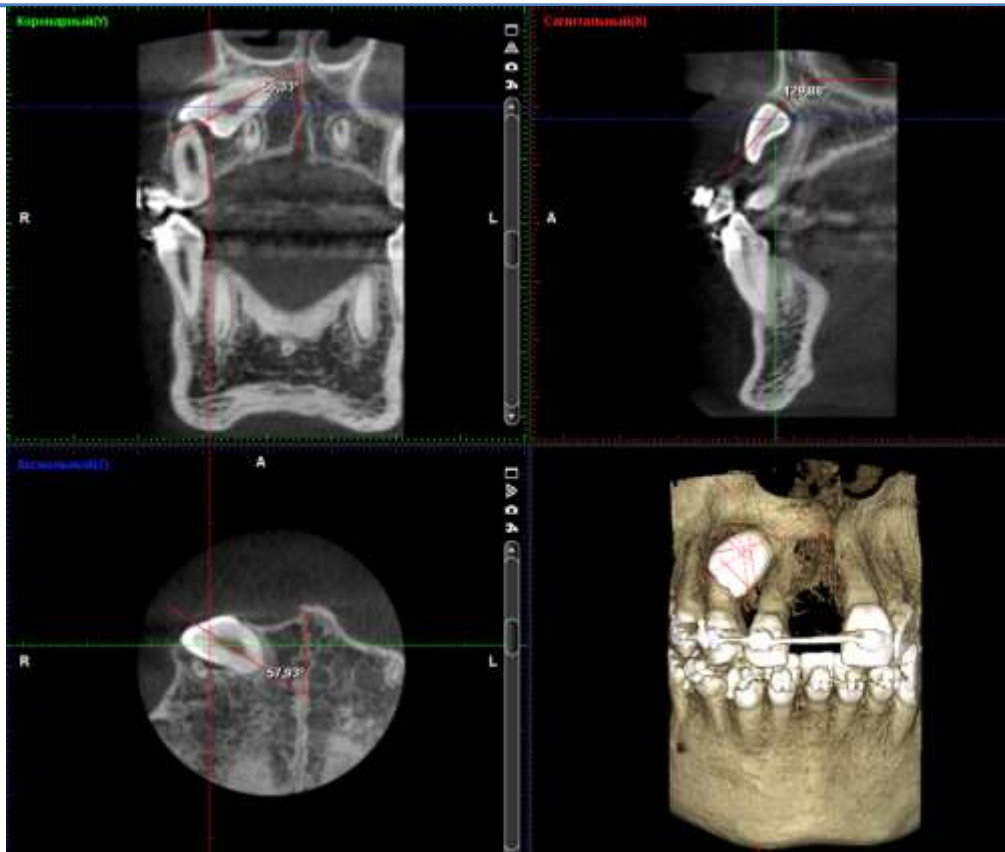
Fig.5. Determination of angles of the impacted tooth 1.1 inclination: in the coronary plane - 56.33 °, in the sagittal plane - 129.88 °, in the axial plane - 57.93 °.

Then, we measured angles of inclination of the impacted tooth 1.1 in three mutually perpendicular planes (Fig. 5).

As a result of measurements, we obtained the following angles: in the coronary plane - 56.33 °, in the sagittal plane - 129.88 °, in the axial plane - 57.93 °. Then, we compared the obtained data with the data in Table 1. Angle of inclination of the impacted tooth 1.1: in the coronary plane - II degree; in the sagittal plane - III degree; in the axial plane - II degree.

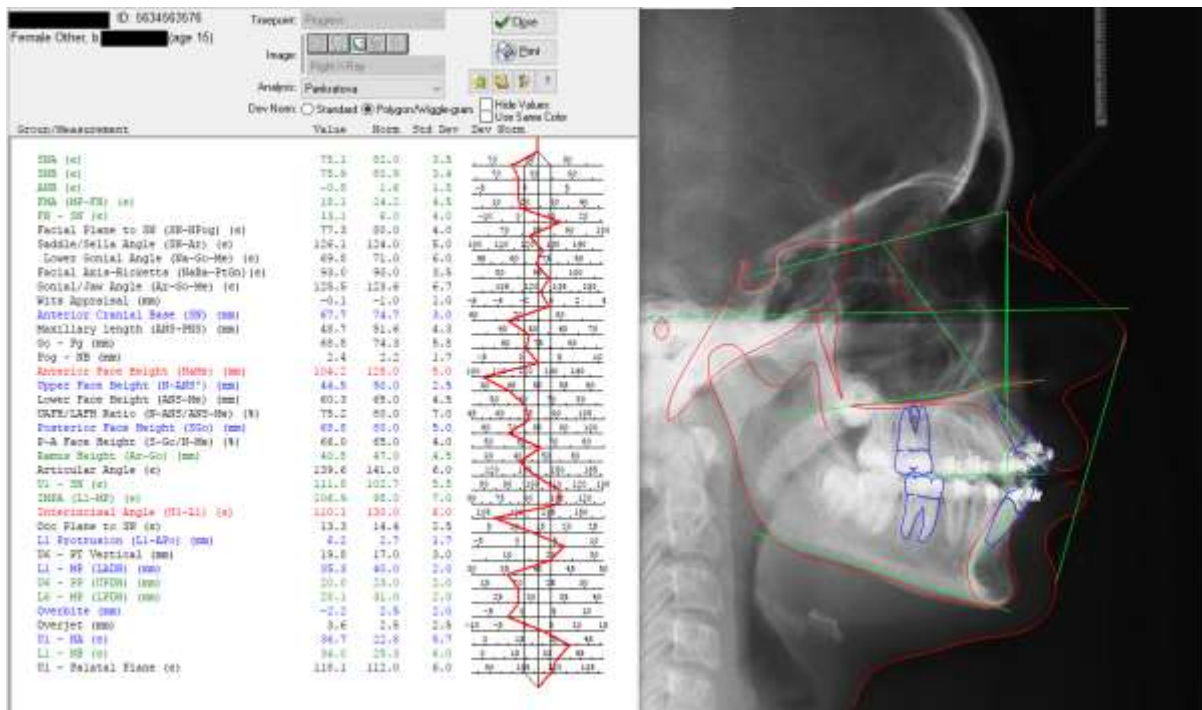
Fig.6. Cephalometric x-ray image of head in lateral projection of the patient O., 15 years old with analysis using Dolphin Imaging software (USA) at the stage of orthodontic treatment.

Patient underwent comprehensive surgical and orthodontic treatment. We made one more cephalometric x-ray at the stage of orthodontic treatment with its analysis in Dolphin Imaging (Fig. 6). X-ray examination was performed again after the orthodontic treatment (Fig. 7, 8). Comprehensive treatment of patient O. lasted 2 years and 5 months.

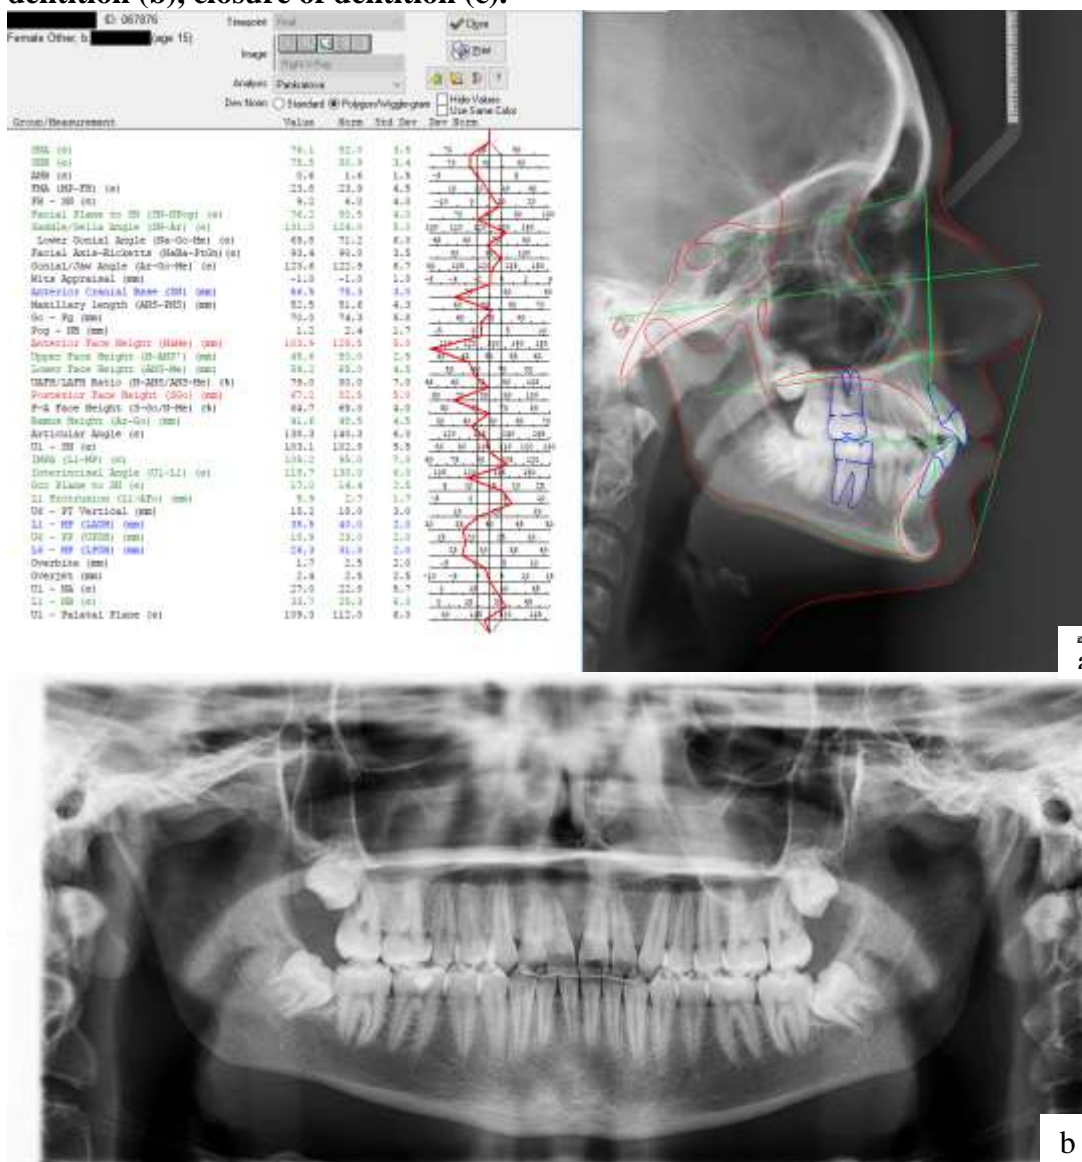
Fig.8. Cephalometric x-ray image of head in lateral projection of the patient O., 15 years old with analysis using Dolphin Imaging software (USA) after orthodontic treatment – a; location of the impacted tooth 1.1 after orthodontic treatment – b.
