## SEISMIC VULNERABILITY ASSESSMENT OF A ROMANIAN HISTORICAL MASONRY BUILDING UNDER NEAR-SOURCE EARTHQUAKE

**Abstract.** *In the present research work, the effect of ground motion vertical component in case of near-source excitations on masonry buildings has been analysed. To this purpose, an investigation has been made on the Banloc Castle, a historical masonry construction damaged by the Banat-Voiteg earthquake occurred on December 1991 in the Romanian Region of Banloc. A FEM model of the building, setup using DIANA FEA analysis software, has been analysed in the non-linear dynamic field. In particular, the records have been referred to the Banloc site, characterized by a moment magnitude of 5.5 and a focal depth of 9 km. In order to estimate the influence of the vertical seismic motion on the case study building in terms of both displacement and internal forces, two different scenarios have been examined. The first scenario has taken into account the horizontal component only, whereas the second one has studied the simultaneous effects of three components of the seismic action. The comparison between the two scenarios has shown that the vertical ground motion significantly modi

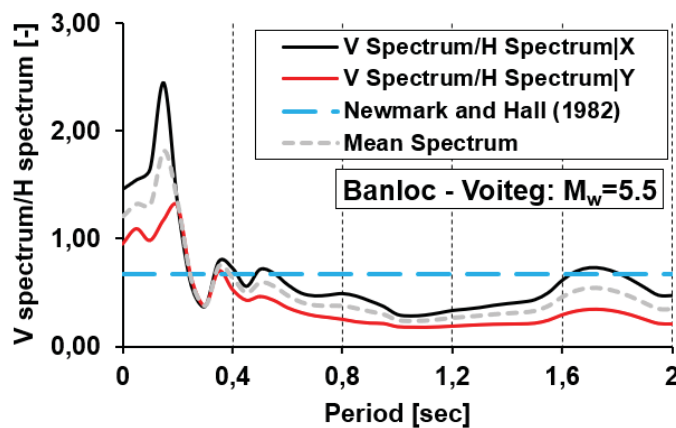
The spectral ratios between vertical accelerations,  $V$ , and the corresponding horizontal ones,  $H$ , for the considered near-source ground motion, have been depicted in Figure 6. These results have shown how the vertical component effects are very important for earthquakes characterized by small site-source distances, where the  $V/H$  limit of  $2/3$  proposed in [9] is exceeded. In particular, Figure 6 shows that for short periods (less or equal than 0,2 seconds), the  $V/H$  ratio is greater than 1; this means that the rule imposed in [9] underestimates considerably the vertical component effects for low periods.

Figure 6: V/H spectral ratios for the Banloc-Voiteg event.

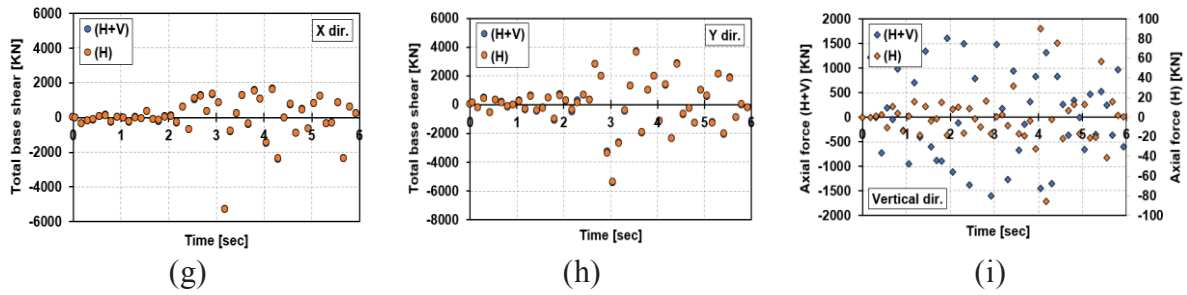
The results obtained have been represented, for the two scenarios considered, namely (H) and (H+V), in terms of dispersion of both mean displacements and resistances. They are referred to the monitoring points at the second floor (see Figure 7) and are summarized in Figure 8. Concerning displacements and strengths regime, positive and negative values of the points cloud denote the change of direction induced by the seismic input with respect to the straight line with equation  $x=y$  (bisector). Furthermore, in order to better highlight the influence of the vertical component, the upper ( $y=0,5x$ ) and lower ( $y=2x$ ) bounds of the dispersion range have been considered. In this way, the greater scatter with respect to the bisector, the larger effect of the ground motion vertical component [11].

Figure 8: Scatter results in terms of displacements (a-f) and forces (g-i).

From the gotten results, it is worth noting how the average dispersions associated with the two main directions X and Y, in terms of displacements and base reactions, are not affected by the influence of the vertical component. However, in vertical direction, there is a marked average dispersion (Figures 8c and 8f) with respect to the case in which the vertical component is neglected (H).

It can be seen that in the first two seconds (in which the vertical component reached its maximum acceleration peak), the displacements are increased by about 6 times compared to the case in which the vertical component is neglected (H). Furthermore, in terms of axial stress, the same condition can be found by comparing the two scenarios, (H) and (H+V) mentioned above (Figure 8i).

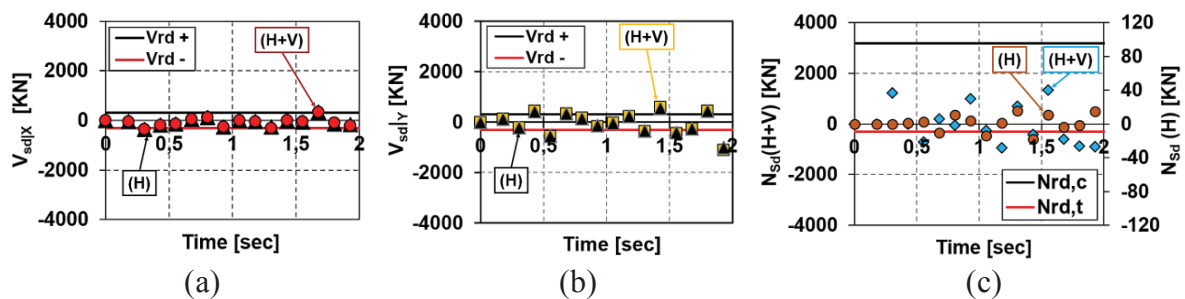
Consequently, a time step of 2 seconds has been considered in order to consider the effect of ground motion vertical component in terms of both shear [22] and axial demands for one of the most stressed pier of the West façade. So, for the sake of representation, (H) and (H+V) scenarios have been compared and plotted according to the recommendations provided by EC8 [22], as reported in Figure 9.

Figure 9: Safety checks for shear stresses (a-b) and axial loads (c) in case of (H) and (H+V) scenarios.

Firstly, in Figures 9a and 9b, it is possible to notice how the seismic vertical component in the two main directions, X and Y, does not produce any significant stress variation for both considered scenarios. Secondly, in Figure 9c, it is shown how the vertical component produces a significant increase in terms of axial load. In fact, at time step of 1.55 seconds (which corresponds to the maximum peak vertical acceleration), the difference between (H) and (H+V) is very high (more than two times). Moreover, it is detected that the axial load demands exceed averagely the corresponding tensile capacities ( $N_{rd,t}$ ) of 2 times.

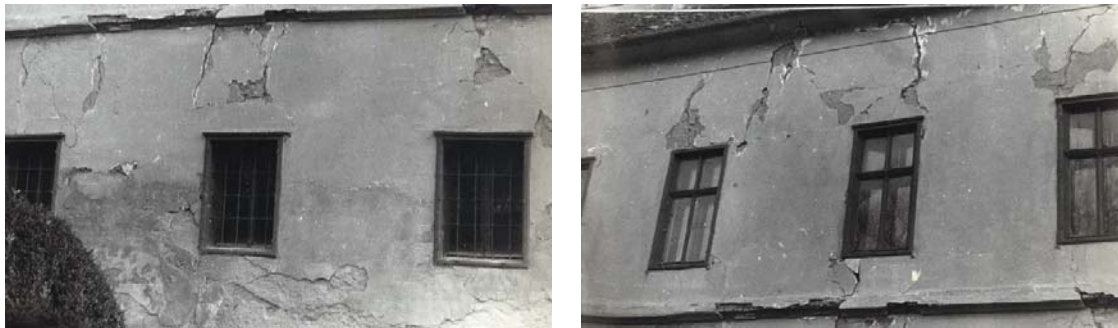
Successively, following the impulsive action, the arrival of the horizontal components produced damage to the vertical structures, mainly represented by shear cracks in the spandrel beams, as shown in Figure 12 [16].

Figure 12: Vertical and diagonal shear cracks detected in the South façade of the case study building [16].

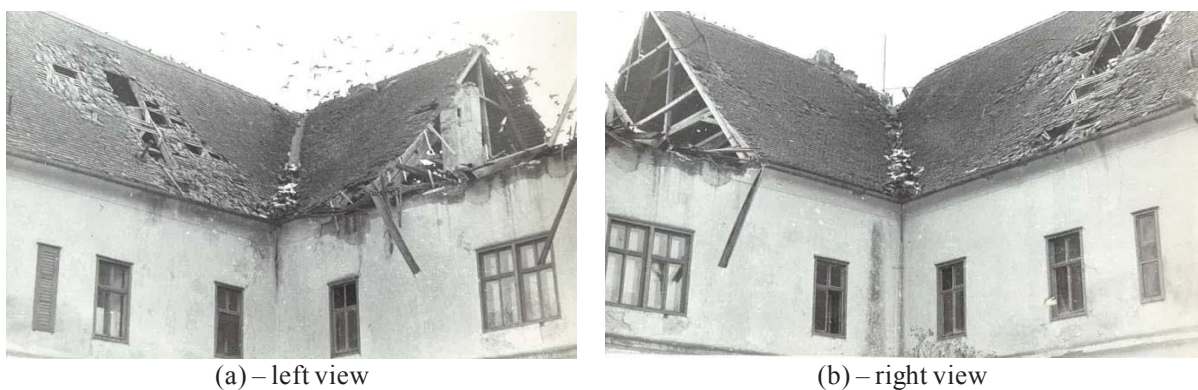
Finally, in the internal court of the building, a partial collapse of the roofing structure was observed. This collapse mechanism was triggered by the impulsive seismic action, as depicted in Figure 13 [16].

Figure 13: Failure mechanisms observed in the internal court of the case study building [16].
