Source distribution of acoustic emissions during an in-situ direct shear test:
Implications for an analog model of seismogenic faulting in an inhomogeneous rock mass

To appear in: *Engineering Geology*

Tsuyoshi ISHIDA, Kyoto University,
Tadashi KANAGAWA, Nittoc Construction Co., Ltd.,
and
Yuji KANAORI, Yamaguchi University

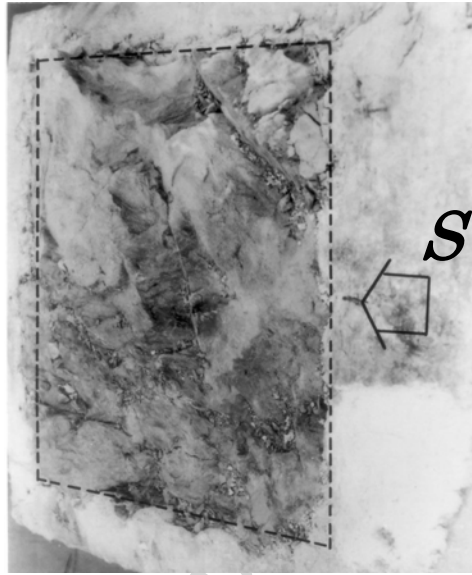
Photo 3 Fractured plane of the test block. This photo was printed by turning over the negative so that the right and the left hand sides along the direction of the shear load appear in the same position as in the other figures.

Photo 3 shows the fractured plane of the upper part of the test block that was removed and turned over. This photo was printed by turning over the negative so that the left and right hand sides (with respect to the direction of the shear load) of the photo correspond with those of Figures 7 and 8. The features of the upper fracture plane shown in Photo 3 correspond to the joints and loosening seam observed on the lower fracture plane shown in Figure 8.
