P. A. KROPACHEV, A. D. MEKHTIYEV, F. N. BULATBAYEV,
Y. ZH. SARSIKEYEV, A. V. YURCHENKO

ISSN 0543-5846
METABK 60(3-4) 343-346 (2021)

METHOD OF RESTORING PIVOT CONNECTIONS CAST IRON BUSHINGS OF HEAT ENGINE WITH EXTERNAL HEAT SUPPLY

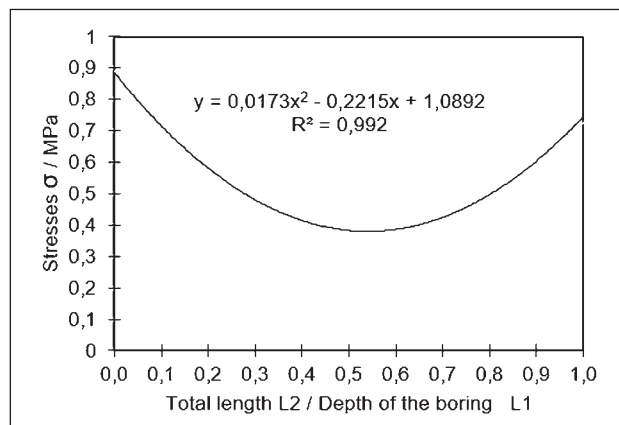
Figure 3 The bushing contact surface stresses dependence by the $L2 / L1$ ratio

The conical shape allows realizing the self-alignment property of the friction pair parts and eliminating radial misalignment when mounting the pin into the bushing, as well as limiting the end movement of the pin in the bushing during operation. The simulation results are shown in Figure 3. There is observed decreasing the contact stresses σ depending on the boring parameters; the total length $L1$ of the bushing is the depth of the boring $L2$, while the $L2 / L1$ ratio is observed. It can be argued that the durability and service life of the

bushing of the pivot connection of the mechanism is $L2 = 0,3 - 0,7$ of its full length $L1 = 1$.

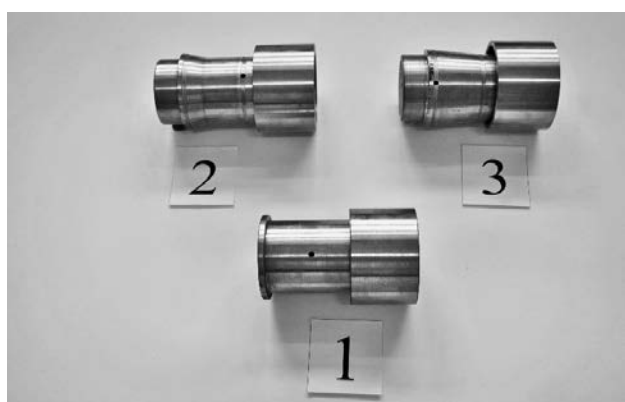
Figure 5 Geometrical shape of the cast iron bushing inner surface: 1 - cylindrical bushing (standard); 2 - bushing with a partial conical bore of the inner cylindrical surface by 0,35 of its length; 3 - bushing with partial tapered bore of the inner cylindrical surface by 0,7 of its length

The task of the study is to determine the presence of significant changes on the surface of mating parts of pivot connections under various conditions. There are compared the friction surfaces of the connection and studied their physical, mechanical and tribological characteristics at various parameters of the cast iron bushing bore. Using the tribological friction machine SMC-2, the study of the main regularities of the pivot connection elements of the hinge joint was carried out to establish the parameters of wear in the area of the contact surfaces (Figure 5).
