Citation: Corradi, Marco, Borri, Antonio, Castori, Giulio and Sisti, Romina (2014) Shear strengthening of wall panels through jacketing with cement mortar reinforced by GFRP grids. Composites Part B: Engineering, 64. pp. 33-42. ISSN 13598368

Shear strengthening of wall panels through jacketing with cement mortar reinforced by GFRP grids

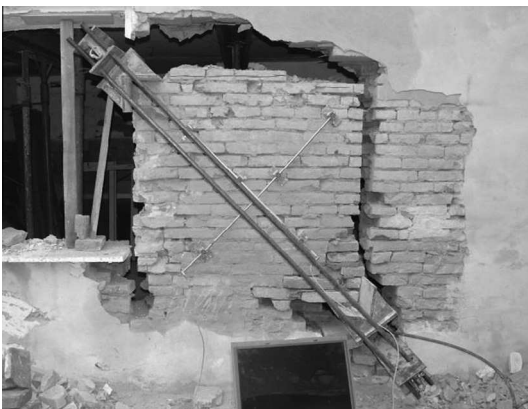
Fig. 1. On-site diagonal compression test (San Felice building).

In the diagonal compression tests, 1200 × 1200 mm panels were isolated from the surrounding walls by making four cuts with a circular saw. In cases where it was possible to obtain samples underneath existing openings, it was possible to reduce the number of cuts made to three (Fig. 1). The shear strength of the masonry at the center of the panel (τ_{OD}) was calculated on the basis of the interpretation of the test reported in the RILEM standards [22]:

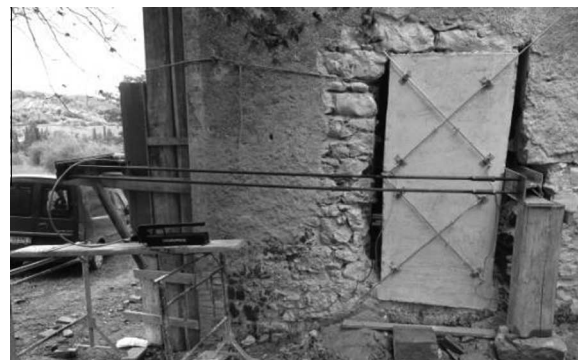
Fig. 2. On-site shear-compression test (Colle Umberto building).

For the shear-compression test, the panel, 1800 × 900 mm in size, was obtained by two vertical cuts in the masonry (Fig. 2), i.e. letting the vertical compression load from the remaining part of the building act on the top of the sample. The horizontal force is applied to the midpoint, and in this way the panel can thus be schematized as two superimposed 900 × 900 mm semi-panels. The vertical stress is estimated based on the analysis of the loads weighing on each sample:

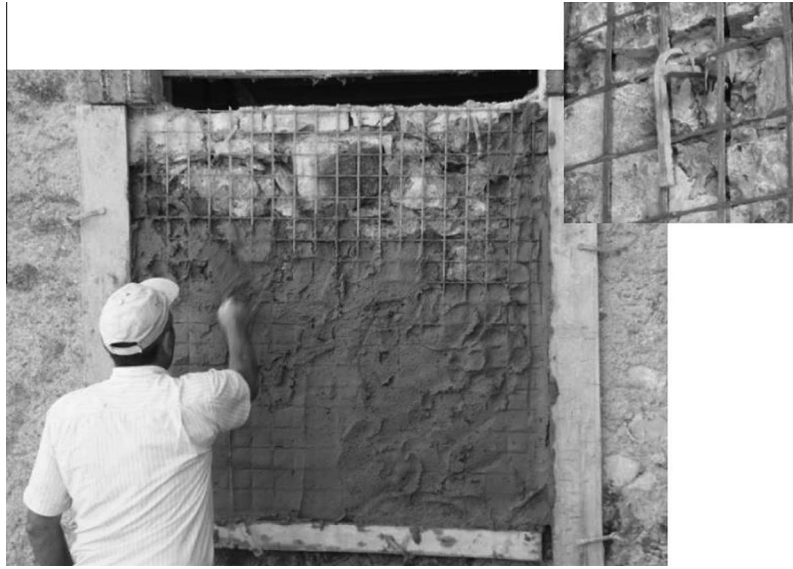
Fig. 5. Application of mortar jacketing and detail of connection between anchors and GFRP grid.

Lastly mortar was applied by hand in a thickness of about 30 mm. Despite the presence of the composite grid, the application of mortar was not difficult, thanks to the large mesh size adopted (Fig. 5).

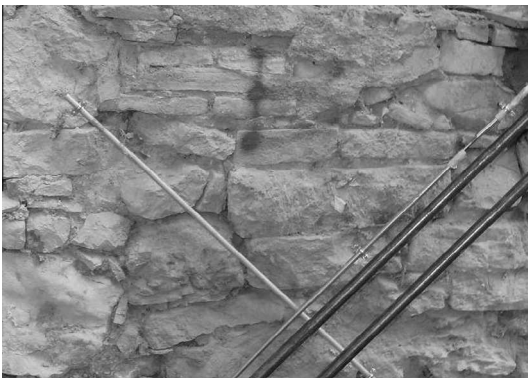
Fig. 6. Stonework of Colle Umberto farm house (19th-century).

The building is characterized on the ground floor by two types of walls built in different periods. The first type, which presumably goes back to the early 1800s, is 560–570 mm thick and was made with very poor lime-based mortar. The stones are up to 350 mm in

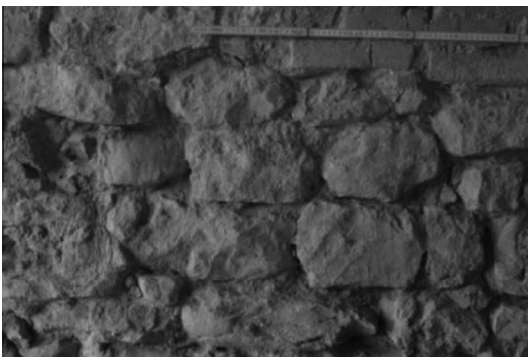
Fig. 7. Stonework of Colle Umberto farm house (20th-century).

size, and are well squared (Fig. 6). The second type, built in the early 1900s, is 480 mm thick and has lime-based mortar with better mechanical properties (Fig. 7). However, the stones are very rough hewn and almost square in shape, with sides of not more than 250 mm. In both wall types there are no through stones.

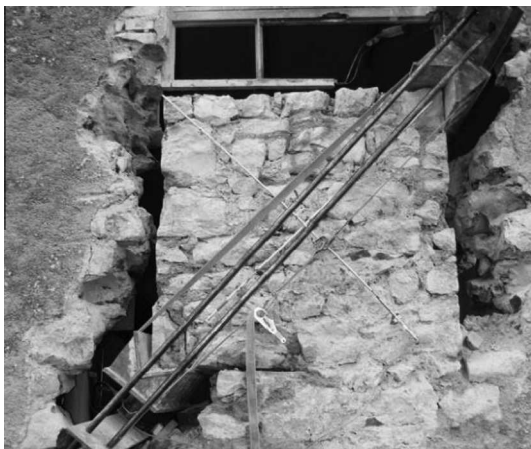
Fig. 9. Un-reinforced panel tested at Colle Umberto.

- 1) For the Colle Umberto building: (a) 5 diagonal compression tests: 2 on unreinforced panels (CD-02-U-OR, CD-06-U-OR), 1 on a panel with preventive reinforcement (CD-07-U-IP) and 2 on repaired panels (CD-08-U-IR, CD-10-U-IR) (Figs. 9 and 10) and (b) 5 shear compression tests: 2 on unreinforced panels (TC-16-U-OR, TC-17-U-OR), 2 on panels with preventive reinforcement (TC-19-U-IP, TC-20-U-IP), 1 on a repaired panel (TC-21-U-IR);

The cracks produced in the unreinforced panels were exclusively in the mortar joints and involved the entire thickness of the wall panel along the compressed diagonal. A similar shear strength (0.020 MPa) was obtained also for the unreinforced panel made with solid bricks at the San Felice building.

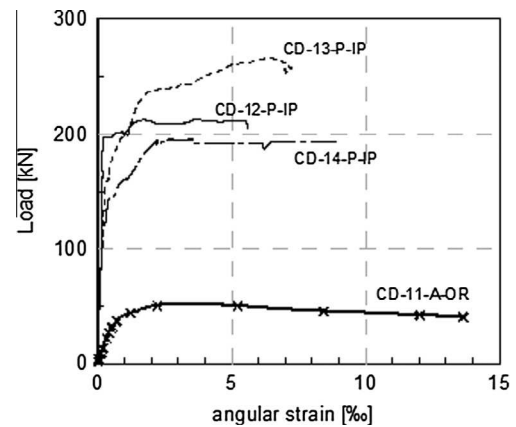
Fig. 15. Curves of the shear stress–angular strain response for stone masonry panels (Diagonal compression test method, L'Aquila).

For panels retrofitted in L'Aquila, the strengthening constrained the development of the cracks, and failure was confined by the GFRP jacketing. The average panel lateral strength increased to 0.0963 MPa (average maximum load 229.7 kN), i.e. the GFRP enhanced the lateral resistance by a factor of approximately 4.33 compared to the control panel (Fig. 15). The ultimate limit state was clearly a shear failure that was initiated by tensile rupture in grid fiber reached when the masonry cracked in tension.

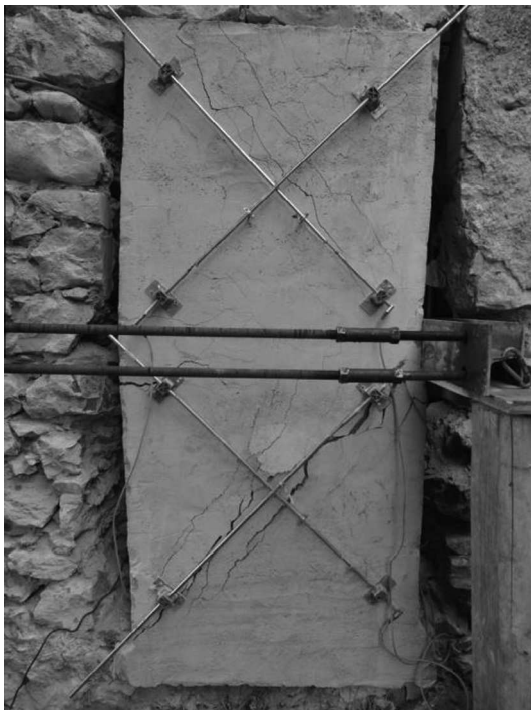
Fig. 14. Crack pattern of a reinforced wall panel tested at Colle Umberto.

Like that observed in the diagonal compression tests, this type of test as well the unreinforced samples showed cracks only in the mortar joints along the compressed diagonals. However a partial change in the type of failure was observed in the reinforced panels. The shear cracks along the compressed diagonals of the lower and upper square semi-panels were formed after evident horizontal cracks due to in-plane bending action at the midpoint of the panel (Fig. 14).
