ZEMCH 2015 International Conference, 22-25 September, Lecce, Italy.

Improving Thermal Comfort in Low-income Tropical Housing: The Case of Uganda

Arman Hashemi¹, Heather Cruickshank², Ali Cheshmehzangi³

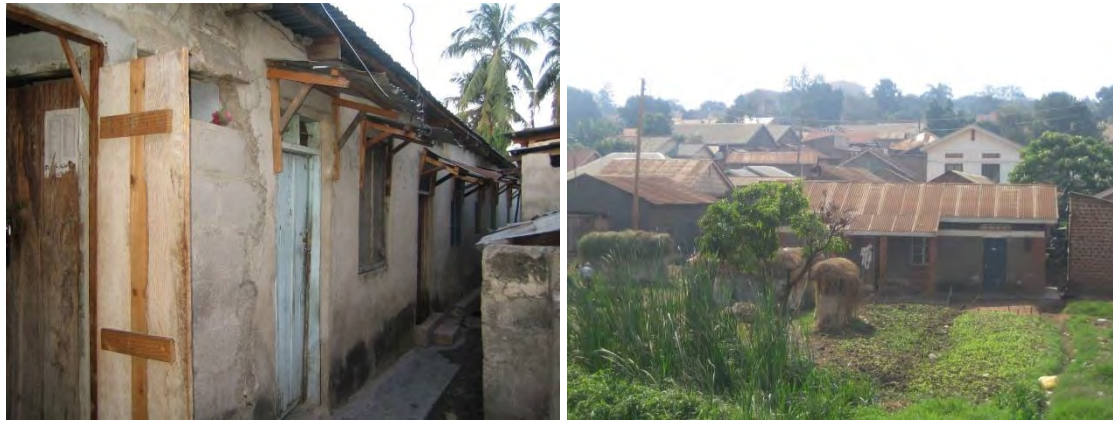
Figure 1: low-income housing with iron sheet roofing.

Figure 1 below also summarises the most common construction methods and materials used in housing projects during 2002-2010. In 2010, around 62% of homes in Uganda (84% in urban areas and 57% in rural areas) were roofed with iron sheets (Figure 2) followed by thatched roof which took a share of 37%. Around 57% (84% urban and 51% rural) of all dwellings had brick walls and 39% (12% urban and 46% rural) were made out of mud and poles. More than 71% of floors were made from earth (25% urban and 82% rural) and 27% (71% urban and 17% rural) were covered with cement (NPA 2010; UBOS 2010).

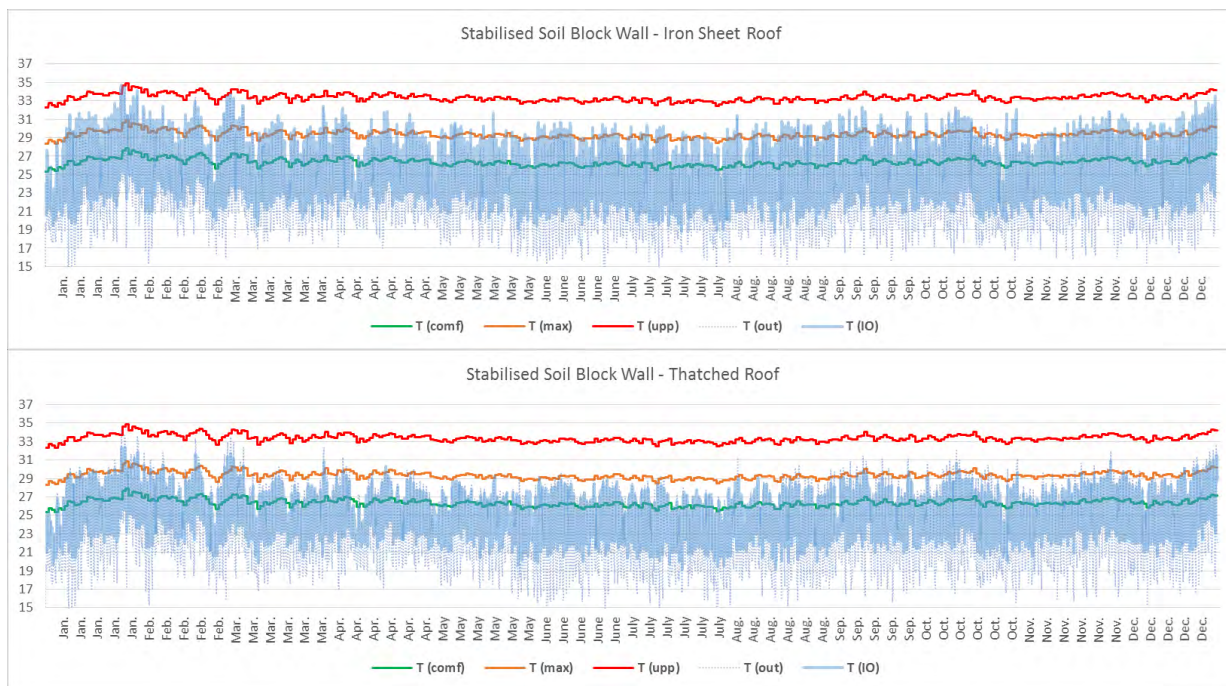
Figure 7: Thermal comfort condition for stabilised soil block walls with iron sheet (top) and thatched roofs (bottom).

Stabilised soil blocks had a similar performance to solid concrete blocks, adobe and brick walls. Similar to all other walling methods/materials, thatched roof had a considerably better performance compared to iron sheet roof. For the iron sheet roof, the buildings was found to be for 7.5% of the occupied periods uncomfortable (criterion 1). W_e was also above the acceptable limit of 6 for 45 days. Regarding criterion 3, ΔT also exceeded the 4 K limit for two days. Criteria 1, 2 and 3 were respectively reduced to 0.8%, 5 days and 0 days for stabilised soil block walls with thatched roof meaning that the building passed criteria 1 and 3 but failed to meet the requirements for criterion 2. Figure 7 compares the thermal comfort conditions for stabilised soil block walls with thatched and iron sheet roofs.
