ENERGY AND LOW-INCOME TROPICAL HOUSING IN TANZANIA

Abstract: Low-income housing in Tanzania is traditionally made from mud and thatch. With thatch having a typical life span of 2-7 years and mangrove poles 5-15 years, low durability is identified as the key issue with the traditional low-income house design. This paper studies the financial and social implications, embodied energy (EE) and human energy (HE) of a variety of materials in a bid to identify both the positive and negative impacts of each material substitution on the overall design, the environment and the local community. Using primary data collected from houses in the Mbweni district of Dar es Salaam and The Inventory of Carbon and Energy to calculate EE, a qualitative and quantitative assessment of each material is made. 47% of residents questioned in Tanzania, identified low durability to be the key issue with their mud house, with design changes which address this issue therefore affecting the largest share of the population. Stabilised bricks are identified as the key material substitution that should be adopted by local people, they perform well in terms of improved durability, financial and environmental conside

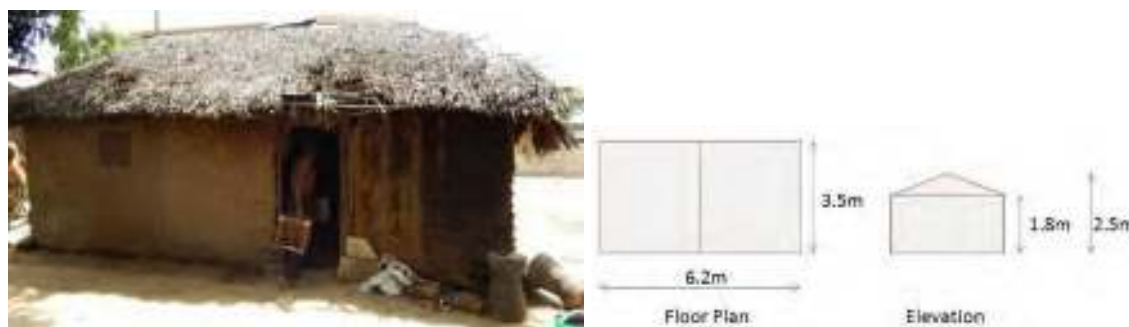
Figure 1: Photo and layout of traditional mud house, House 6

Almost all of the observed low-income houses were made from mud and pole walls covered with a thatch roof. The dimensions of the houses that were surveyed by the author during the field work were noted and the average dimensions computed. 'House 6' (Figure.1.) from the survey matches, almost exactly, the dimensions of the average house calculated. This two room house has therefore been taken for this research as the typical traditional house design, on which design modifications are based.

Using previous research combined with primary data from the field, calculations of the cost and EE of constituent elements for each house design were calculated, based on the house outlined in Figure.1. Table.4. provides a summary of the values associated with each material for each element of the house, allowing comparisons of durability and social and environmental impacts to be drawn.

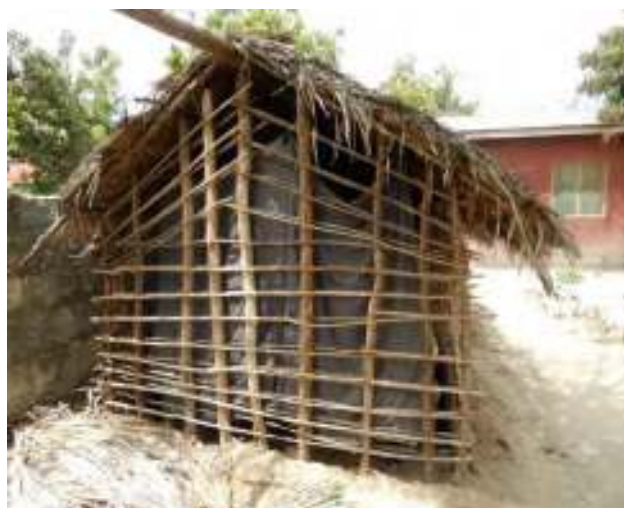
Figure 2: Detail of timber support to a mud house, House 7

The walls are made from mangrove poles dug vertically into the ground, strung together with bamboo poles and the frame (Figure.2.) filled with mud. The roof is made from coconut palm fronds, woven together and built into a pitch, supported by mangrove poles (Wells 1998). Iron sheeting is commonly placed at the ridge of the roof, as it is difficult to get a perfect seal between the two slopes. Salvaged material is often used to patch up sections of the house, in a bid to improve the overall durability. Traditionally the houses are built by the local community, using free collected materials or materials bought from local traders, keeping money exchange within the community. The house is constructed in a collaborative effort by local people for convenience, ease of repair and to reduce labour costs.

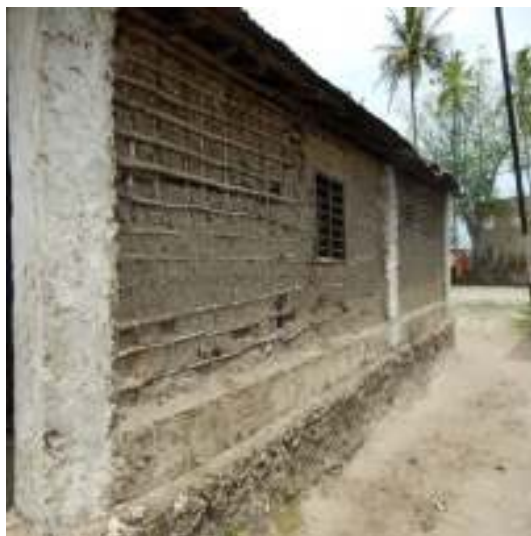
Figure 3: Mud house with concrete foundation (Author)

The use of concrete blocks, stabilised bricks and sisal fibre roof tiles all require the installation of a concrete foundation, for safety reasons. Installing a concrete foundation has huge durability benefits as shown by House 20 (Figure.3.) which was built 40-50 years ago and since then has required little repair expect for "sometimes filling in the gaps in the walls with more mud". As this design change needs to be installed first, the traditional design cannot be gradually improved using the methods studied, highlighting the need for other small-scale modifications, which do not require concrete foundations. Protective measures, such as covering mud walls with plaster or paint and using baked mud bricks should therefore be considered. When a mud house is sold, the buyer pays for the cost of the plot of land the house sits on, so investments made to make small scale improvements to the design using plaster and paint, are not recovered upon sale. If there is a concrete foundation or brick/block walls, extra revenue is obtained in the sale, recovering some of the initial investment. Therefore, there is a point at which small-scale improvements to mud houses become economically unviable in the long-term compared with block/brick designs. In order to save enough money to make substantial design improvements families stop making repairs to their current houses and save up money to invest in more durable designs, causing families to live in extremely poor conditions with all their hope pinned on a better house in the future.
