Energy Procedia 134 (2017) 815–824

9th International Conference on Sustainability in Energy and Buildings, SEB-17, 5-7 July 2017,  
Chania, Crete, Greece

# Effects of thermal insulation on thermal comfort in low-income tropical housing

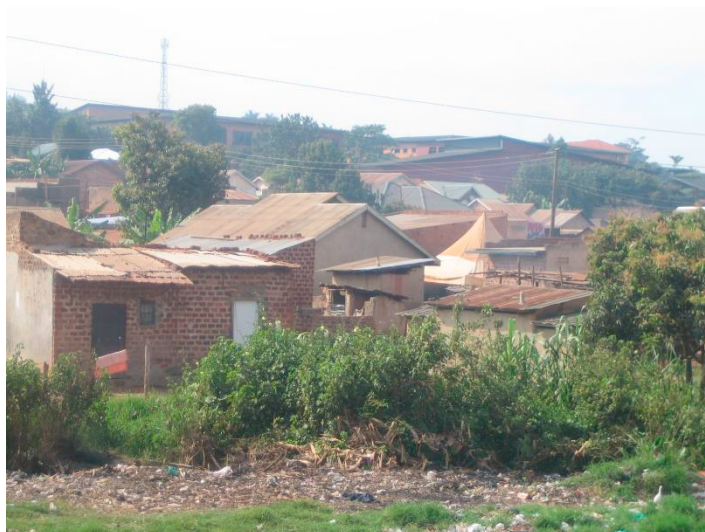
Fig. 1. Low-income housing.

urban population live in slums [4,5] and over 50% live in single-roomed overcrowded properties [6] built from low quality materials (Figure 1). Moreover, rapid urbanisation and growing housing demand are some of the other current challenges of the country [7]. Currently, embodied energy of construction methods and materials seems to be the major challenge which requires immediate attention to mitigate negative environmental effects of the construction industry [8,9].
