TESIS DE MÁSTER

Ingeniería Estructural y de la Construcción.

"Application of System Dynamics to model rework in construction projects".

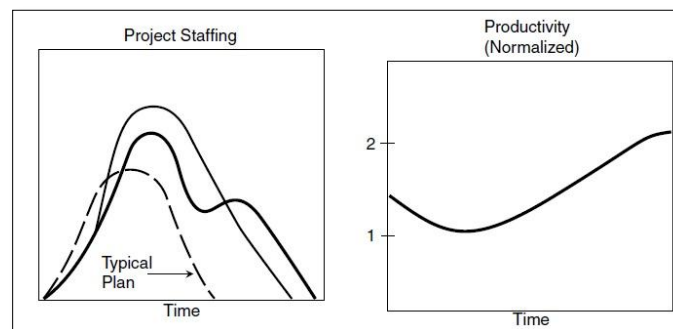
According to (Lyneis, G. Cooper, & A. Elsa, 2001), in an ideal project, staffing follows the plan and increases to a peak, then falls off as the work is completed. In reality, however, project staffing is often slower to build up than planned and frequently exceeds planned levels for an extended period, commonly known as the overrun. On most projects, managers also assume, either explicitly or implicitly, that productivity will remain constant over the duration of the project. This behavior is presented on Fig. 2.1.

Fig. 2.1: Dynamic of a standard project.

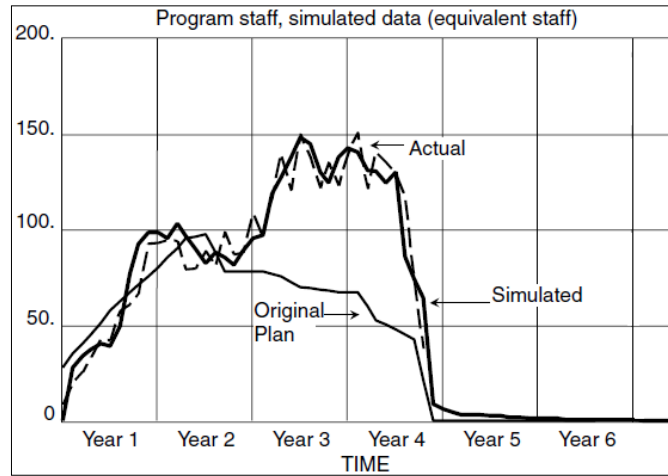
In reality, productivity typically falls from the beginning through the middle of the project, before rising at the end. Productivity often varies by a factor of two over the course of a project. This real behavior is shown in Fig. 2. 2.

Fig. 2. 2: Staffing behavior in reality.

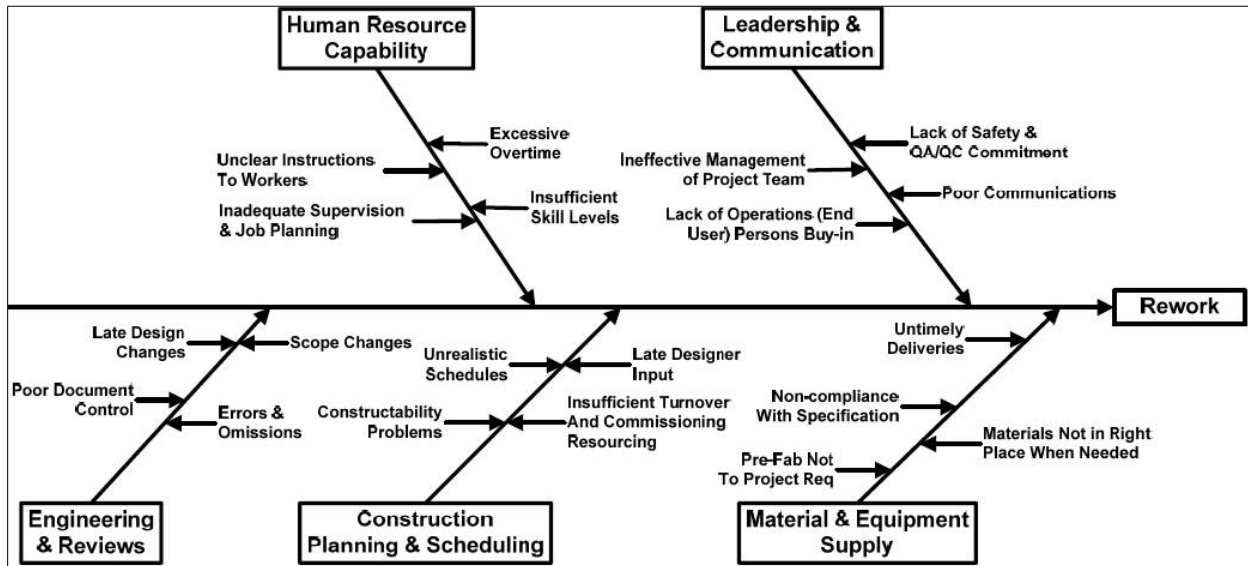
Another author with a similar point of view in this matter is Pei-Yin Feng. The author (Pei-Yin Feng, 2009) states that many sources of rework have been identified in the construction industry. The "cause and effect" diagram shown on Fig. 2.4 lay out the five main causes of rework in the construction phase of a project, which are:

Fig. 2.4: Main causes of rework arise in construction projects.

1. Human resource capability: categorizes rework that deals with the capabilities of the engineers, contractors, and subcontractors that are involved with the project. Untrained personnel working on a facility can lead to rework.

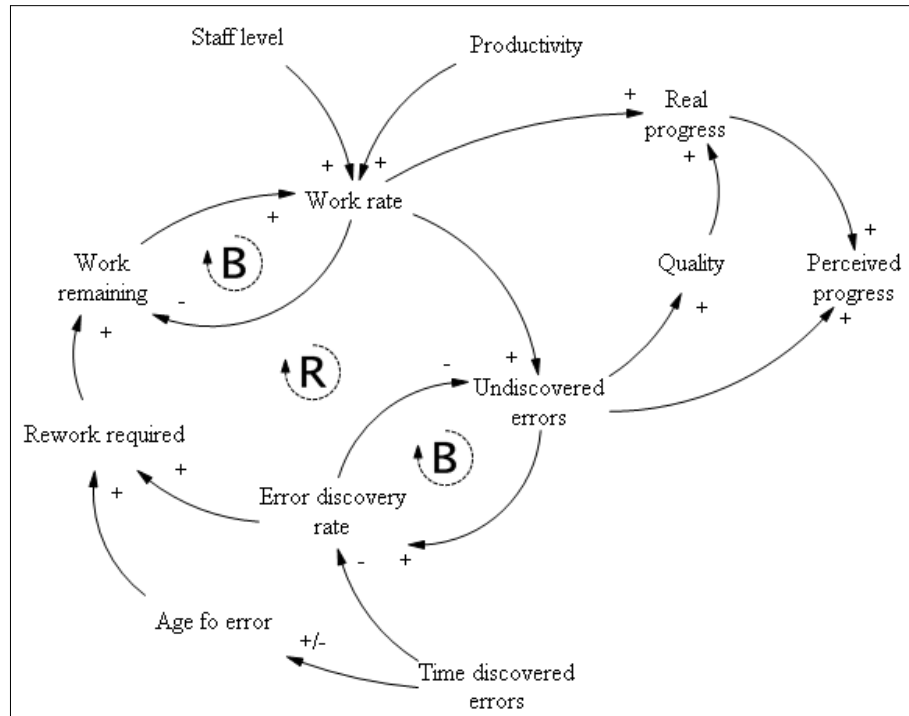
After sometime these errors are detected and rework is identified which increases the amount of work to be undertaken by staff (Cooper, 1993); (Rodrigues & Bowers, 1996) (G. Rodriguez & M. Williams, 1998). The degree of rework required is dependent on how long the error has remained undetected. (Love, Goh, & Han, 2010).

Fig. 2.5: Cooper's rework Cycle.

If the error needs a major change be undertaken, then all the perceived progress prior to the error occurring may be considered wasted. Addressing the error may generate more work for individuals and the possibility of more errors being generated. This is denoted by a reinforcing loop in the model, indicated by **(R)**.

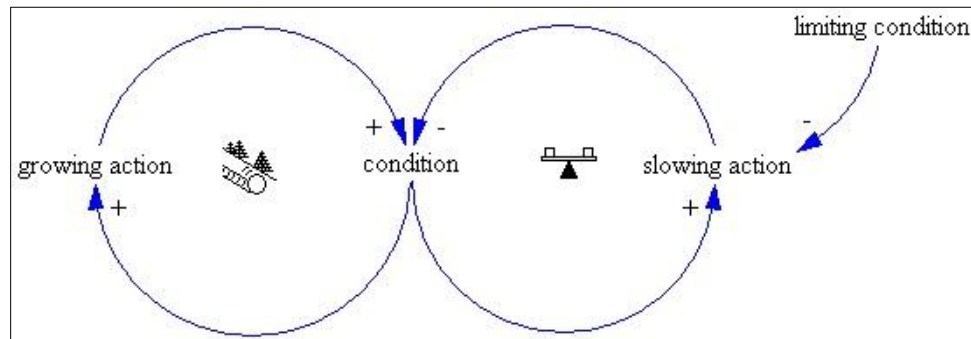
As seen on Fig. 2.7, a positive link (arrow with a "+") indicates that if the cause increases, the effect increases above what it would otherwise have been, and if the cause decreases, the effect decreases below what it would otherwise have been. A negative link (arrow with a "-") indicates that if the cause increases, the effect decreases below what it would otherwise have been, and if the cause decreases, the effect increases above what it would otherwise have been.

Fig. 2.7: Example of causal loop modeling within System Dynamics.

A causal loop diagram can show explicitly the direction and type of causality among the major factors, which is fundamental in understanding rework in a project system. It can be used to model the influences of inputs on outputs and vice-versa. (If variable "A" is causing a change in variable "B", the direction of causality is from "A" to "B". If an increase (decrease) in variable "A" leads to increase (decrease) in variable "B" then the type of causality is positive. (Love, Mandal, & Li., 1999).

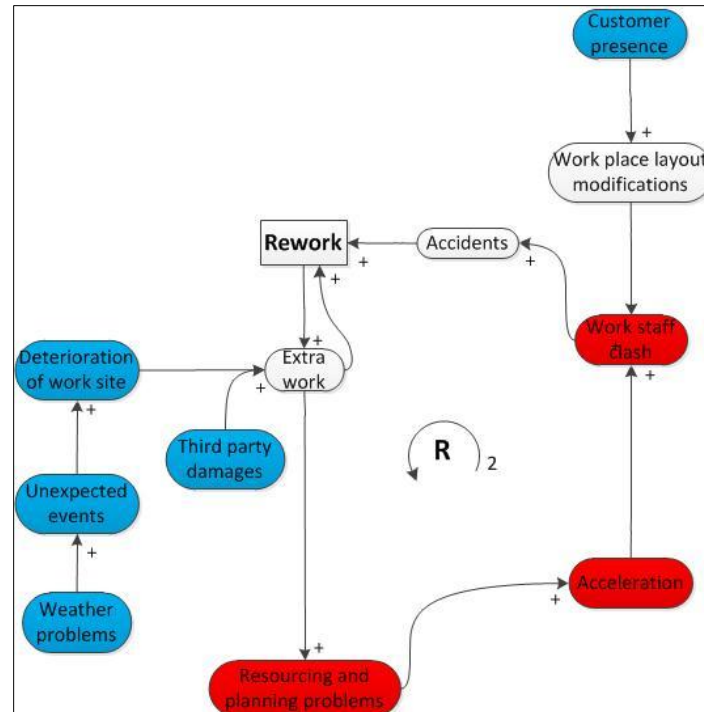
As for "**Deterioration of site**", factors like "**Weather**" and "**Unexpected problems**" played a leading role affecting the work site. As for unexpected problem, the equation was addressed as a 1.4 times of "weather problems" that affected the course of repairs. And so, these problems deteriorated the worksite directly, affecting all previous works done until that point.

Fig. 4.6: Loop no. 2 S.D. repair model.

At this point, "**Extra work**" generated more "**Resourcing and planning problems**". Basically, there was a need of more materials and resources to redo activities that were meant to be accomplished on a first try. Planning goes forward and backwards to keep up with everything that's happening, but eventually problems start to accumulate.

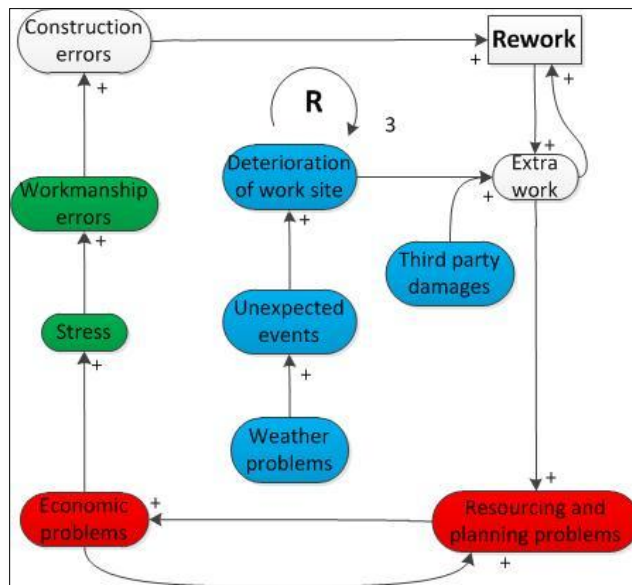
The final loop of this model, shown on Fig. 4.8, basically present the path in which rework produces more extra work, eventually leading into committing more construction errors. Loop starts in the same way as Loop 2 mentioned before. Rework increases the amount of "Extra work" to be addressed and this, directly generates more "Resourcing and planning problems".

Fig. 4.8: Loop no. 3 S.D. repair model.

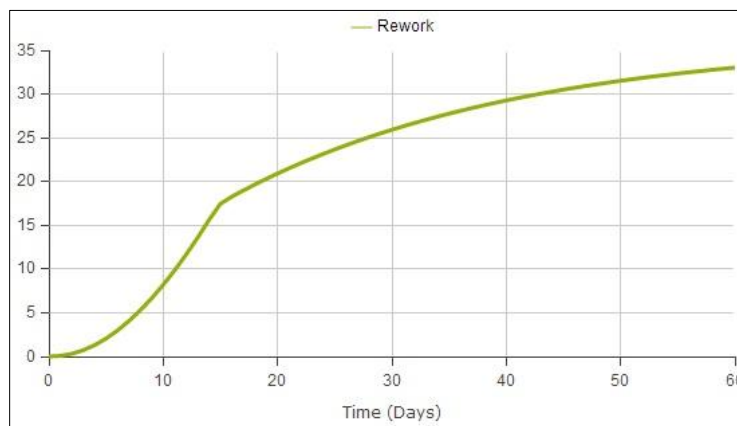
On the image it can be seen that the behavior of the overall rework repair begins with an exponential growth for the first 15 days, but then the performance curve undergoes a change in slope, which indicates a slight progressive reduction in the amount of rework produced during repairs. This occurs because, on repair stage, there aren't many factors that influence on the supply of new incidents to pile up new task that need rework, so the feedback loop is progressively reduced to reach an "apparent" stability, but maintaining the "quantity" of rework over time, until this situation is properly corrected.

Fig. 4.11: Rework S.D. for repair stage

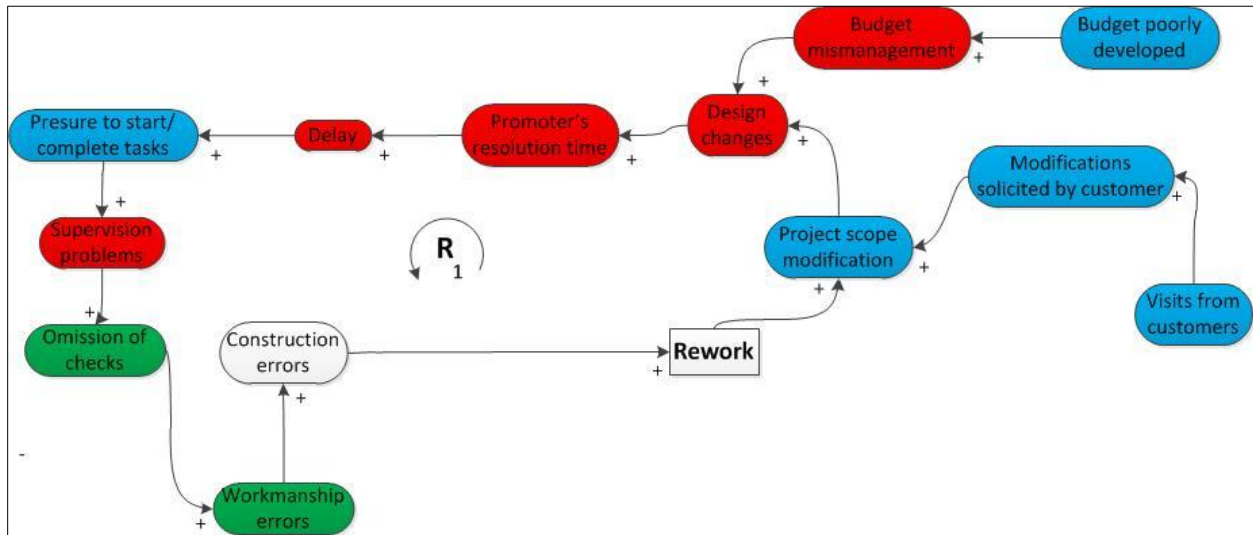
The first loop, shown on Fig. 4.12 mainly exposes how changes from different sources affect the final product. Each change or modification would ultimately lead into rework's increase. These changes were mostly solicited by customer or promoter, or if there was an error on blueprints and modifications were in order to improve the final product. The stocks participating in this loop are "Rework" and "Construction errors".

Fig. 4.12: Loop no. 1 S.D. construction model.

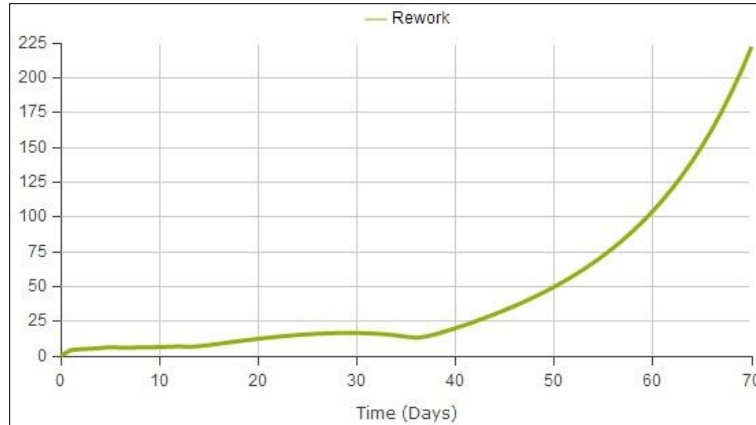
"Supervision problems" directly affected the **"Omission of checks"** and, subsequently, with omissions came an increase in **"Workmanship errors"**. Last, with an increase or errors from workers, there was a notable increase in **"Construction Errors"**. All these relationship were directly proportional into each other. Finally, the loop is closed when all **"Construction errors"** start directly increasing the amount of **"Rework"** on site.

Fig. 4.13: Construction S.D. Loop 1 simulations results.

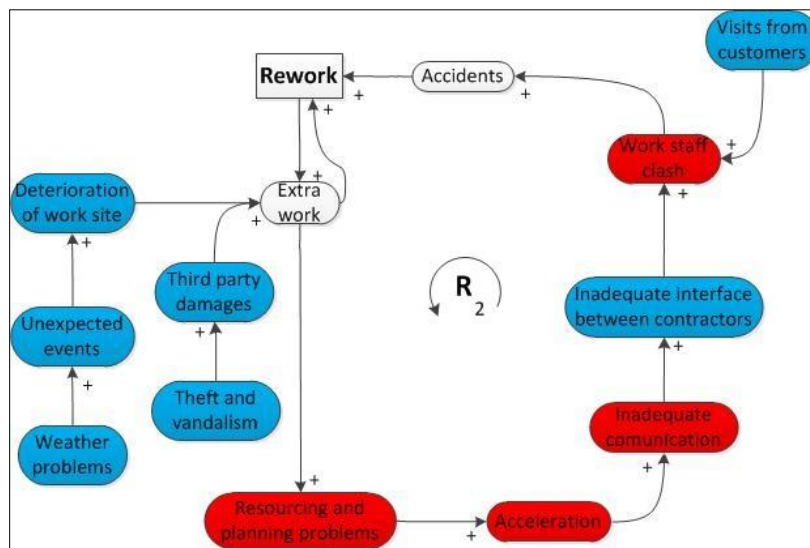
Fig. 4.14 shows the second loop in construction S.D.. In here, it attempts to cover how rework generates more non-expected work. This situation demanded more resources and planning to redo activities that were supposed to be perfectly done in the first try. To address these circumstances, it has essential to some acceleration to keep up with the schedule and avoiding wasting more time. But eventually several teams clash into each other, causing accidents that need to be addressed quickly, entering once again into Rework stock.

Fig. 4.14: Loop no. 2 S.D. construction model.

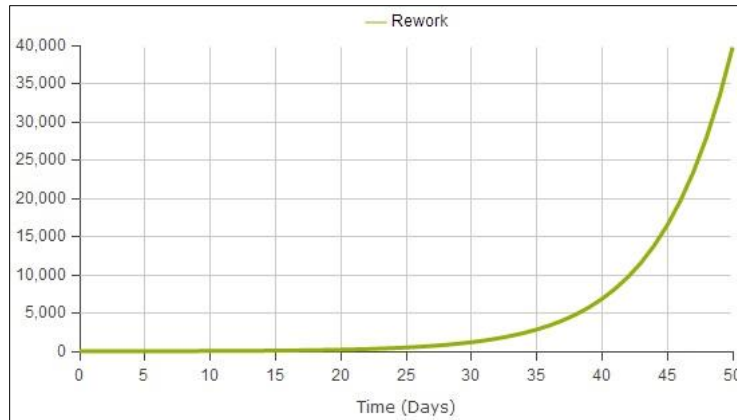
Along with "**Communication problems**" and adding "**Surprise visits from customers**" to glance work progress, this created a situation of chaos inside the work site and caused work teams to "**Clash**" into each other ruining their works. Through "**Clashes**" and misunderstandings, this proportionally affected the amount of "**Accidents**" and damages occasioned. At the end, all these accidents came back to accumulate more "**Rework**" to be redone once again.

Fig. 4.15: Construction S.D. Loop 2 simulations results.

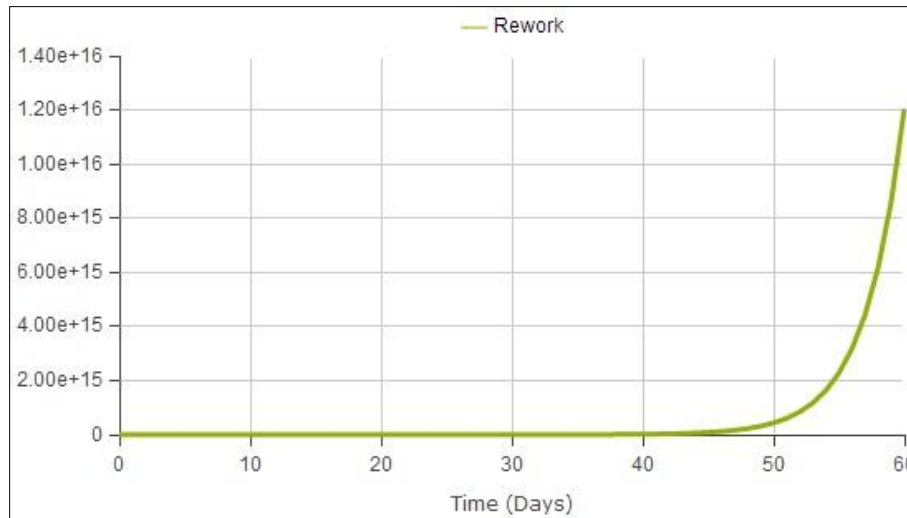
With new work staff, it was expected a direct increase in the amount of "**errors from workers**" due to lack of experience and "Stress". Subsequently, these "Workmanship errors" led directly into more "**Construction errors**" and finally completing the loop with an increase in the amount of "**Rework**" within the project.

Fig. 4.17: Construction S.D. Loop 3 simulations results.

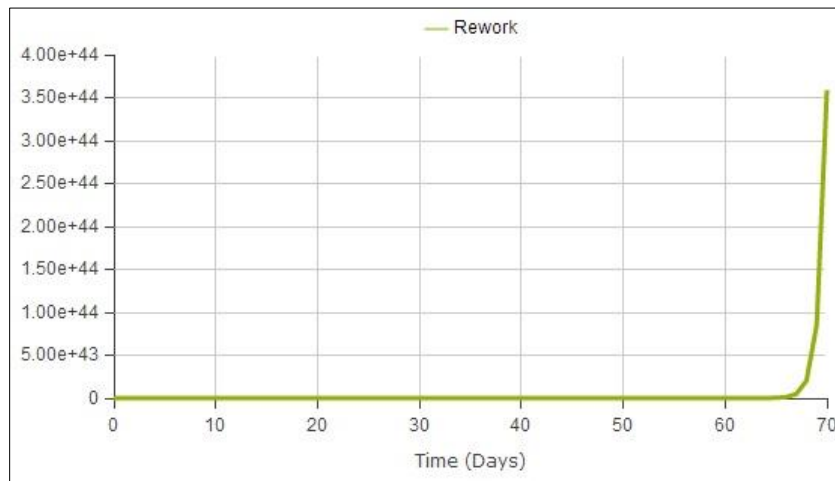
Fig. 4.19: Rework S.D. for construction stage
