Building WF16: construction of a PPNA pisé structure in Southern Jordan

Building WF16: construction of a Pre-Pottery Neolithic A (PPNA) pisé structure in Southern Jordan

Pascal Flohr¹, Bill Finlayson², Mohammad Najjar² and Steven Mithen³

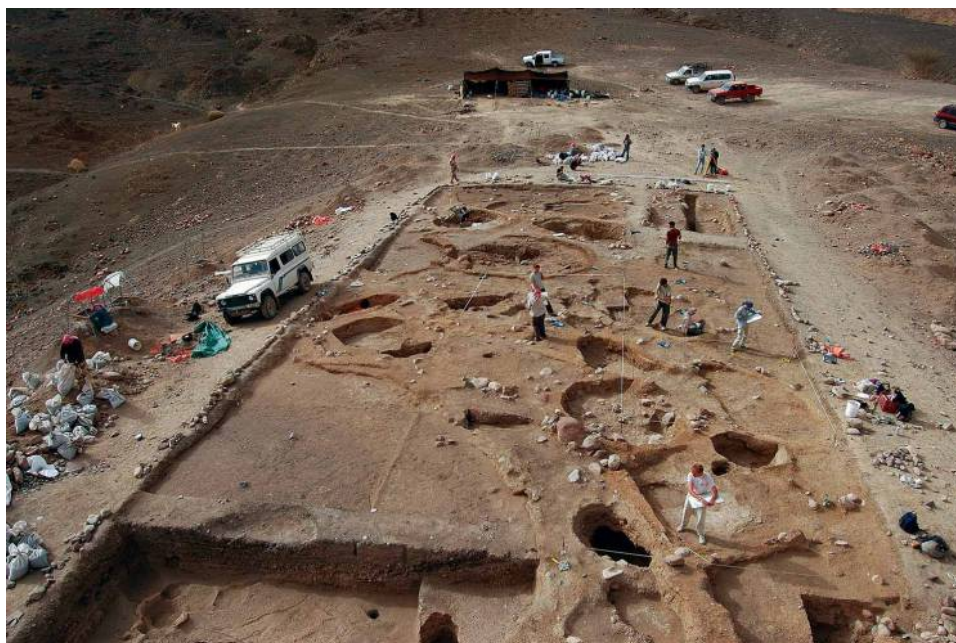
Figure 4 Excavation at WF16, April 2009, showing accumulation of midden deposits within structure 075 and a cluster of semi-subterranean pisé built structures. Structure O11 can be seen in the far left part of the trench.

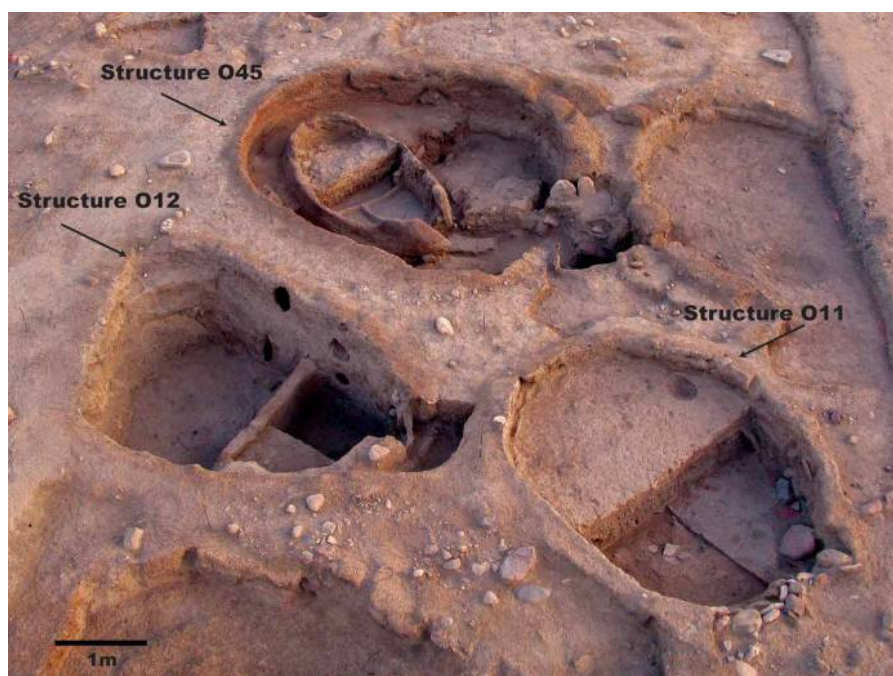
Figure 5 Structures O11, O12 and O45 at WF16.

The experimental structure was based on the PPNA structures at WF16; it was specifically based on Structure O11 (Fig. 5), but non-conflicting information and features of other structures were incorporated as well, such as the presence of a niche in the walls as in Structure O12 (Fig. 5). Information regarding how the roof could have been made was based on well-preserved roof material from Structure O45 (Figs 5, 6) (see Finlayson *et al.* 2011b for a description of these structures and their context within the settlement).

Structures at WF16 were mostly small, semi-subterranean, circular to elliptical, with mud wall lining and mud-plaster floors (Figs 3–5; Finlayson *et al.* 2011b). Structure O11 is a typical example of this, measuring about 3.5 m × 2.5 m, with a cup-hole mortar placed within its floor (Fig. 5). The internal faces of the subterranean cut were lined with pisé, which was also used to construct the above ground walls, surviving to a height of *c.* 0.5 m. Several mud-plaster floors were exposed during excavation. Indications of a stone-lined ramp leading to an entrance were also found. Although the walls of Structure O11 have not been sectioned, and future analyses of wall sections will be required to show precisely how they were built up, our preliminary interpretation was that the mud wall had been shaped while wet. In addition to this use of pisé, in some of the other structures at WF16 pre-moulded and possibly sun-dried lumps of building material had been used in the above ground walls, most clearly visible in the rapid backfilling of Structure O33. The excavation of walls elsewhere at WF16 exposed stone foundations; we suspect that these might also underlie the unexcavated walls of O11.

As explained above, the experimental structure was based on Structure O11 from WF16 (Fig. 5), but non-conflicting information and features of other structures were incorporated as well, especially roof evidence from Structure O45.

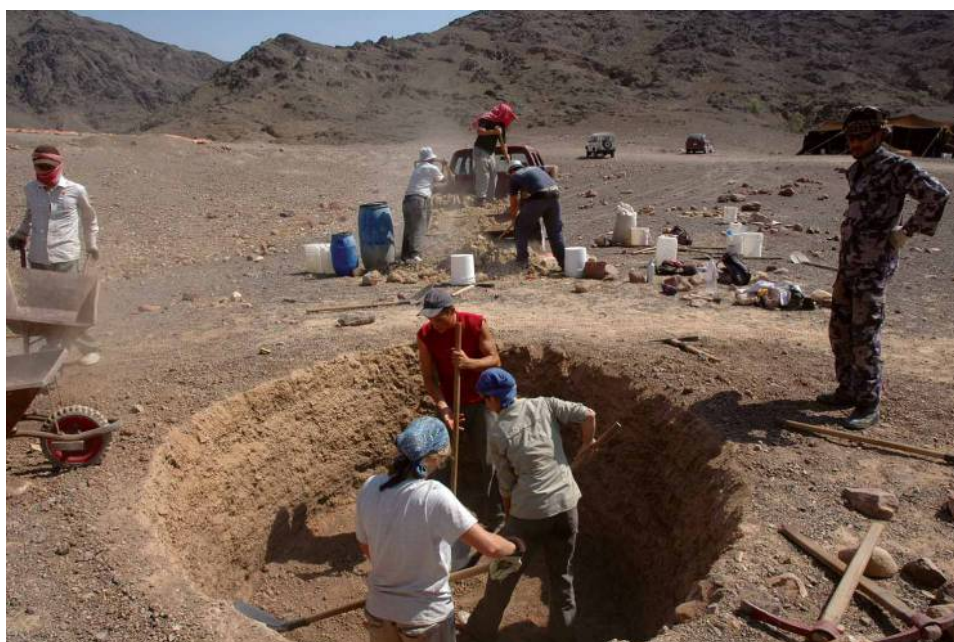
Figure 8 Digging of the pit, which measured 2.5 m × 3.5 m on top and was dug 1.2 m deep. In the background a load of sediment is unloaded. To the left, part of WF16 is visible.

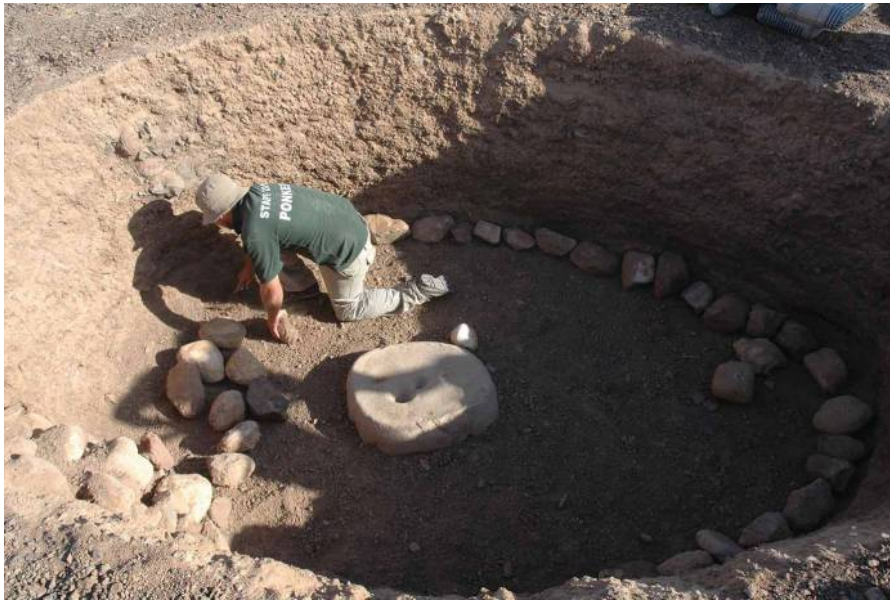
Figure 9 Laying of the foundation layer of boulders.

- (3) a foundation layer of boulders (each up to 0.2 m in length) was laid around the edge of the base of the cut (Fig. 9).
- (4) the stone foundation was covered with a first layer of the mud mix. When this layer was leather-hard, i.e. dry enough not to collapse when additional weight was applied, but not so dry that the next layer would not stick to it, a second layer was applied. This sequence was repeated until the top of the pit was reached, every time applying a layer of 10–15 cm (Fig. 10). Each layer, containing around 140–150 litres of mud, took three people around one hour to apply. Although individual members of the team developed their own preferences, in general the mud was applied by either kneading it in the hand and subsequently pressing it onto the wall, or by putting some mud on the wall and pressing hard into it. A niche was made within the wall

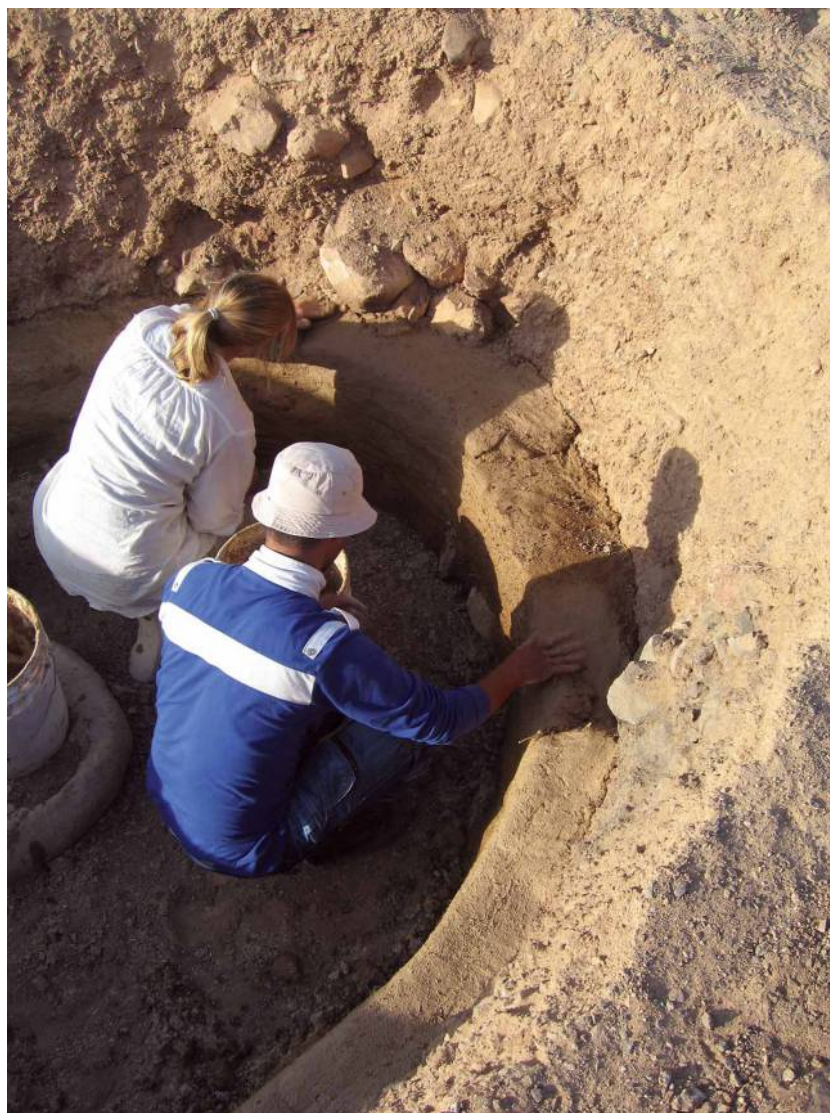
Figure 10 Application of wet pisé layers of 10–15 cm thick each.

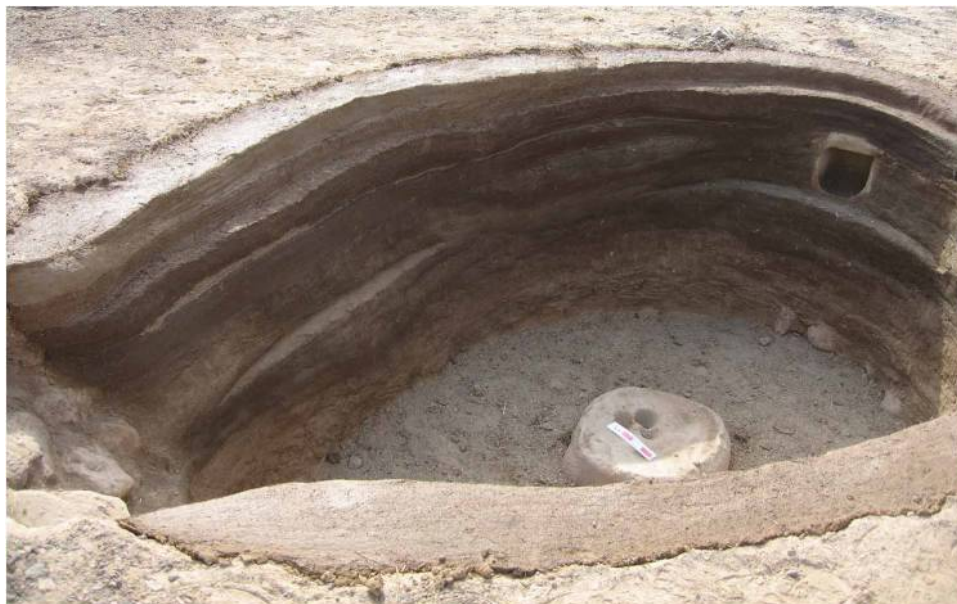
Figure 11 Stepping in of the southern wall, to avoid the wall becoming too thick as a result of bulging of wet walls and sloping edges of the pit.

with flat stones. When parts of the wall began to become too thick where they bulged inwards because of the weight of wet mud and because the edges of the pit cut sloped slightly outwards, the wall was realigned by stepping the next layer in. In the northern part this was done once, in the southern part twice (Fig. 11).

factors, it was decided to step the wall in. This was done twice in the southern, shaded part (Fig. 11), and once in the northern part. Interestingly, stepped walls had also been found in Structure O11 at WF16. These had been interpreted during excavation as indicating a realignment of the wall; the current study's experimental work suggests a simple pragmatic structural technique may have been responsible for this archaeological feature.

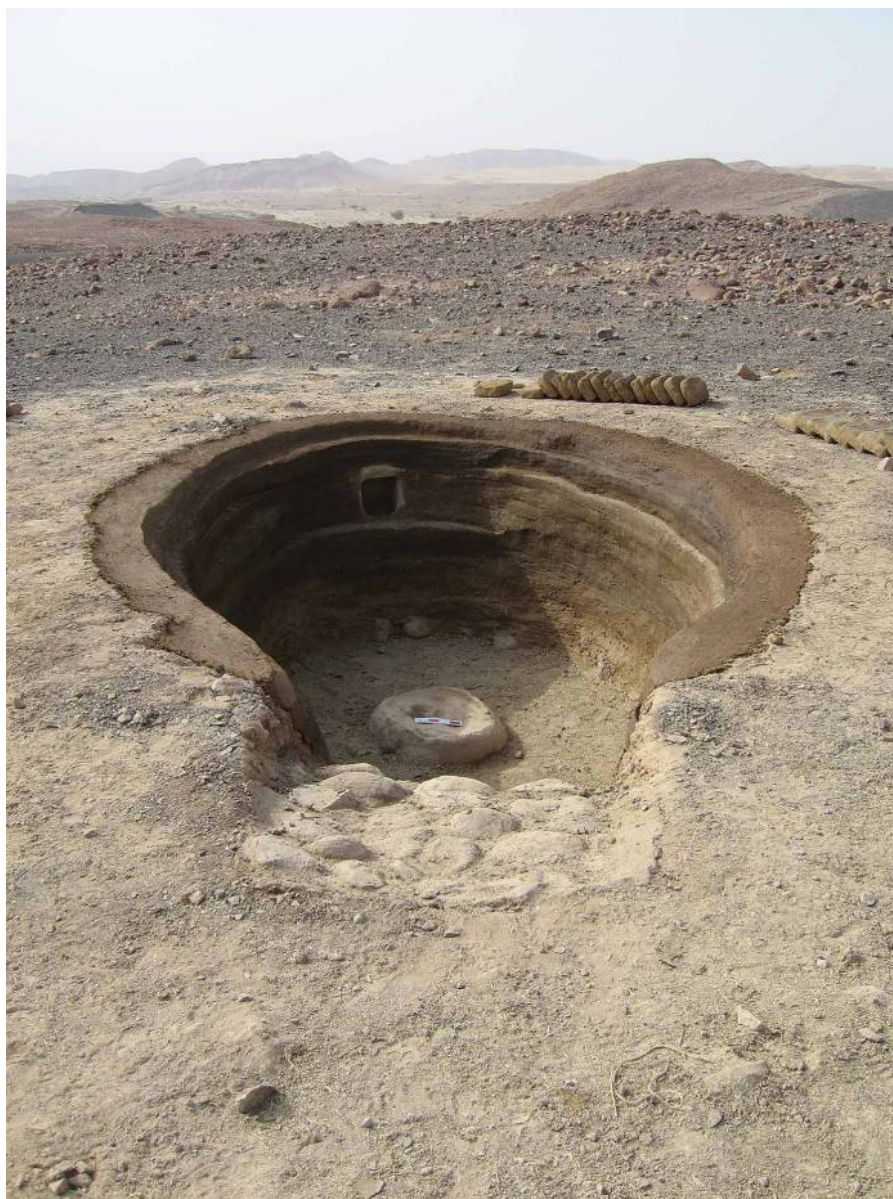
Figure 12 The finished pisé wall (looking north-west), with the ramp on the foreground, and the niche in the west part of the wall. The different layers are drying in different colours. The stepping in of the wall is visible.

- (6) at the same time (contemporaneous with steps 4 and 5), 210 mudbricks were formed and sun dried. Once the wall below the ground surface was complete (Fig. 12) these bricks were laid lengthwise (with the long side in line with the building, i.e. the short side perpendicular to the building) in six to seven courses each one brick thick, bound together by mortar, to form a *c.* 40 cm high wall on top of the mud wall (Fig. 13). The walls were immediately plastered. While it would have been more beneficial to have done this after the walls had dried, to prevent cracking of the plaster as the walls dry, time precluded this. Cracks in the plaster were filled up during the next days. Whereas the preparation of the mudbricks had taken up a considerable amount of time (Table 1), the laying of the wall was very quick and took less than 2 days.

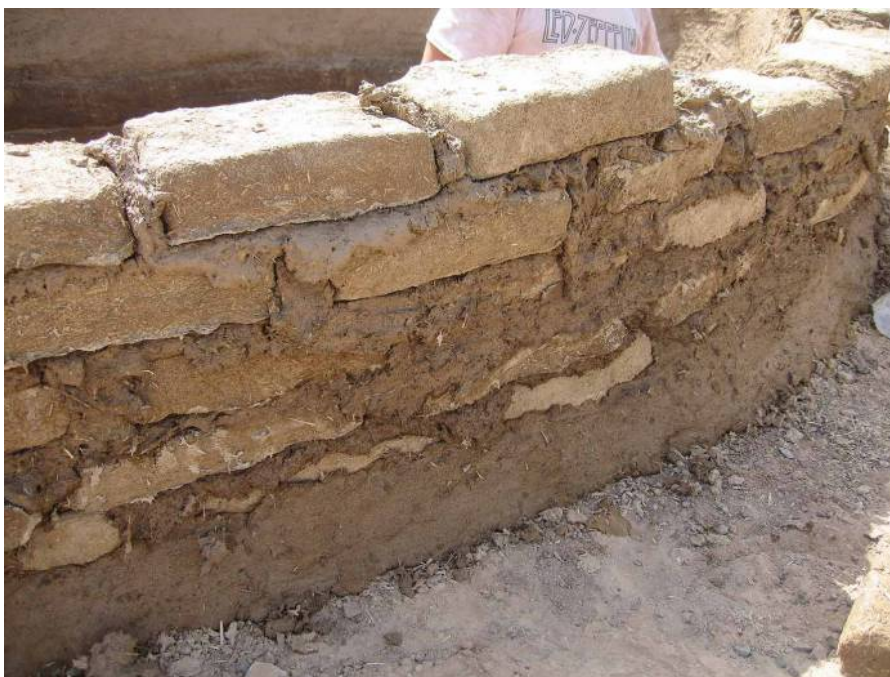
Figure 13 Mudbrick wall, bound with mortar and in the process of being covered with mud plaster.

As the mudbricks were dried before use in the construction, there were no problems with wetness, bulging and sloping of the mudbrick part of the wall. Although the mudbricks required some time to prepare, the wall could be built quickly. It is therefore not hard to see why the use of mudbrick was later (after the PPNA) more widely adopted instead of the use of pisé.

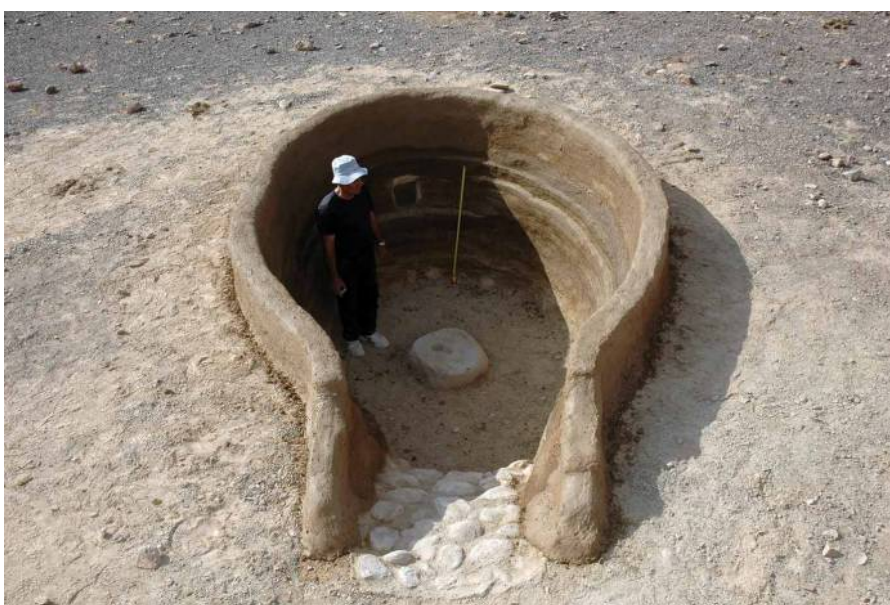
Figure 14 Finished wall with human scale and measurement tape (1 m scale).

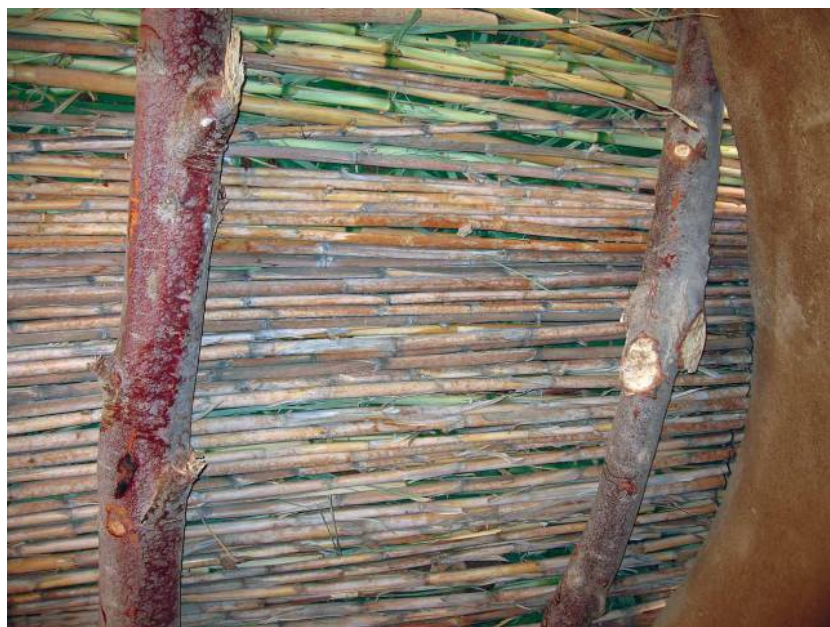
Figure 15 Roof construction with wooden beams supporting reeds (in turn supporting mud), seen from below.

The construction of the roof appears to work well. The beams were laid on top of the walls, where their weight and the weight of the mud on top kept them in place. It is possible that in the WF16 buildings the beams would actually have been set in the upper

layers of the wall, as observed in modern mudbrick construction (e.g. Keefe 2005). Also, in this case the only beams available were bent. While this might have been the case in some PPNA structures as well, this resulted in having to use more mud on top than would have been the case with straight beams, to avoid a concave roof, in which puddles of water might collect and damage the roof. Even though the walls were only about 20 cm wide, they were strong enough to carry the weight of the roof. As other structures at WF16 had walls of either similar or a greater width, and in the absence of postholes, this confirms that the roofs could have been directly supported by the walls. Moreover, the roof and its supporting walls proved strong enough to allow herds of goats and people to walk over it, indicating that it was possible to use such a roof as an activity area (see further below).

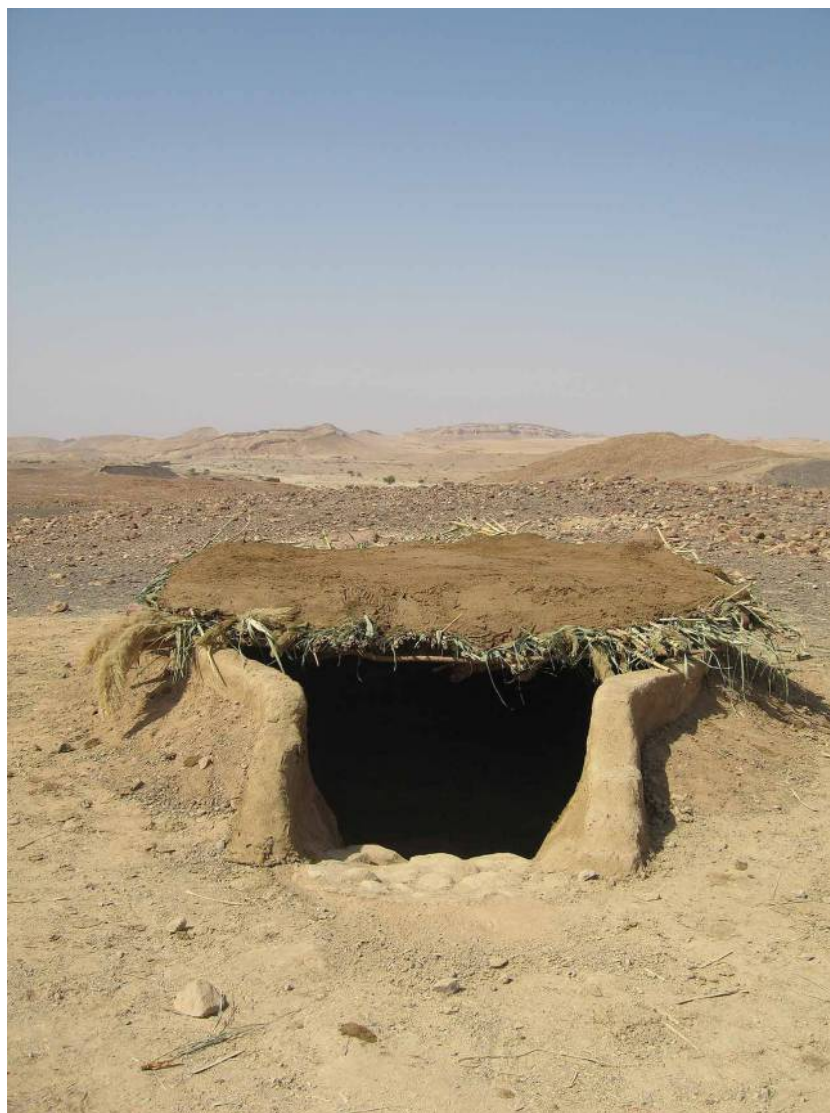
Figure 16 The finished structure in its surroundings (looking north-west). The mud-covered roof is clearly visible.

After the structure had dried out for a couple of weeks, it was possible to stand on the roof. If indeed the roofs were flat as the evidence suggests, they could provide an activity area. This is also confirmed by chipped-stone fragments found on the surface of collapsed roof segments of Structure O45 at WF16.
