## Thermal Degradation Phenomena of Polymer Film on Magnet Wire for Electromagnetic Coils

Kavanagh, DF, Gyftakis, K & McCulloch, M 2020, 'Thermal Degradation Phenomena of Polymer Film on Magnet Wire for Electromagnetic Coils', *IEEE Transactions on Industry Applications*, vol. 57, no. 1, pp. 458 - 467. <https://doi.org/10.1109/TIA.2020.3040201>

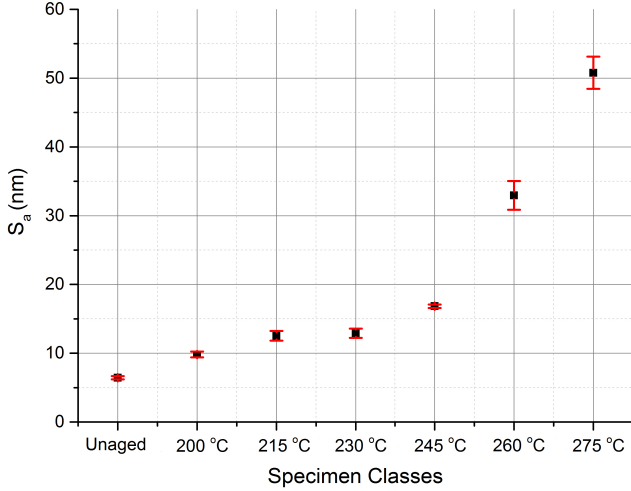
Fig. 6: Average surface roughness  $S_a$  of the specimens for the early onset ageing period of 100 h.

The surface roughness measurements are qualitatively shown in Fig. 5. The unaged sample has a relatively smooth surface with subtle horizontal lines due to the coating process, in the direction of the insulation extrusion. It can be observed that these lines become broader and more pronounced as the ageing exposure temperature increases. The changes in surface roughness is quantified using the a surface roughness parameter  $S_a$ . The variation in  $S_a$  with respect to temperature is shown in Fig. 6, a trend exists showing the roughness

increase from around 6 nm in the unaged sample to about 18 nm at 245 °C ageing and 51 nm at 275 °C ageing.

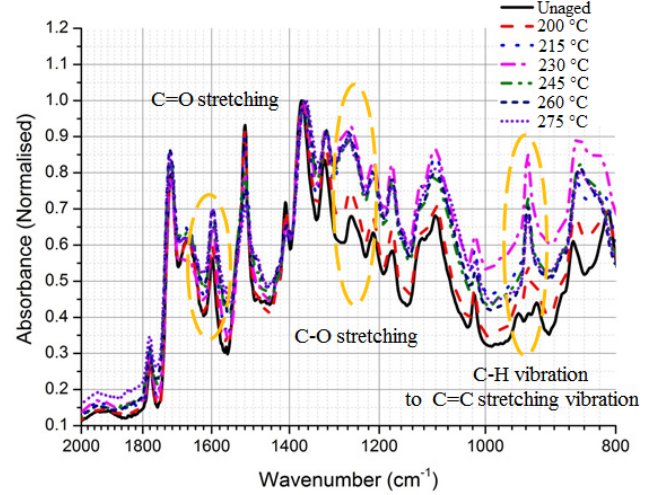
Fig. 8: The FTIR absorbance spectra for the different specimen temperature classes for the early onset ageing period of 100 h.

Fig. 8 shows the FTIR absorbance signatures for the PAI outer insulation layer for the different specimen classes. The spectra are in the range from 2000 to 800 cm<sup>-1</sup>. Three different regions are highlighted which relate to changes in the molecular structure in the regions of 1596 cm<sup>-1</sup>, 1258 cm<sup>-1</sup>, 928 cm<sup>-1</sup>. These can be referenced to different characteristic molecular bond vibrations. These are annotated on the plot in the regions of interest. The first case suggests increases in the levels of carbon and oxygen double bond stretching. The second case suggests increases in carbon and oxygen single bond stretching with respect to higher exposure temperatures. Finally, the third case suggests that carbon and hydrogen bond vibration peak reduction was replaced by carbon and double carbon bond stretching with respect to the specimens exposed to higher temperatures.

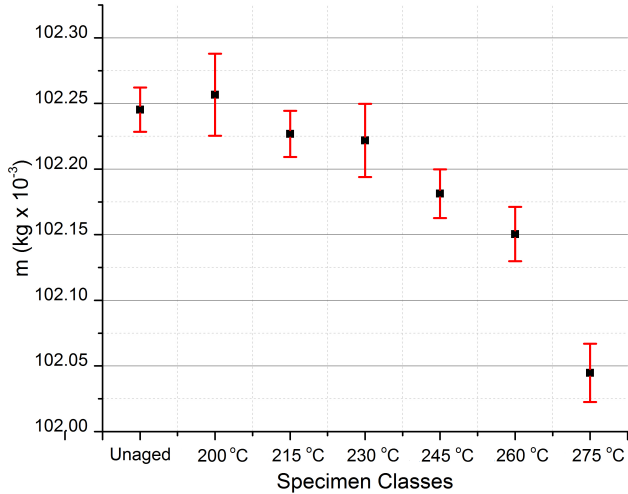
Fig. 7: Average mass of the specimens for the early onset ageing period of 100 h.

The results for the measured average masses of the samples at various ageing temperatures are shown in Fig. 7. There is a clear trend of decreasing mass as ageing temperature increases. The mass of copper on the sample specimens was estimated at approximately 101 g with a density of 8.96 g/cm<sup>3</sup> whereas the polymer PAI and PEI layer is only 460 mg with a density of 1.44 g/cm<sup>3</sup>.

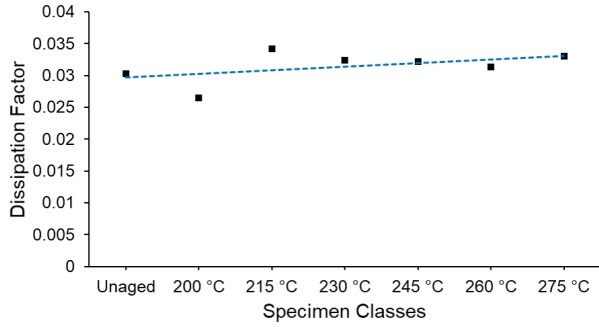
Fig. 10: Dissipation Factor for each of the specimen classes for the early onset ageing period of 100 h.

The dielectric impedance measurements are shown in Fig. 9 and Fig. 10, which show the measured capacitance and the dissipation factor (DF) for the different thermal specimen classes. The measurements have been averaged over the frequency range of 100 kHz to 1 MHz. Linear trend lines have been fitted to the measured data to ease the interpretation of the changes which have occurred. A capacitance of 6.2 pF is recorded for the unaged specimens which rises to 8.2 pF for the specimens which were aged at 275 °C as shown in Fig. 9. In the case of dissipation factor, for the unaged specimens a value of 0.03 was measured and at the more elevated temperature class that of 275 °C a value of 0.033 was measured.

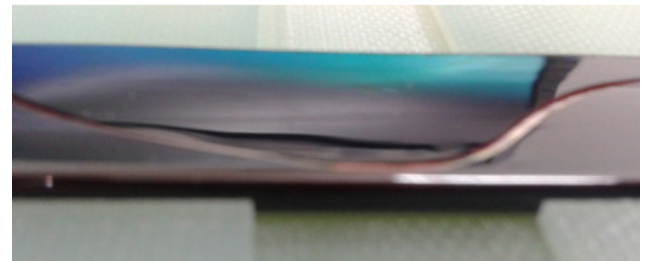
Fig. 17: Catastrophic failure of sample specimen aged at 200 °C (a) crack running the entire length of specimen (b) observed severe delamination underneath the cracked region.

In addition, some catastrophic failure modes were observed in the form of meandering cracks typically running the entire length of the magnet wire specimens which show the occurrence of severe delamination. A representative example of this phenomena is shown in Fig. 17.
